TRAVIS AIR FORCE BASE  
ENVIRONMENTAL RESTORATION PROGRAM

ANNUAL REPORT  
ON THE STATUS OF  
LAND USE CONTROLS  
ON RESTORATION SITES  
IN 2008

FINAL

60<sup>TH</sup> CIVIL ENGINEER SQUADRON  
Travis Air Force Base, California

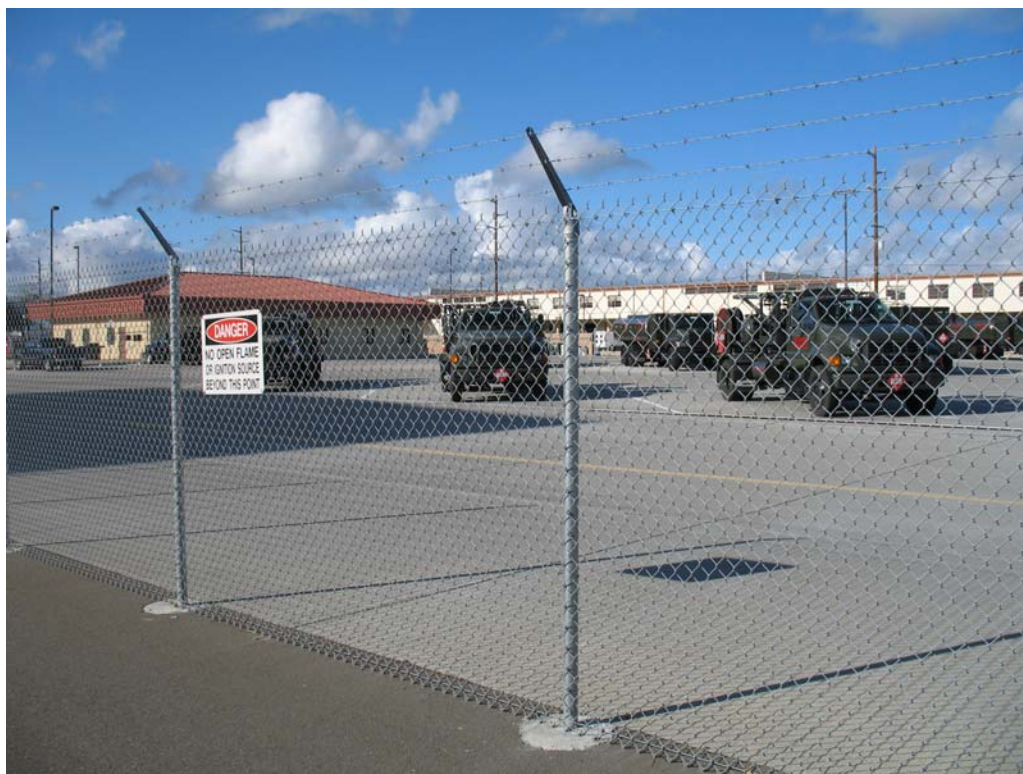
Photograph 1: Controlled Area at SS015.

The 2008 inspection of the LUCs at SS015 found that administrative controls and existing physical infrastructure are adequate to enforce the environmental restriction. In addition, the inspectors noted a potential for additional physical barriers (i.e., fences) and signage to adversely impact vehicle operations. There is no evidence that the cadmium-impacted soil beneath the concrete parking area has been disturbed. Photograph 1 in Appendix B of this report shows the controlled area at SS015.

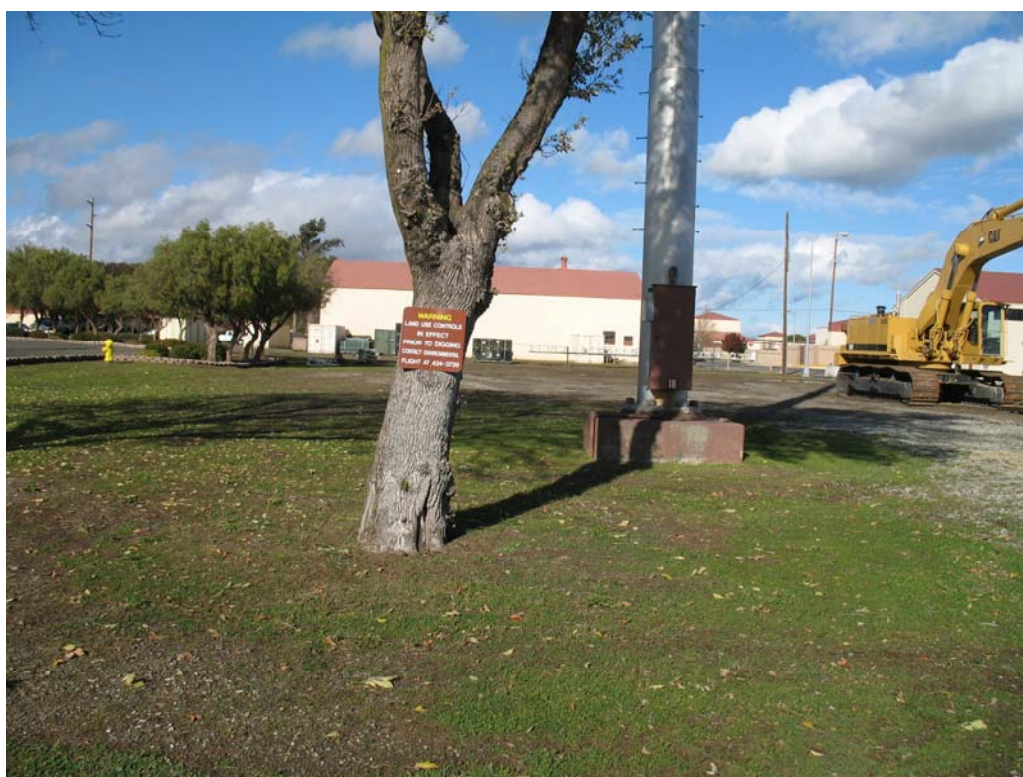
Photograph 2: Controlled Area at SS016.

The 2008 inspection of the LUCs at SS016 found that administrative controls are adequate to enforce the restriction, so physical barriers (i.e., fences) are not needed. There is no evidence that the PAH-impacted soil has been disturbed either with or without proper authorization. A warning sign has been posted on a tree in the middle of the site to notify base workers of the

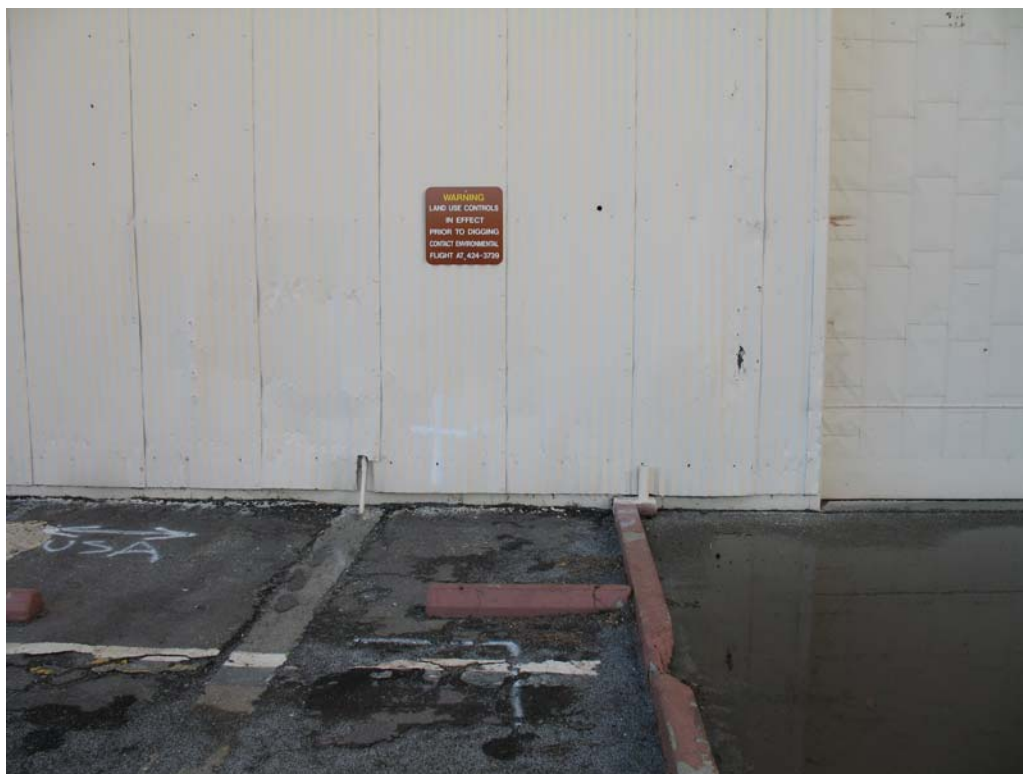
The 2008 inspection of the LUCs at the soil portion of SD033 found that administrative controls are adequate to enforce the restriction, so physical barriers (i.e., fences) are not needed. There is no evidence that the cadmium- and benzo(a)pyrene-impacted soil has been disturbed. Warning signs have been posted on both sides of Facility 810 to notify base workers of the presence of the controlled area. Photographs 3 and 4 in Appendix B of this report show the controlled soil areas at SD033.

Photograph 3: Warning Sign at Controlled Area on East Side of SD033 (soil).

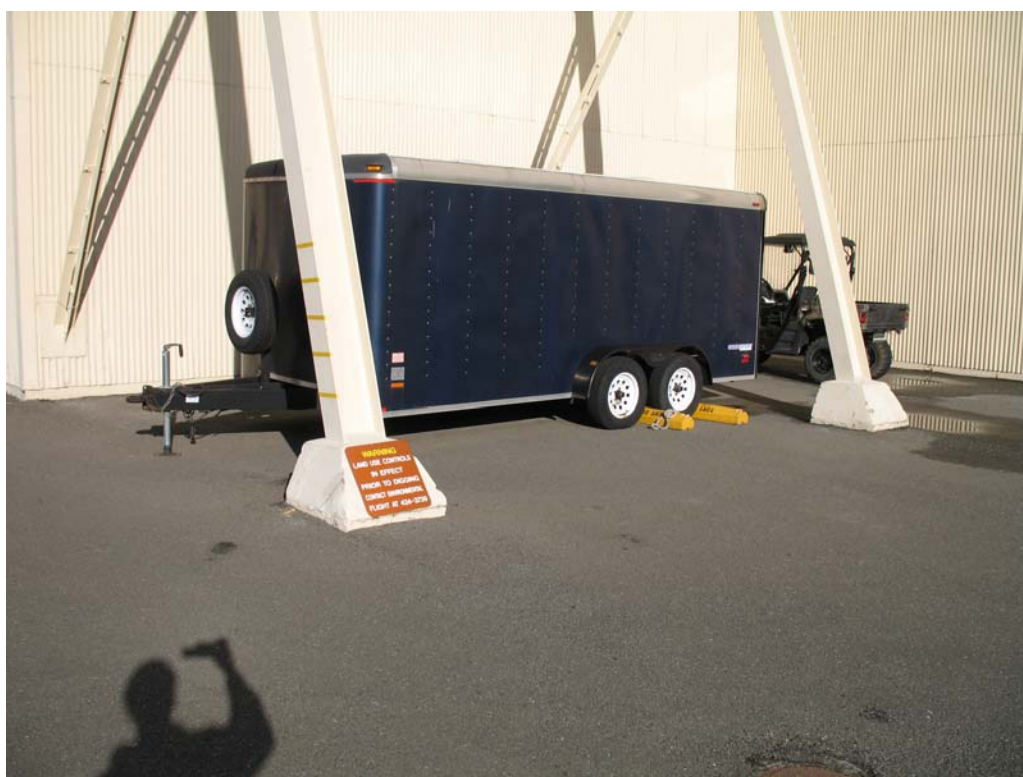
Photograph 4: Warning Sign at Controlled Area on West Side of SD033 (soil).

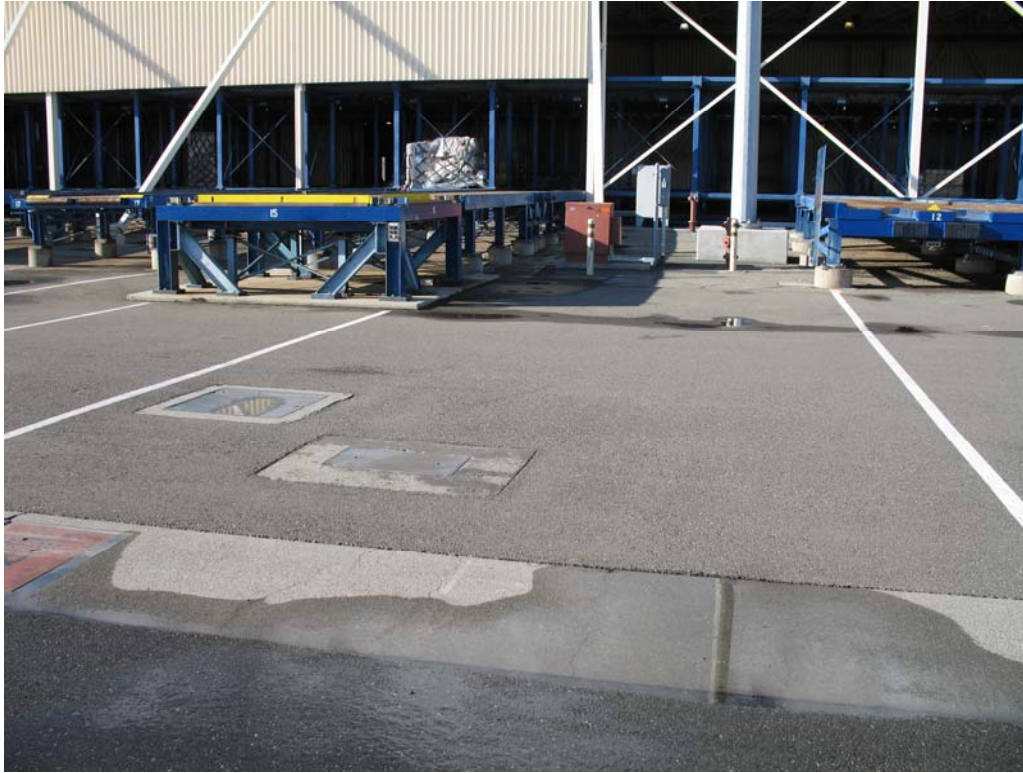
Photograph 5: Controlled Area on Southeast Side of SD037

The 2008 inspection of the LUCs at SD037 found that administrative controls are adequate to enforce the restriction, so physical barriers (i.e., fences) are not needed. Although the contaminated soil cannot be seen (since it is covered with asphalt), the asphalt work area surrounding Building 977 is in excellent condition and has not required maintenance in the past year. So, there is no evidence that the PAH-, lead-, and TPH-impacted soil has been disturbed.

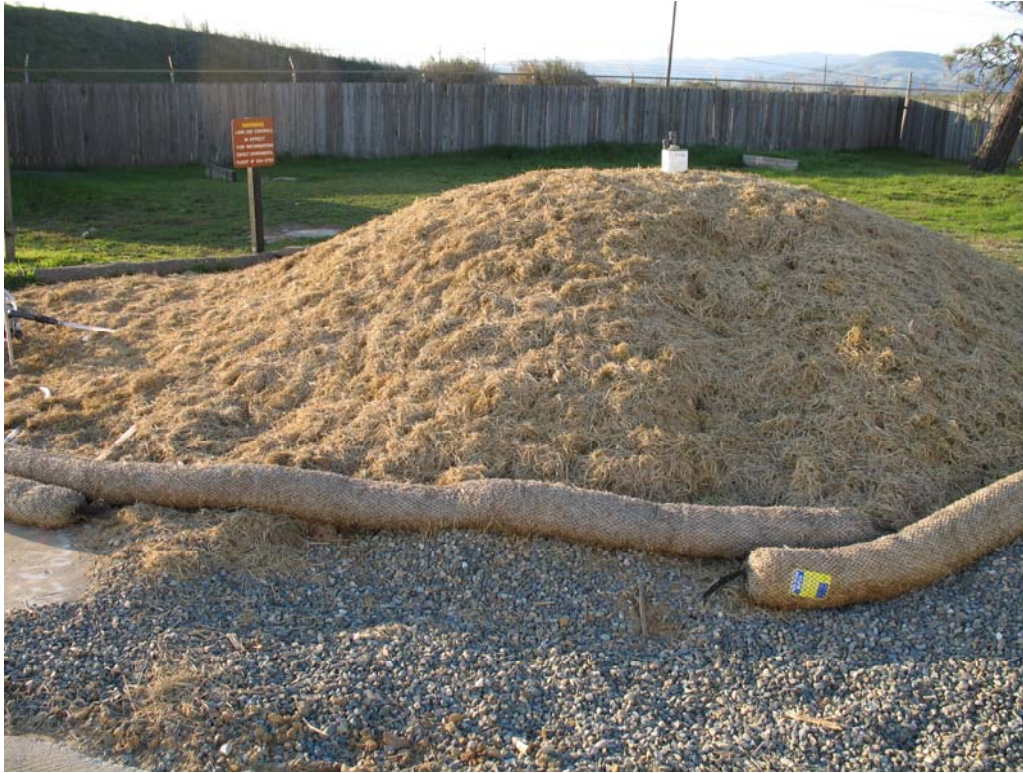
The 2008 inspection of the LUCs at DP039 found that administrative controls and a LUC warning sign are still adequate to enforce the restriction, so physical barriers (i.e., fences) are not needed. The lead-impacted soil has been excavated and sent by truck to an appropriate landfill as a result of the bioreactor demonstration project. Travis AFB will continue to enforce the DP039 controls until the upcoming bioreactor report has received regulatory review and the base receives permission to officially remove the controls. Photograph 7 in Appendix B of this report shows the surface of the bioreactor over the controlled area at DP039. The warning sign that notifies visitors to the site of the presence of LUCs can be seen in the background. Building 755 will soon be vacated and is scheduled for demolition in 2009.

Photograph 7: Controlled Area at DP039 (Post Bioreactor Construction)

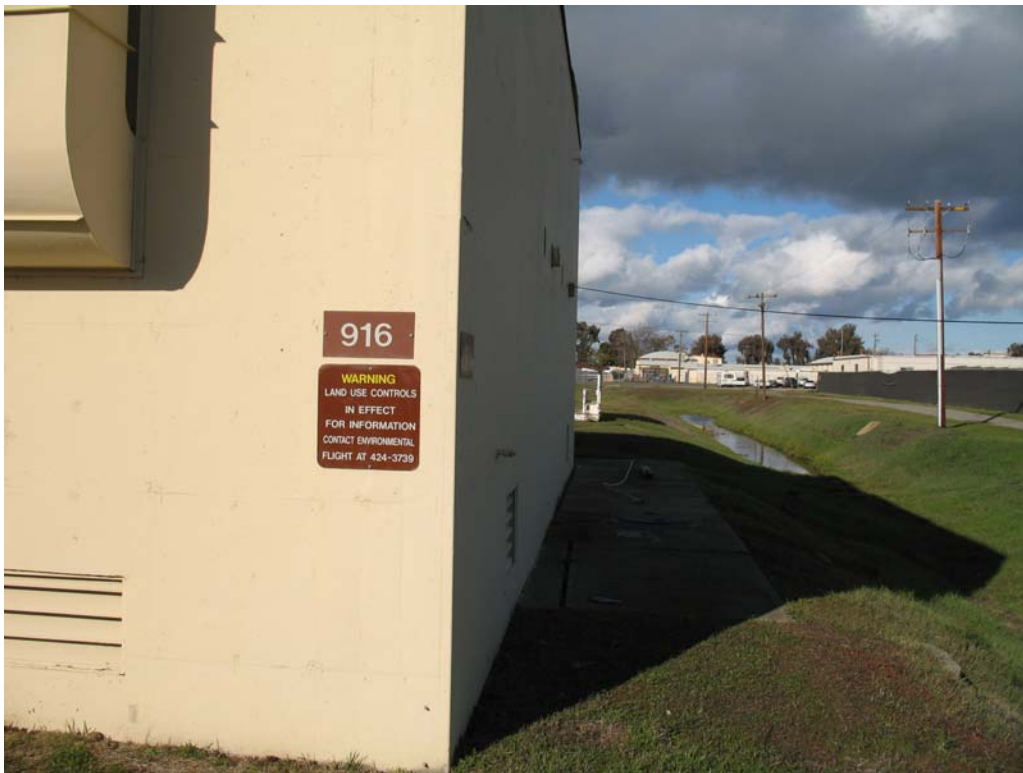
The 2008 inspection of the LUCs at SD043 found that administrative controls are adequately enforcing the restriction, so physical barriers (i.e., fences) are not needed. There is no evidence that any soil disturbances in the vicinity of the concrete pad and generator took place in 2008. Photograph 8 in Appendix B shows the east side of the generator and pad south of Building 916, and photograph 9 shows the warning signs in relation to the west side of the controlled area at SD043.

Photograph 8: Sign Near East Side of Installed Generator at SD043

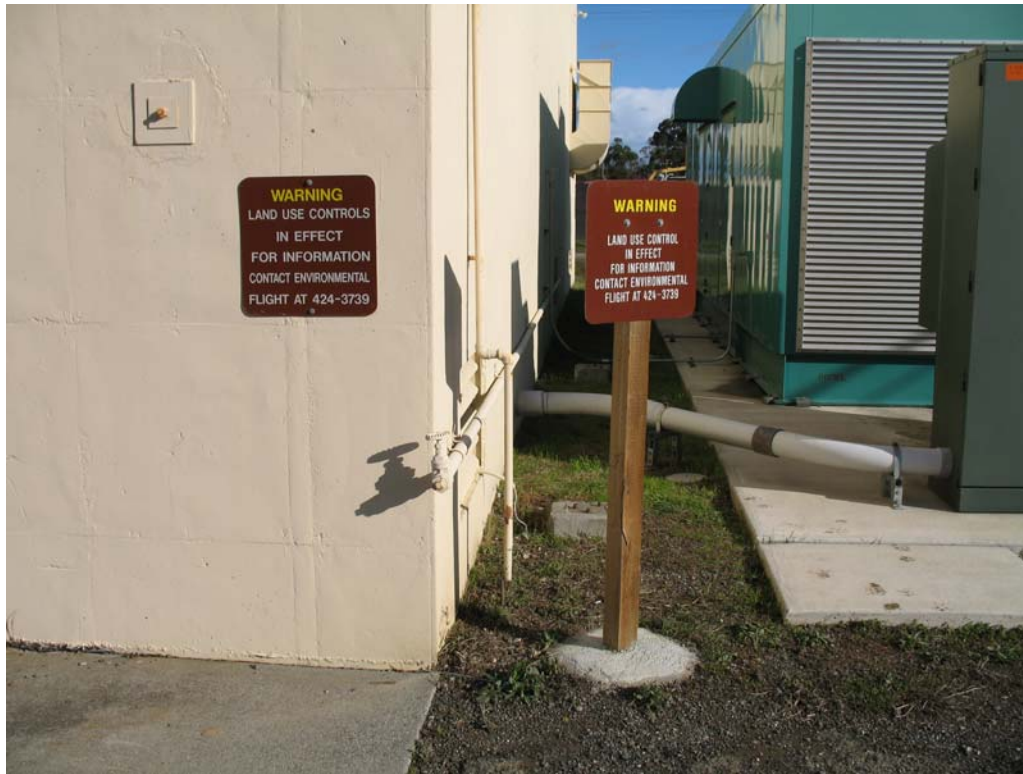
Photograph 9: Generator Pad and Warning Signs at SD043. Stanchion of Former Pad with Leaking Transformers is visible in the foreground.

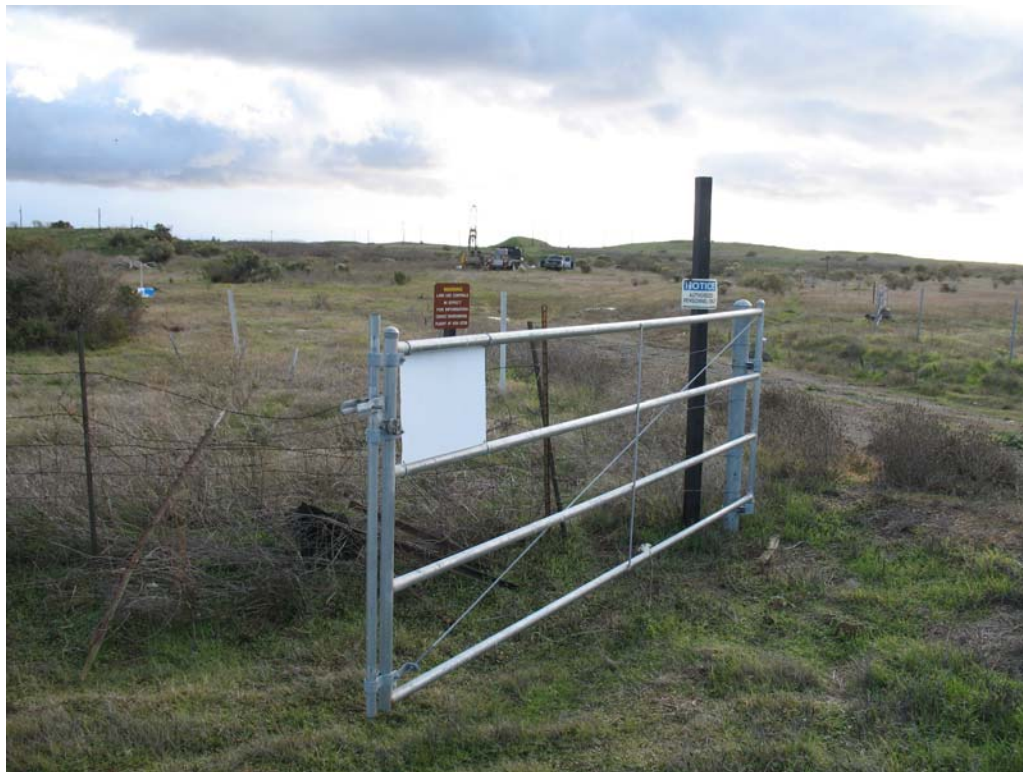
The 2008 inspection of the LUCs at LF044 found the fence and signs to be in excellent physical condition, except for the part of the fence that was cut to allow base firefighters access to the site to respond to the October 2008 fire. Preliminary repairs have been made to the fence, and the base will include additional repairs in a 2010 LUC maintenance project.

There is no evidence to suggest that the property is being used for other than industrial purposes. Both gates were locked, and the Asset Management Flight keeps a copy of the keys. Photograph 10 of Appendix A shows the warning sign at the north access gate, and photograph 11 shows the west side of the fence. The gates are in excellent physical condition, and warning signs at each gate are clearly visible.

Photograph 10: Warning Signs at LF044 Entrance near the North Access Gate.

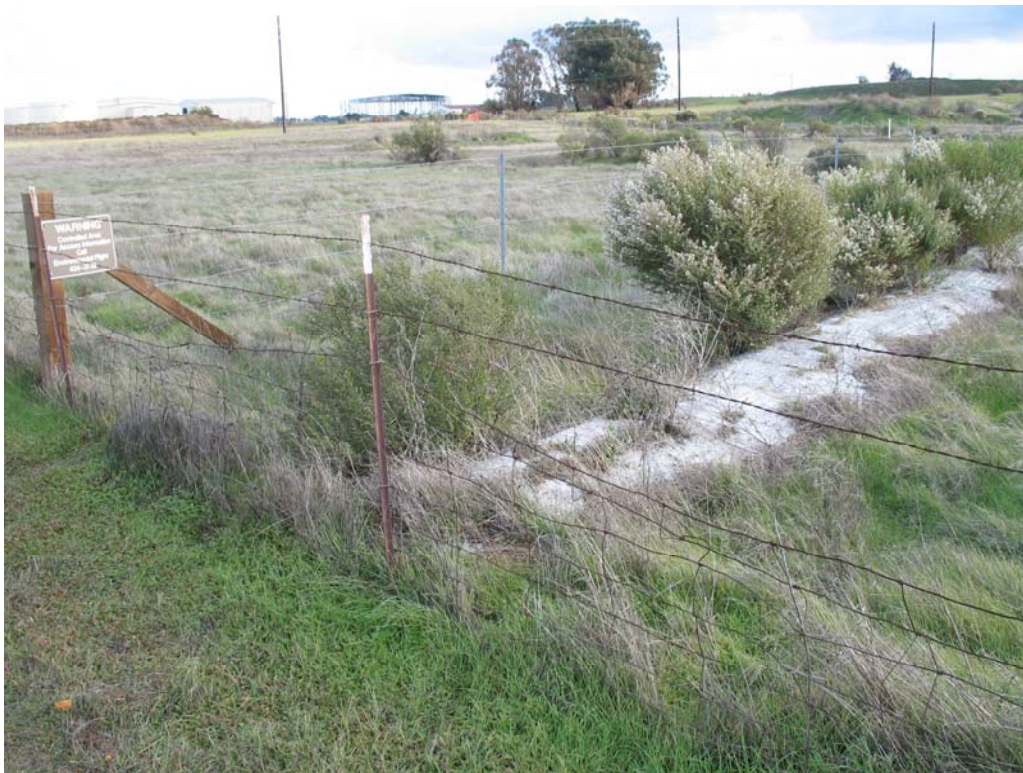
The 2008 inspection of the LUCs at LF044 found the berm to be in good to excellent physical condition. The responders to the October 2008 fire did drive their firefighting equipment over the berm in one location, resulting in slight damage to the berm surface.

Native grass, weeds and small shrubs have grown over portions of the berm, which serves to increase its cohesiveness. The base has not received sufficient rainfall to demonstrate that the berm is performing as designed, but the damage to the berm from the October 2008 firefighting response should not adversely impact its ability to prevent contaminated sediment from entering the nearby wetlands. No accumulation of surface runoff was observed along the berm, and the adjacent wetlands are dry. Photograph 12 of Appendix B was taken during the inspection of the berm and the north side of the fence.

Photograph 12: Fencing and Berm on East Side of LF044.

The inspectors noted the slight degradation of the fence and berm at LF044 as a result of the base response to a brush fire in October 2008. Repairs and potential upgrades to the physical controls at LF044 will be scheduled in 2010 as part of a basewide LUC maintenance project.

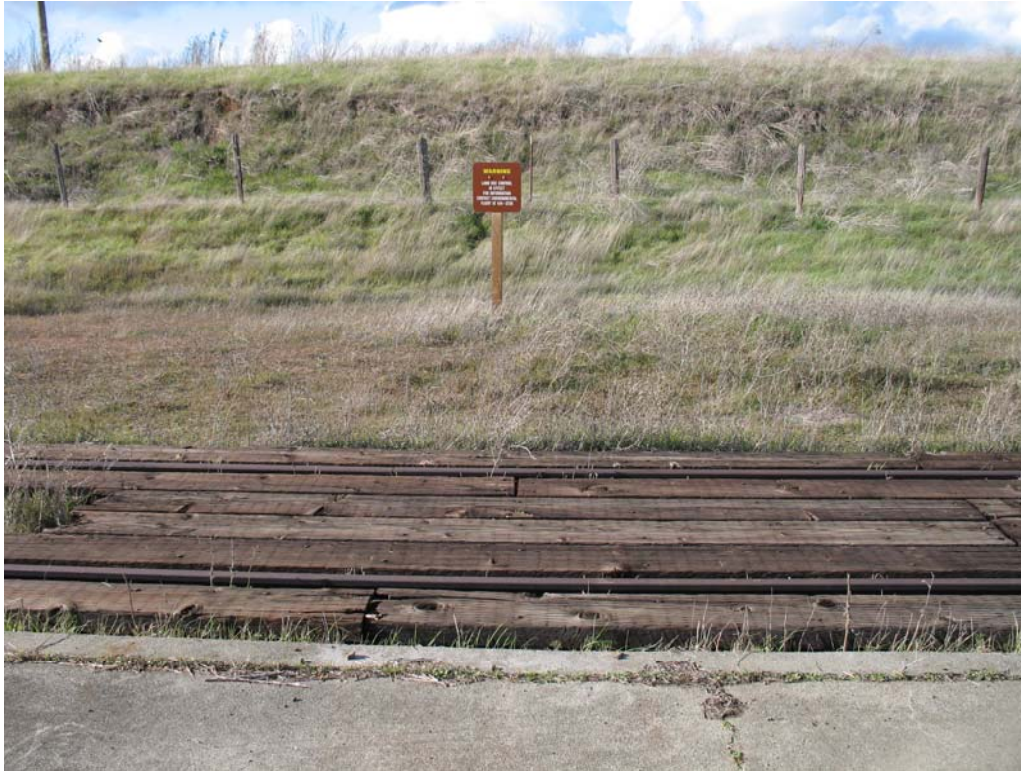
Photograph 13: Warning Sign at West Side of SS046.

The 2008 inspection of the LUCs at SS046 found that administrative controls and two warning signs are adequate to enforce the restriction, so additional physical barriers (i.e., fences not associated with the Grazing Management Unit) are not needed. There is no evidence that the contaminated soil has been disturbed. Photograph 13 of Appendix B of this report shows the warning sign at the west end of the SS046 controlled area, and photograph 14 shows the warning sign at the east end of the controlled area.

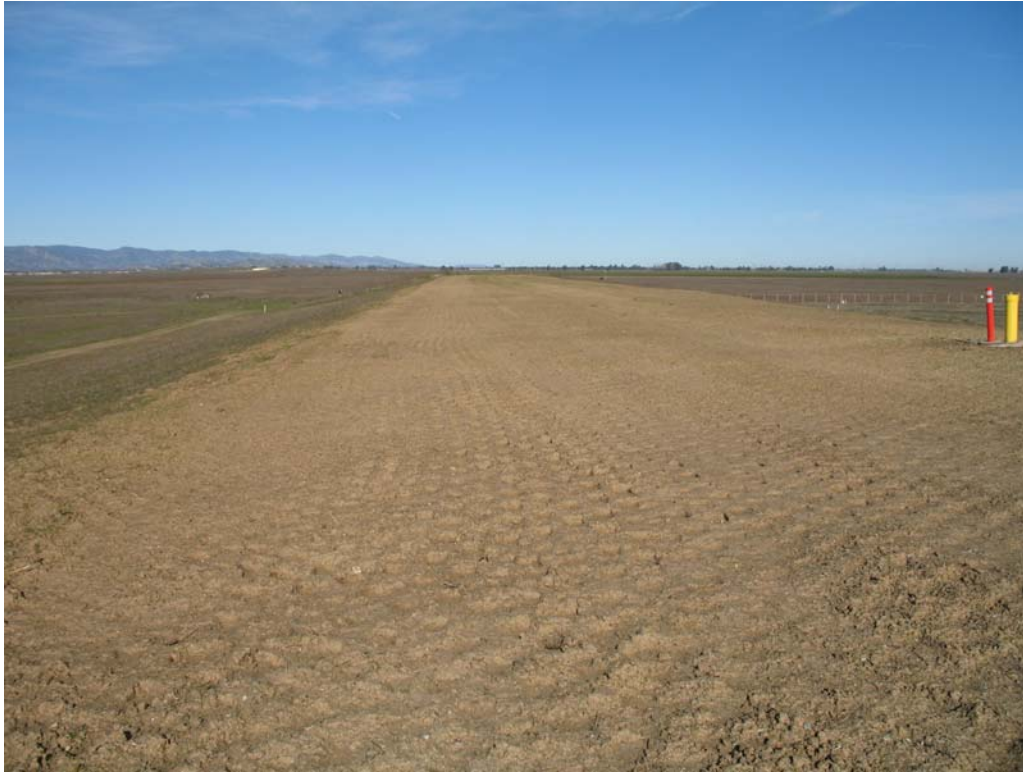
The 2008 inspection of the LUCs at LF007 found that the current administrative and physical controls are adequate to enforce the restrictions. There is no evidence that the contaminated soil at LF007 has been disturbed. Photograph 15 in Appendix B of this report shows the top of CAMU Phase 3 after the completion of maintenance activities. Photographs 16 shows the south side of the CAMU, and Photograph 17 shows the warning sign at the CAMU entrance. There is also no evidence that the active operations at Buildings 1360, 1365 and 1370 are compromising the LUCs in place on the portions of LF007 discussed above.

Photograph 15: Top of CAMU Phase 3 after Preventive Maintenance.

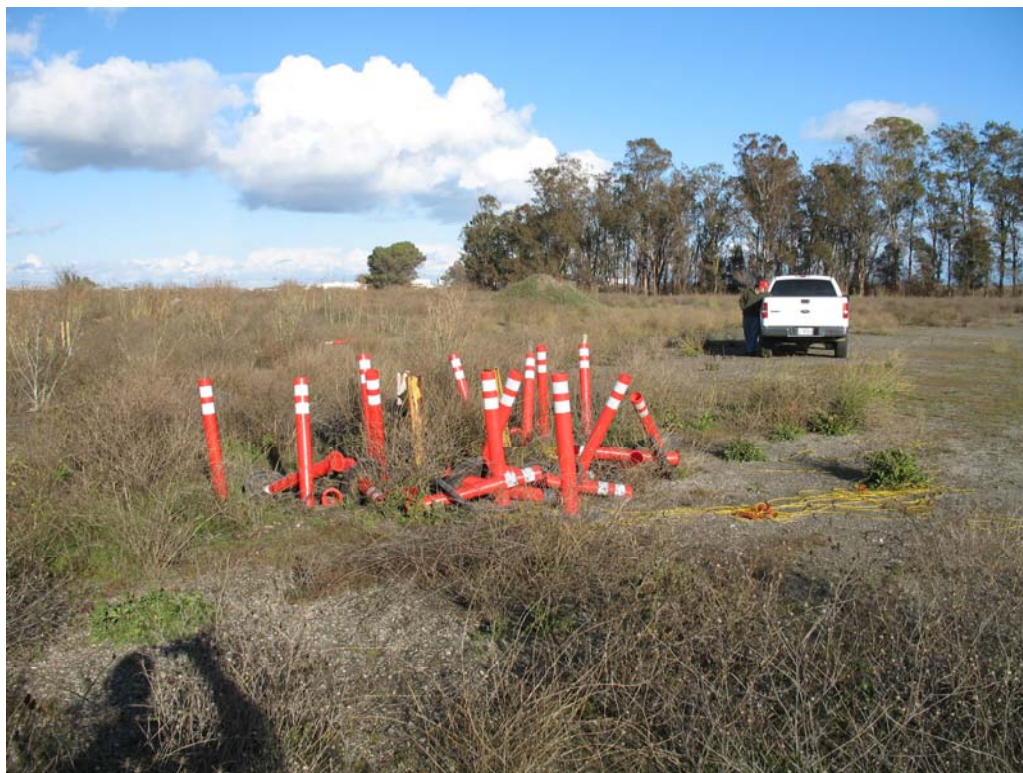
Photograph 18: Controlled Area at FT005.

The 2008 inspection of the LUCs at FT005 found that administrative controls are adequate to enforce the restriction, so additional physical barriers (i.e., fences not associated with the Explosive Ordnance Disposal area) are not needed. There is no evidence that an unauthorized

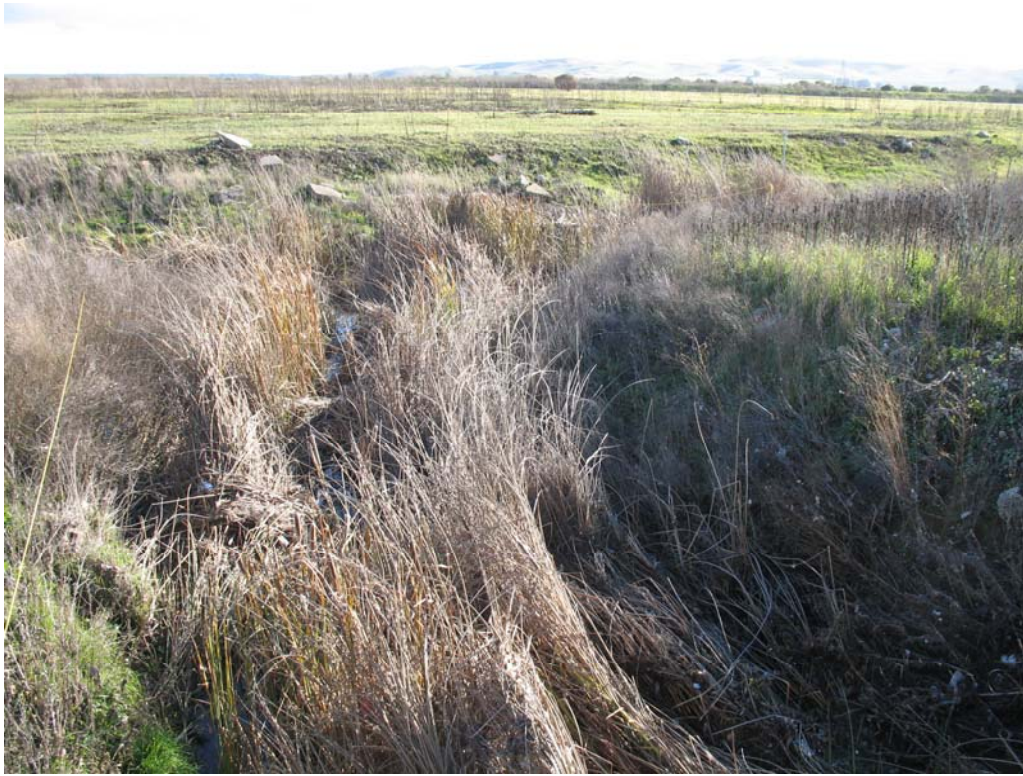
Photograph 19: Controlled Area at Sediment Portion of SD033.

The inspectors also visited the sediment portion of SD033 and noted its remote location and large amount of natural vegetation both within the creek and along both of its sides. They concluded that signage is not needed to maintain the controls at this site and could pose a potential hazard to emergency vehicles that may need to access the area in the future. Photograph 19 in Appendix B shows the controlled sediment area at SD033.

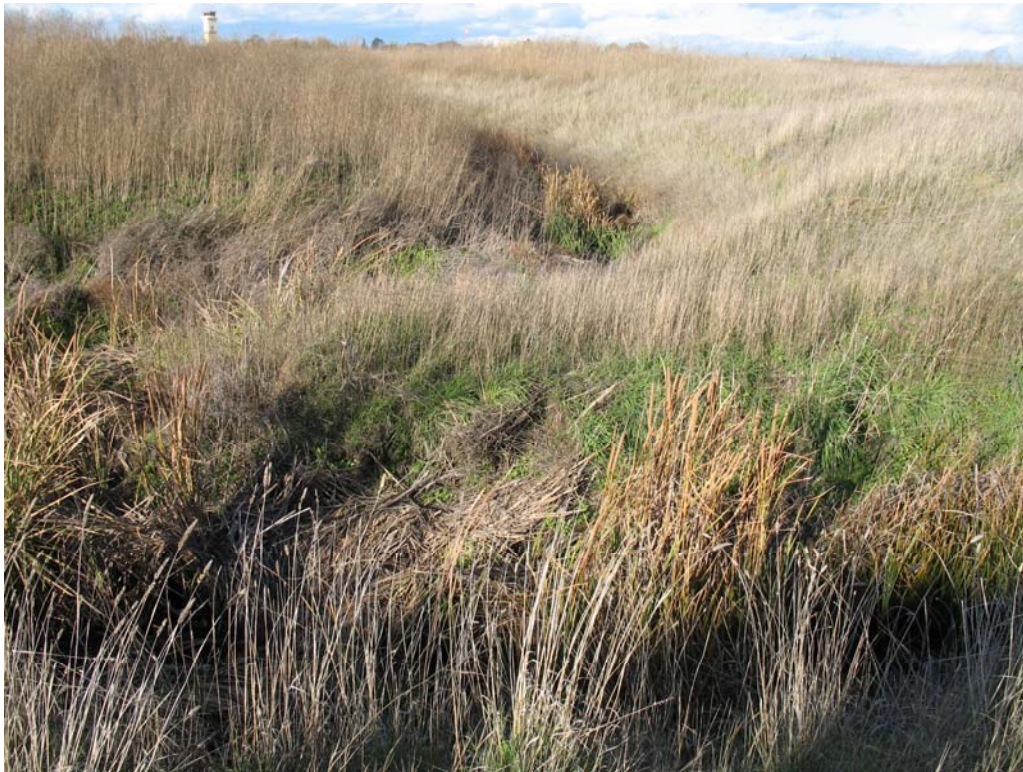
Photograph 20: Controlled Area at SD001.

The 2008 inspection of SD001 found that administrative controls are adequate to enforce the sediment disturbance restriction, so physical barriers are not needed. There is no evidence that the contaminated sediment has been disturbed from unauthorized activity. Photograph 20 of Appendix B of this report shows the controlled area at SD001.
