TRAVIS AIR FORCE BASE
ENVIRONMENTAL RESTORATION PROGRAM

**ANNUAL REPORT
ON THE STATUS OF
LAND USE CONTROLS
ON RESTORATION SITES
IN 2017**

FINAL

APRIL 2018

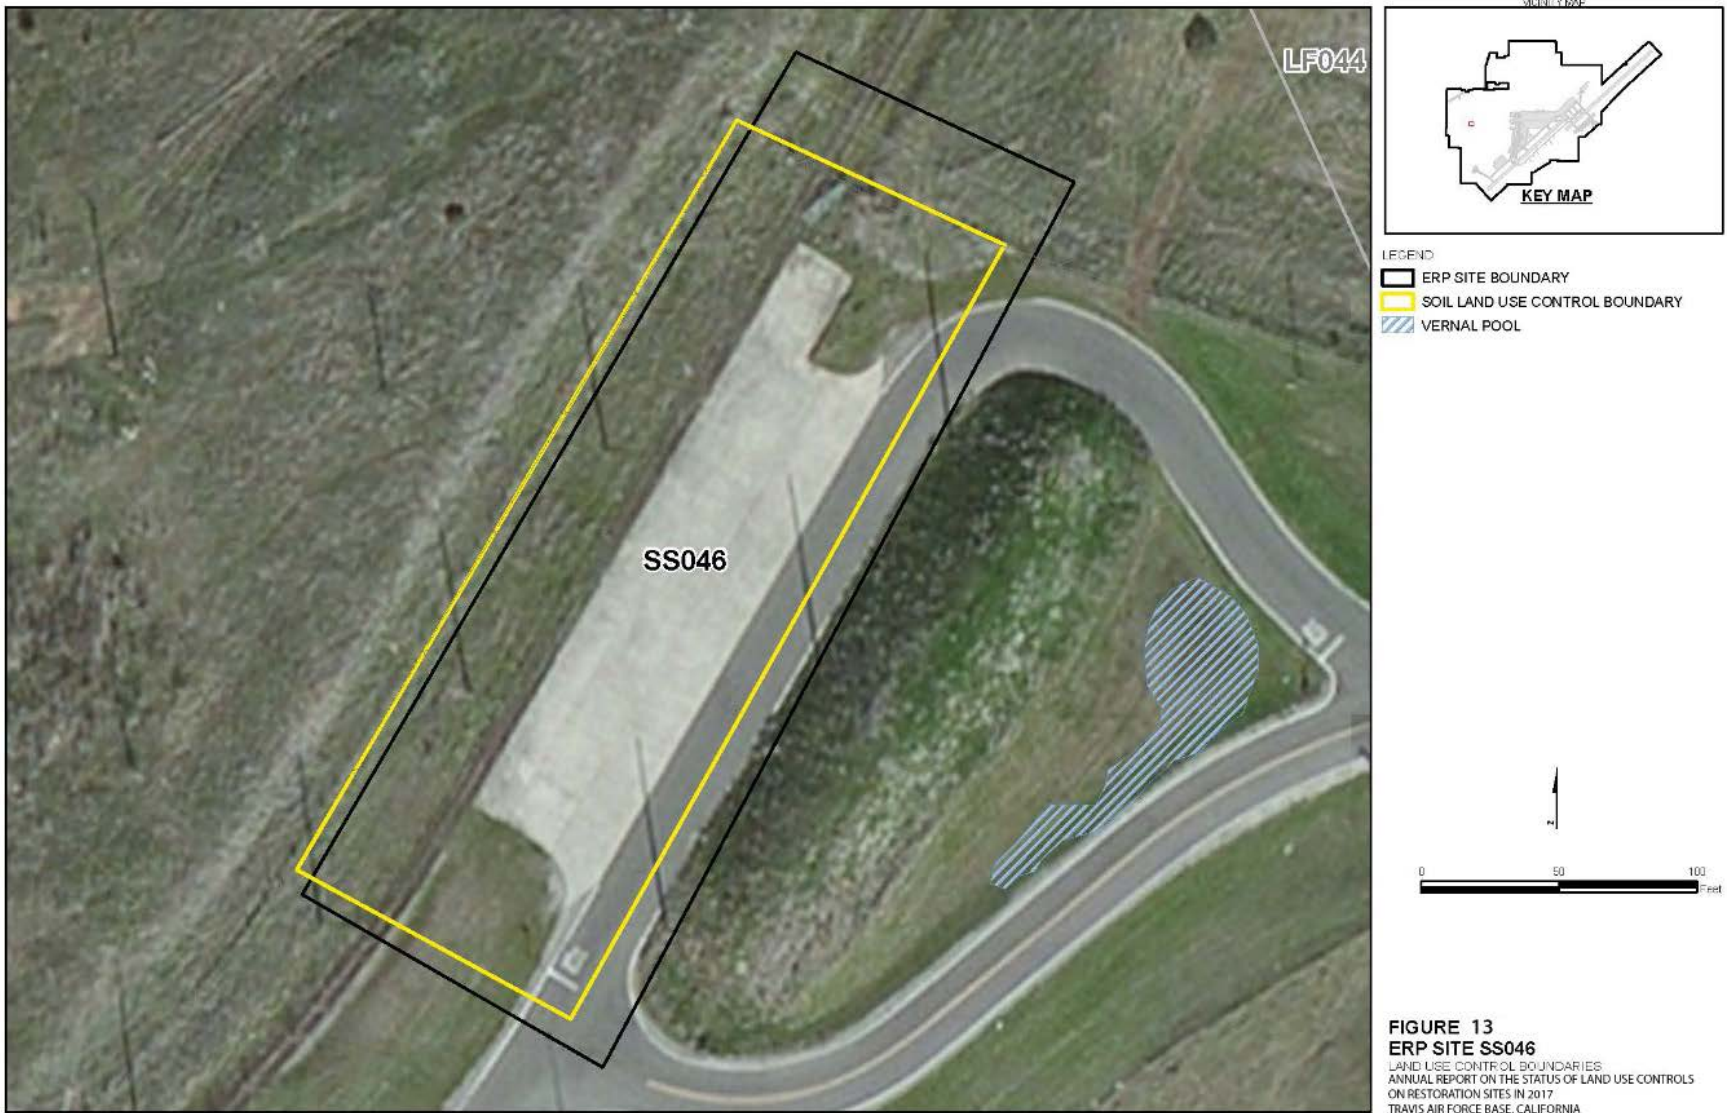
FIGURE 13
ERP SITE SS046
 LAND USE CONTROL BOUNDARIES
 ANNUAL REPORT ON THE STATUS OF LAND USE CONTROLS
 ON RESTORATION SITES IN 2017
 TRAVIS AIR FORCE BASE, CALIFORNIA

The 2017 inspection of the LUCs at SS046 found that administrative controls and two warning signs are adequate to enforce the restriction, so additional physical barriers (i.e., fences not associated with the Grazing Management Unit) are not needed. There is no evidence that the contaminated soil has been disturbed. Photograph 36 of Appendix A of this report shows the warning sign at the east end of the SS046 controlled area, and Photograph 37 shows the warning sign at the west end of the controlled area.

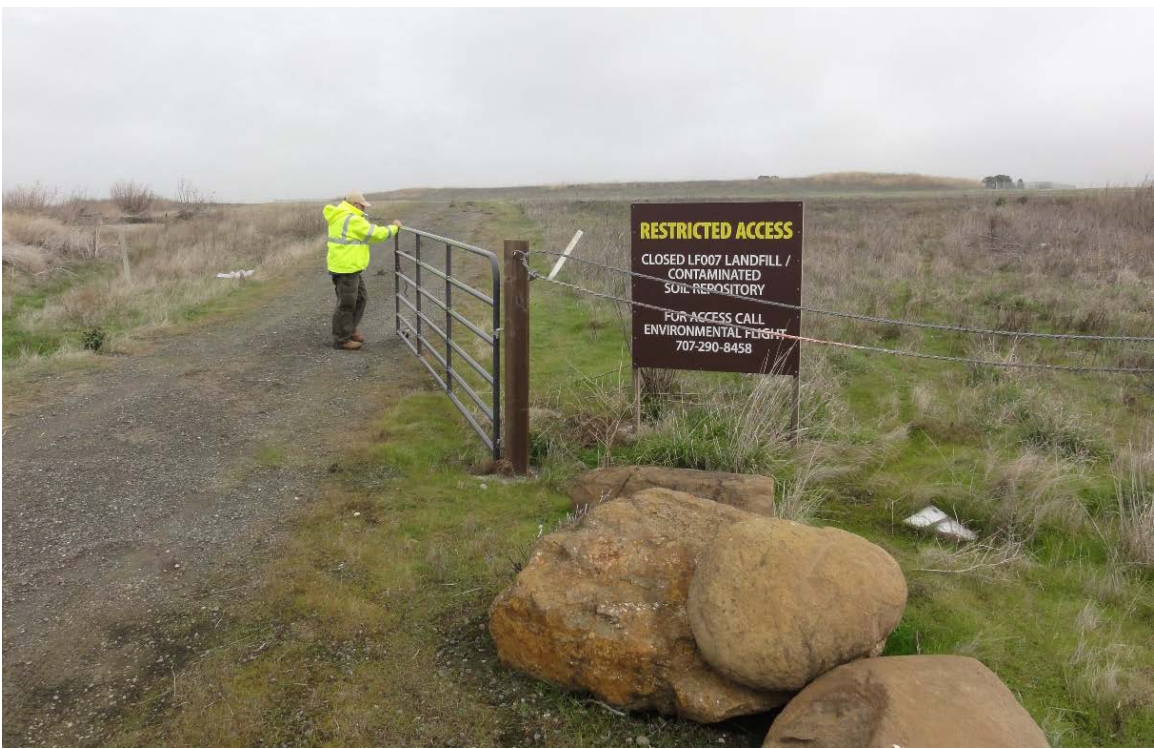
Photograph 5: LF007 Entrance Gate with New Warning Sign [N]

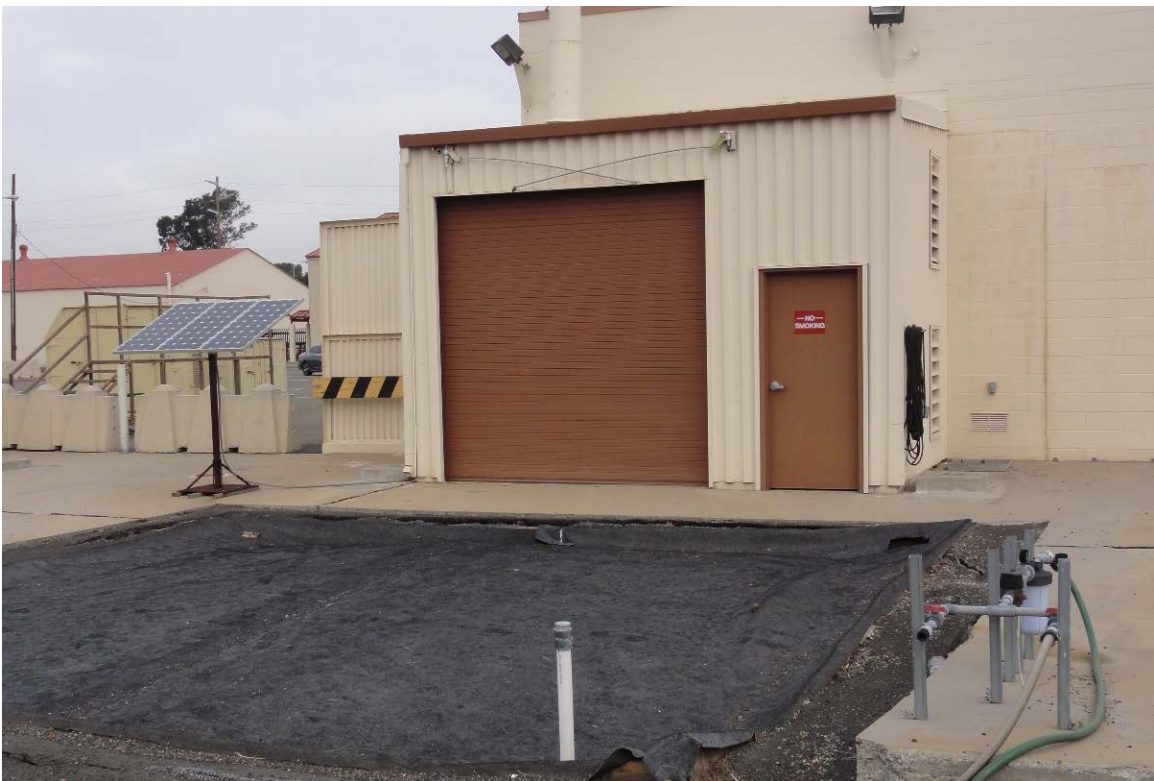
Two warning signs have been placed on the two office doors of Building 18. Photograph 14 in Appendix A of this report shows the SS016 bioreactor, and Photograph 15 shows the warning sign on the north side of Building 18.

Photograph 14: SS016 Bioreactor [NNW]

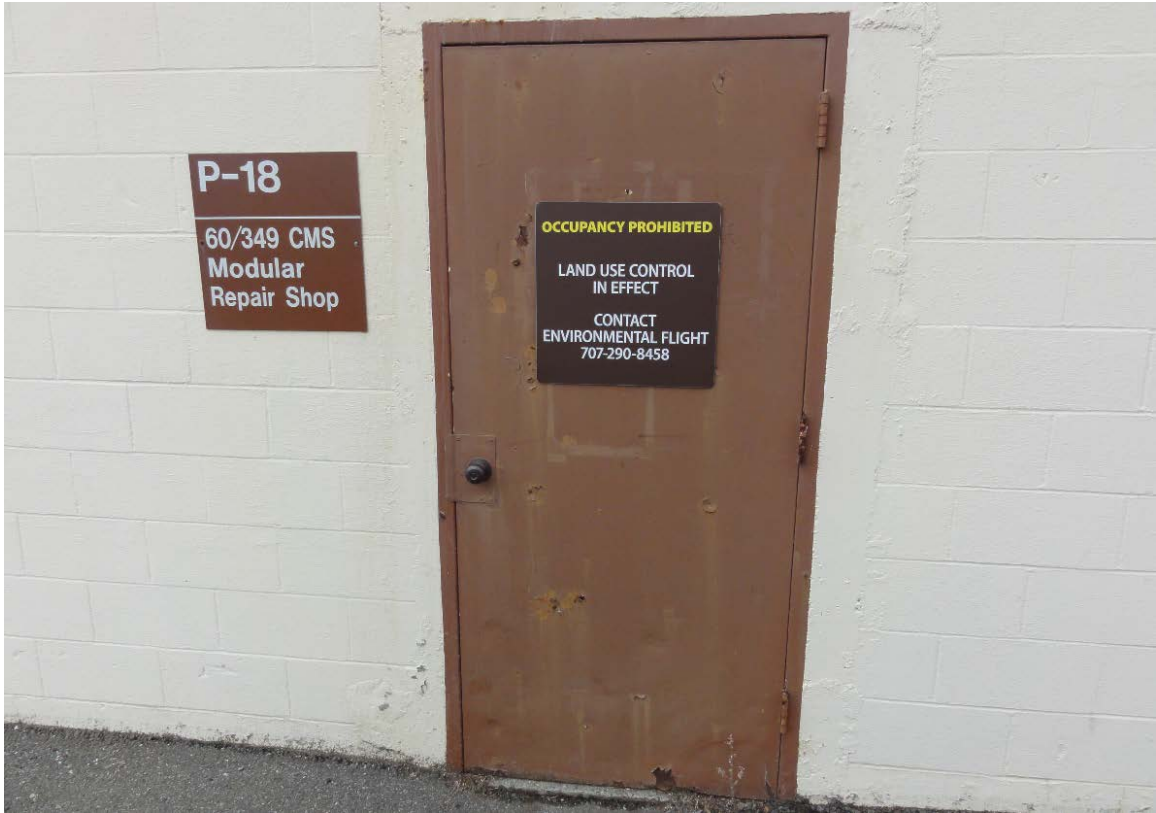
Photograph 15: SS016 Building 18 [S]

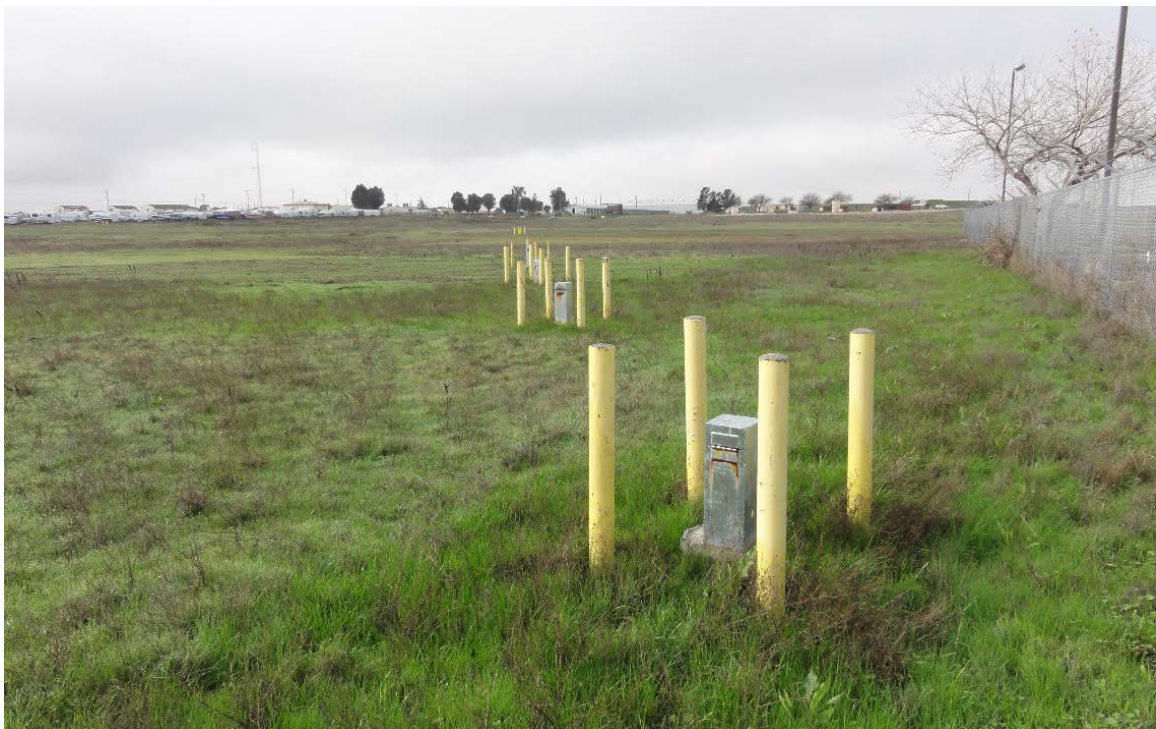
The 2017 inspection of the groundwater LUCs at DP039 found that administrative controls are adequate to enforce the groundwater and vapor intrusion restrictions. There is no evidence of any activities that could expose base personnel to contaminated groundwater or vapor, and no new non-environmental construction has taken place at the site. The inspectors noted the new sign on the north side of the phytoremediation tree stand. The DP039 wells and piezometers have either stovepipe or flush mounted completion, depending on the surface where the wells have been installed. The LUC inspection identified no evidence of damage or excessive wear that could adversely impact the use of these wells. Photograph 29 shows the entrance to the phytoremediation area, and Photograph 30 shows a portion of the DP039 biobarrier.

Photograph 30: Controlled Area at DP039 (Biobarrier) [W]

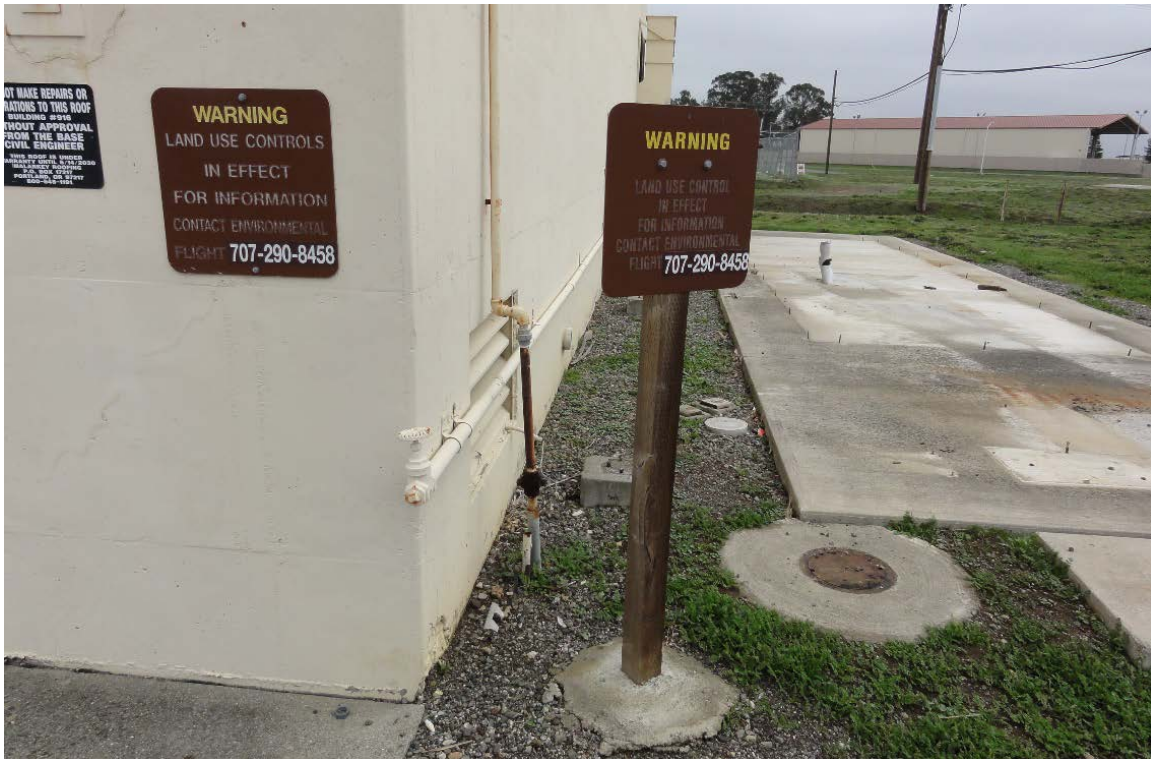
Photograph 32: Generator Pad and Warning Signs at SD043. Stanchion of Former Pad with Leaking Transformers is visible behind the warning sign post. Generator has been relocated. [E]

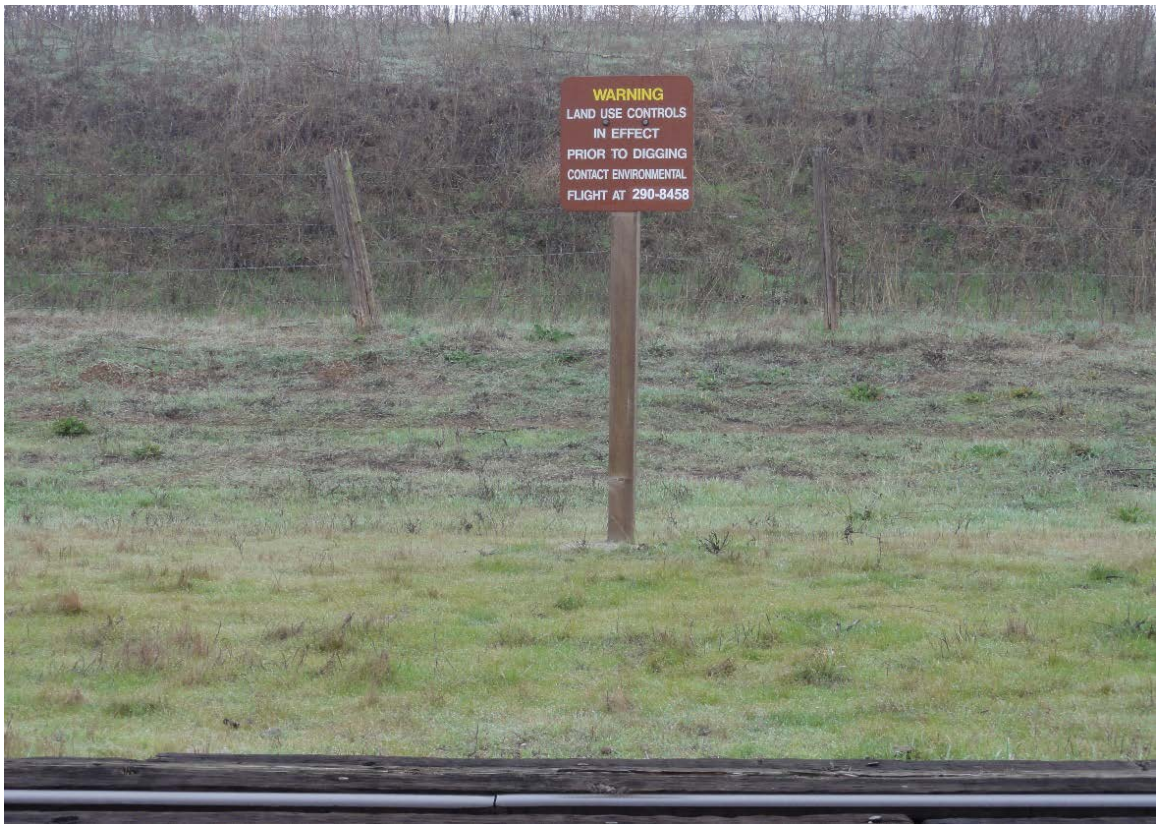
Photograph 37: Warning Sign at West Side of SS046 [NW]
