ENVIRONMENTAL RESTORATION PROGRAM

West/Annexes/Basewide Operable Unit
Travis Air Force Base

ANNUAL REPORT ON THE STATUS OF LAND USE CONTROLS ON RESTORATION SITES

JANUARY 2004

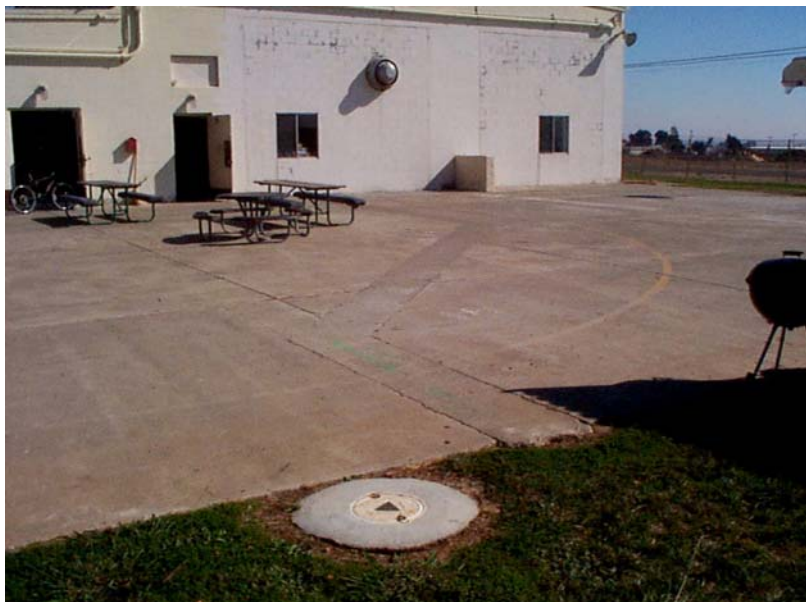
Figure 2: Lead-Impacted Soil at the Battery Shop

Note: the lead-impacted surface soil surrounds the monitoring well that is shown in the foreground. The well was placed within the former sump area. The contaminated area extends laterally approximately twelve feet from the well, except where there is concrete.

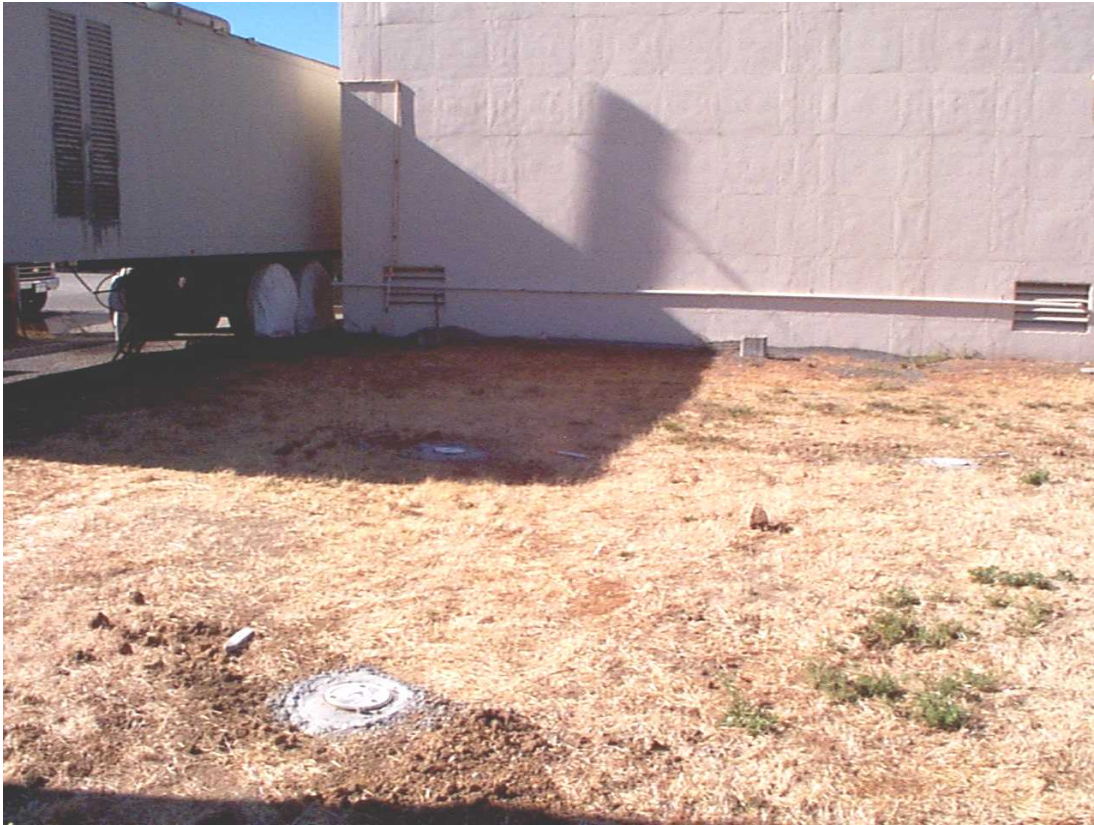
Figure 4: PCB-Impacted Soil at Building 916

Note: the PCB-impacted surface and subsurface soil extends laterally from the southwest corner of Building 916 to approximately ten feet in an eastern direction and five feet in a southern direction. In the above photograph, this area is covered by the shadow. It extends vertically to the water table.

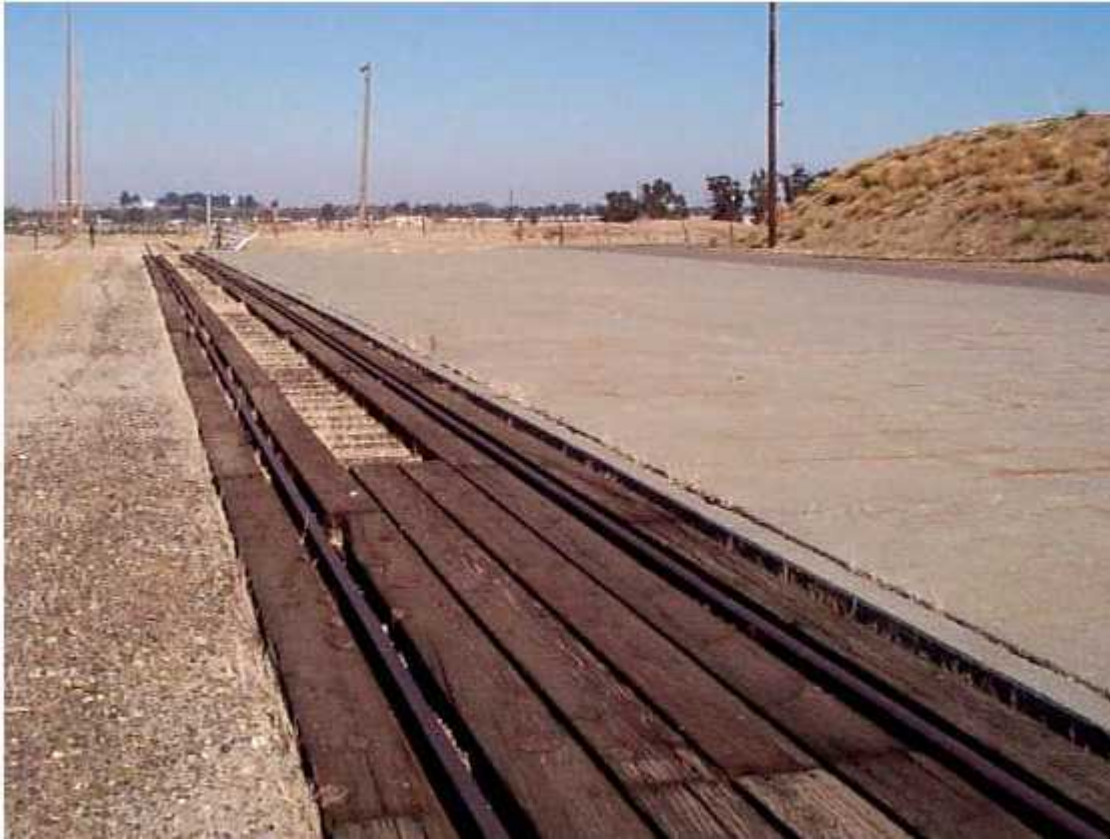
Figure 8: Metals-Impacted Soil at the Railhead Munitions Staging Area

Note: Most of the contaminants are found in the soil beneath the railroad tracks. Figure 7 shows the three small areas where metals concentrations are elevated. In this eastern view of the site, two of the three areas are located beyond the concrete pad in the background.

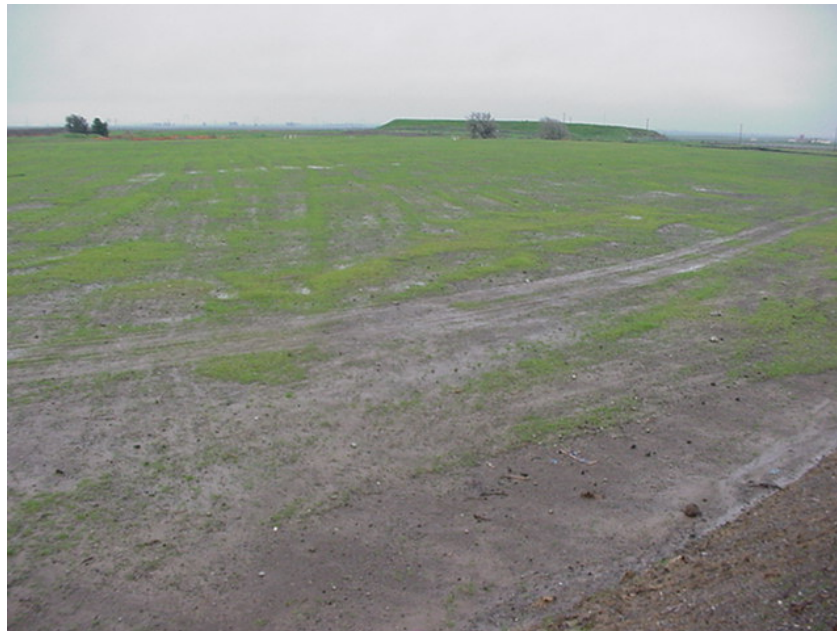
Figure 10: Landfill #2 after the Completion of CAMU Phase 1

Note: The CAMU will be built in four phases. Phases 1 and 2 are complete, and the remaining two phases will be built through 2008. The base small arms range is located southeast of the CAMU foundation.

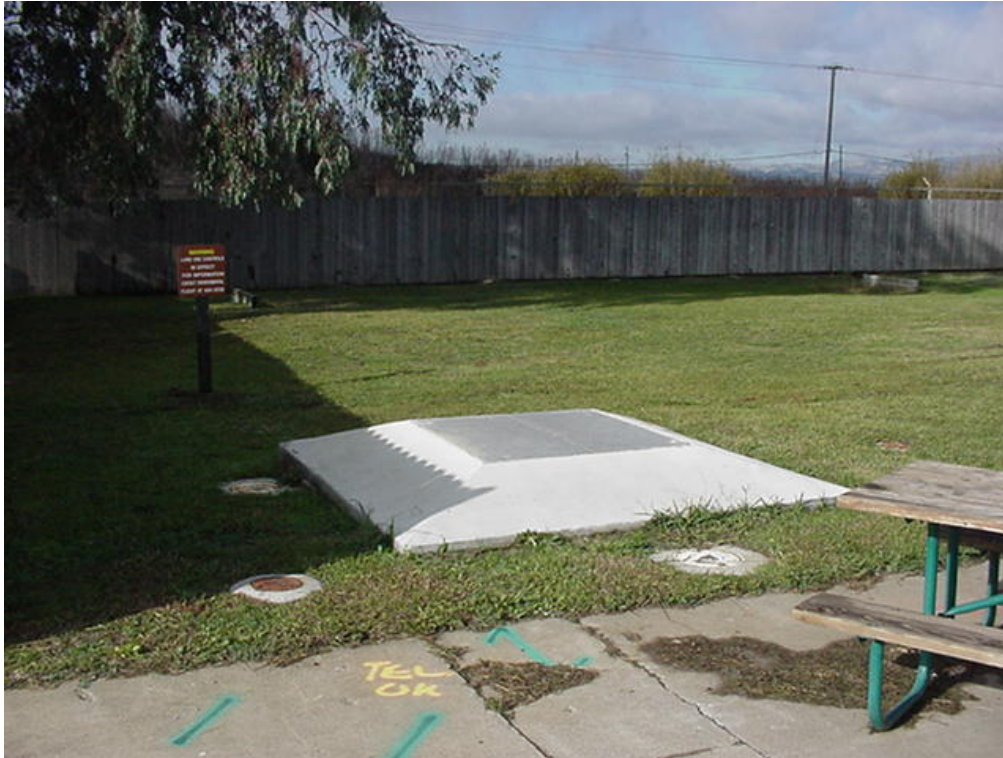
The 2003 inspection of the LUCs at DP039 found that administrative controls are adequate to enforce the restriction, so physical barriers (i.e., fences) are not needed. There is no evidence that the lead-impacted soil has been disturbed. Photograph 1 in Appendix B shows the controlled area at DP039, and Photograph 2 shows a warning sign that has been placed in the vicinity of the LUC area to ensure that visitors and occupants of Building 755 are aware of the presence of LUCs. Identical signs have been placed in the other LUC areas in the WABOU.

Photograph 1: Controlled Area at DP039.

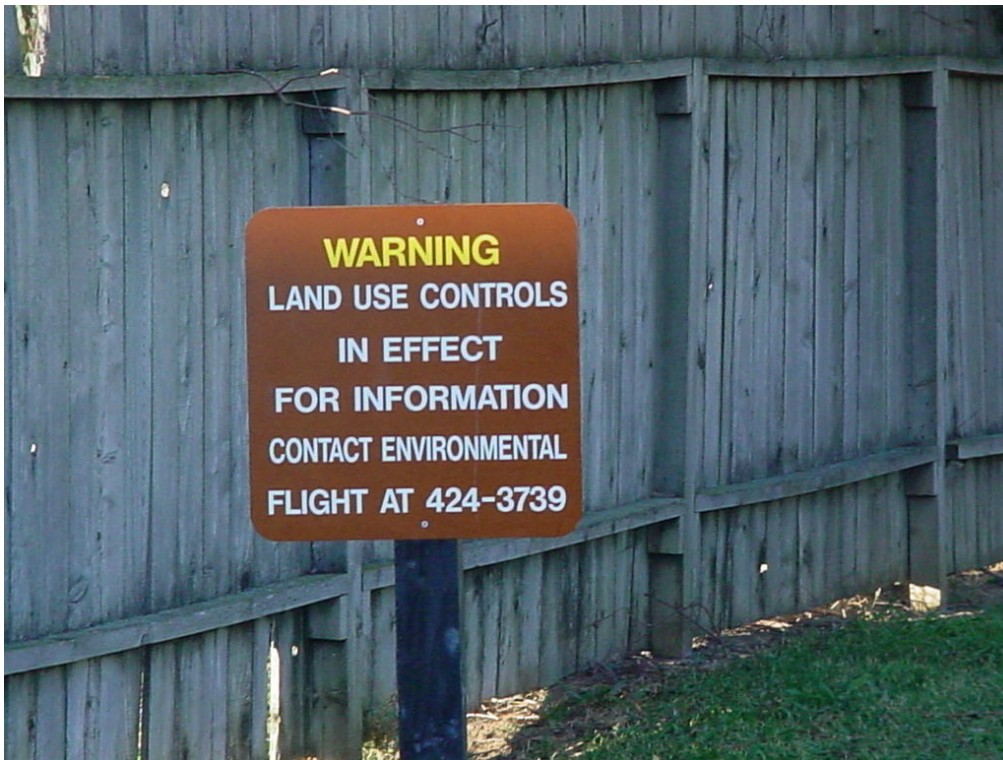
Photograph 2: Warning Sign at DP039.

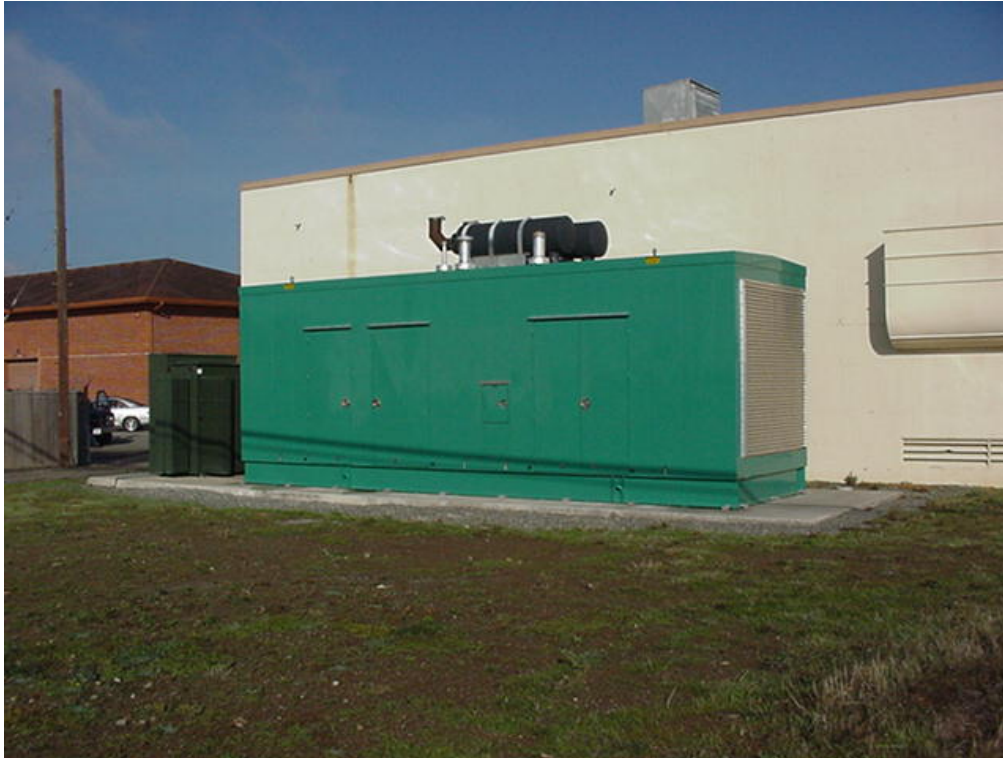
Photograph 3: Installed Generator at SD043.

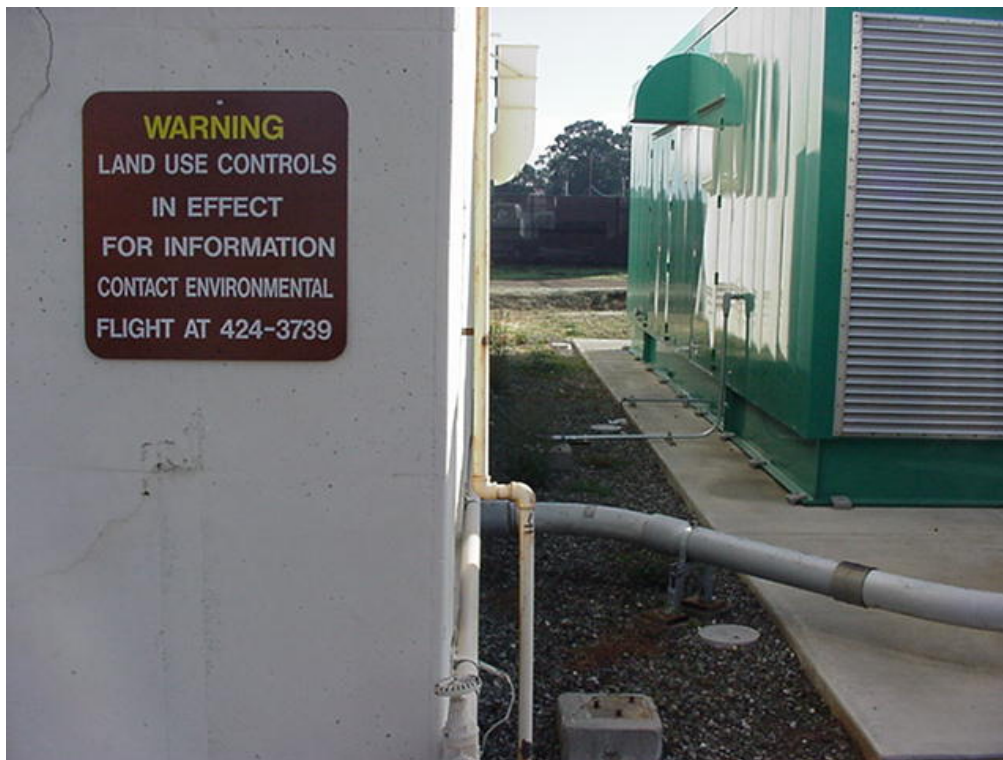
As discussed in section 4.0 of this report, reliance upon an old excavation permit that had not undergone an environmental review resulted in the construction of a concrete pad in the vicinity of the controlled area at SD043.

Photograph 4: Generator Pad and Warning Sign at SD043. Stanchion of Former Pad with Leaking Transformers is visible in the foreground.

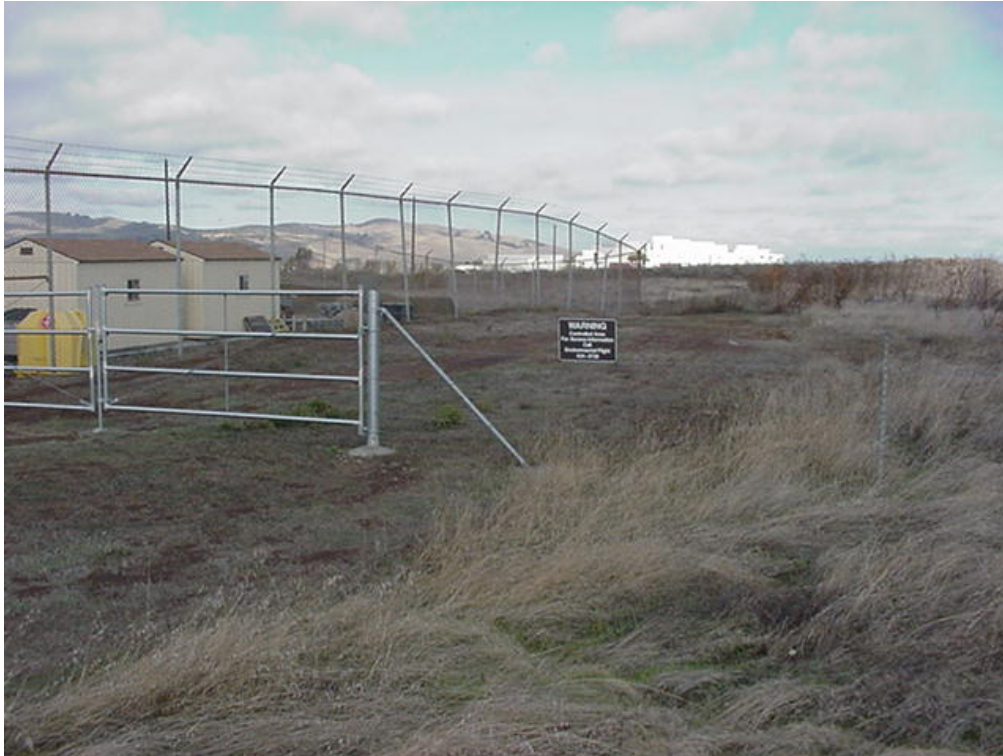
The 2003 inspection of the LUCs at LF044 found the fence and signs to be in excellent physical condition. There is no evidence to suggest that the property is being used for other than industrial purposes. Both gates were locked, and the Environmental Flight keeps a copy of the keys. Photographs 5 and 6 of Appendix B show the south and north access gates to LF044, respectively. Warning signs at each gate are clearly visible.

Photograph 5: South Access Gate to LF044. Warning Sign on Fence is Visible.

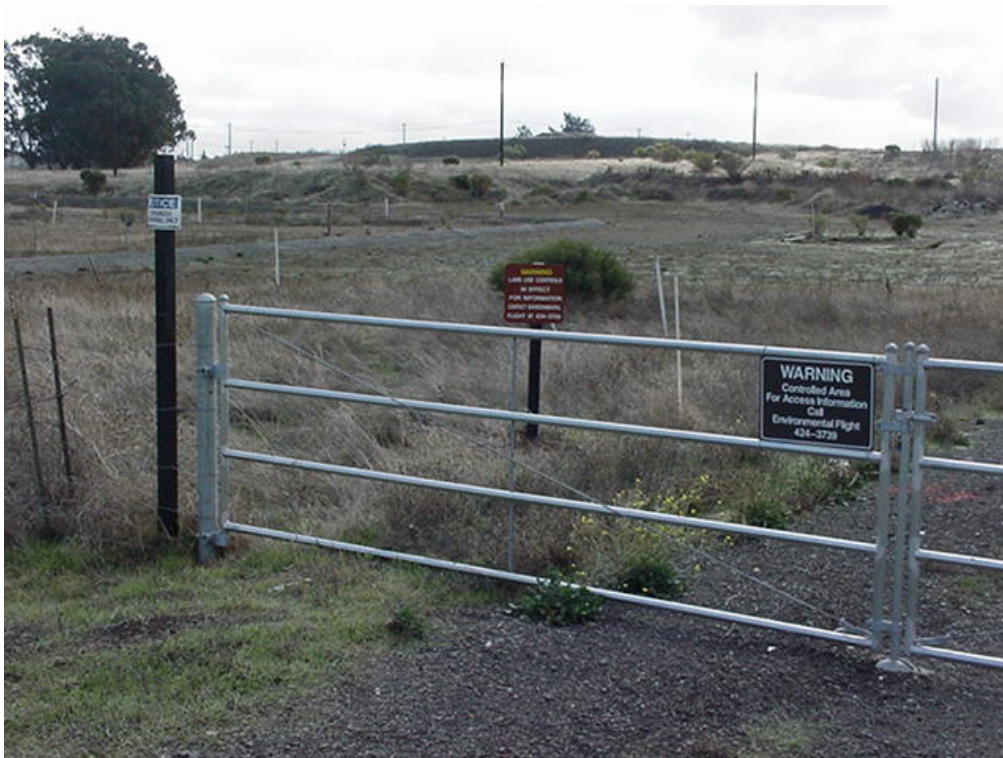
Photograph 6: North Access Gate to LF044. Warning Signs on Gate and at Entrance are Visible.

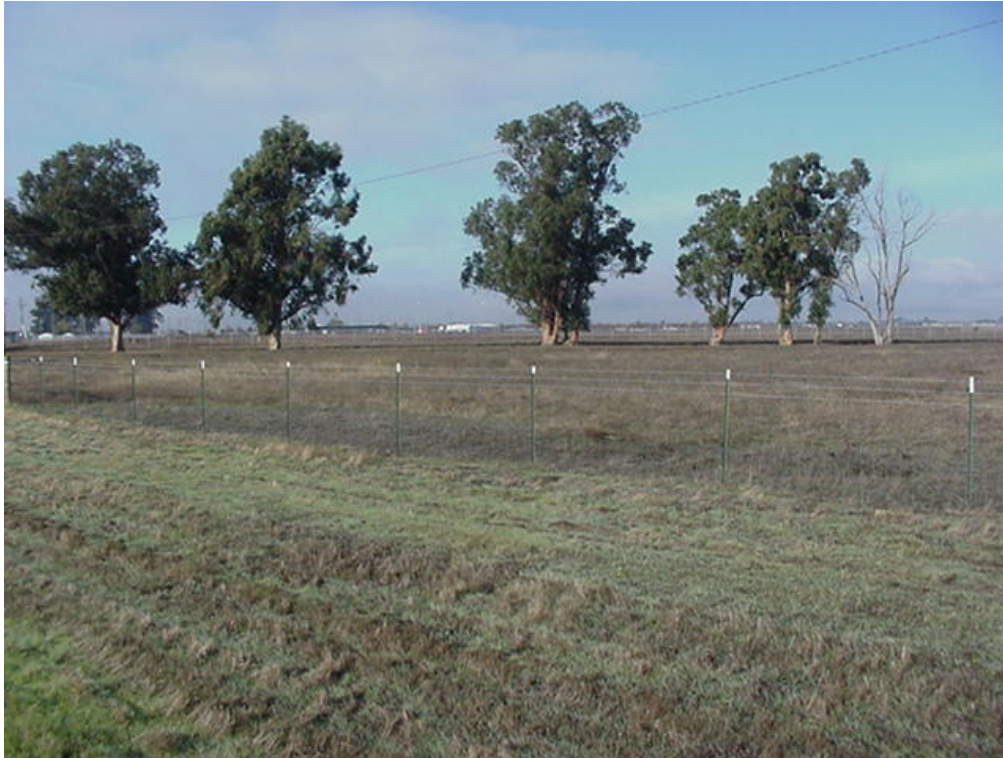
The 2003 inspection of the LUCs at SD045 found that land use controls for pre-cleanup ERP sites are adequate to prevent unauthorized use of the property. There is no evidence that the metals-impacted soil has been disturbed. A sign at the entrance to the GMU notifies visitors and base workers of the presence of ecologically sensitive areas near SD045. Photograph 7 of Appendix B of this report shows the controlled area at SD045.

Photograph 7: SD045 in Background (Beyond Fence).

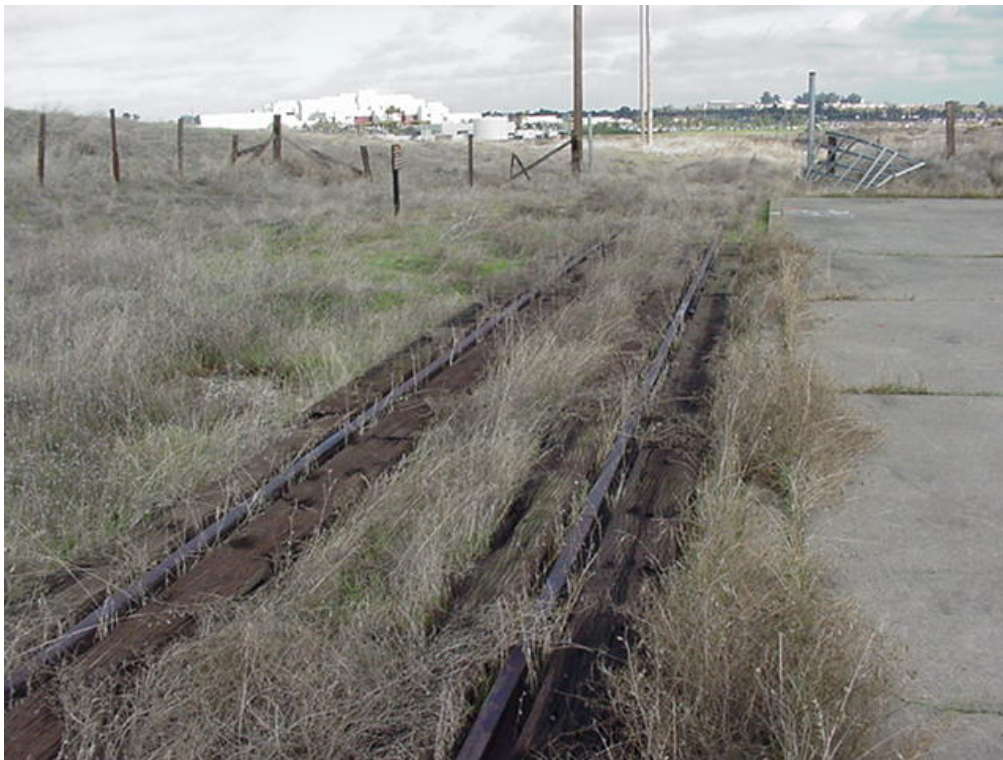
The 2003 inspection of the LUCs at SS046 found that administrative controls are adequate to enforce the restriction, so additional physical barriers (i.e., fences not associated with the Grazing Management Unit) are not needed. There is no evidence that the contaminated soil has been disturbed. Photograph 8 of Appendix B shows the controlled area at SS046, and photograph 9 shows the warning sign that has been placed in the vicinity of the LUC area to notify visitors and base workers of the presence of LUCs.

Photograph 8: SS046 in Foreground.

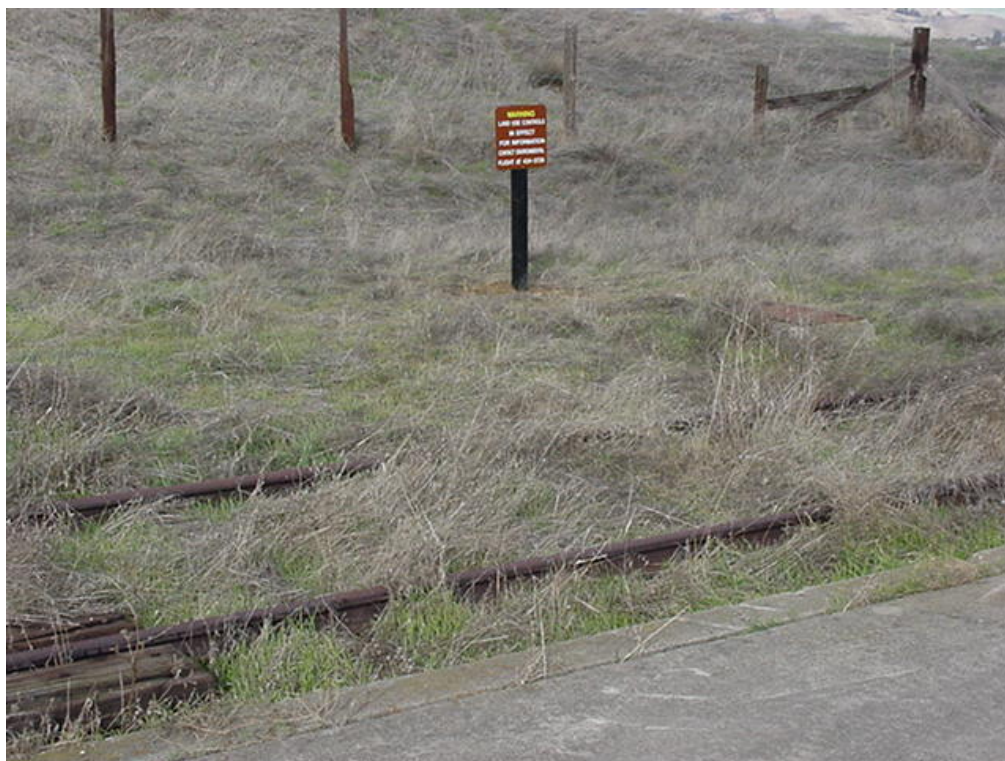
Photograph 9: Warning Sign at SS046.

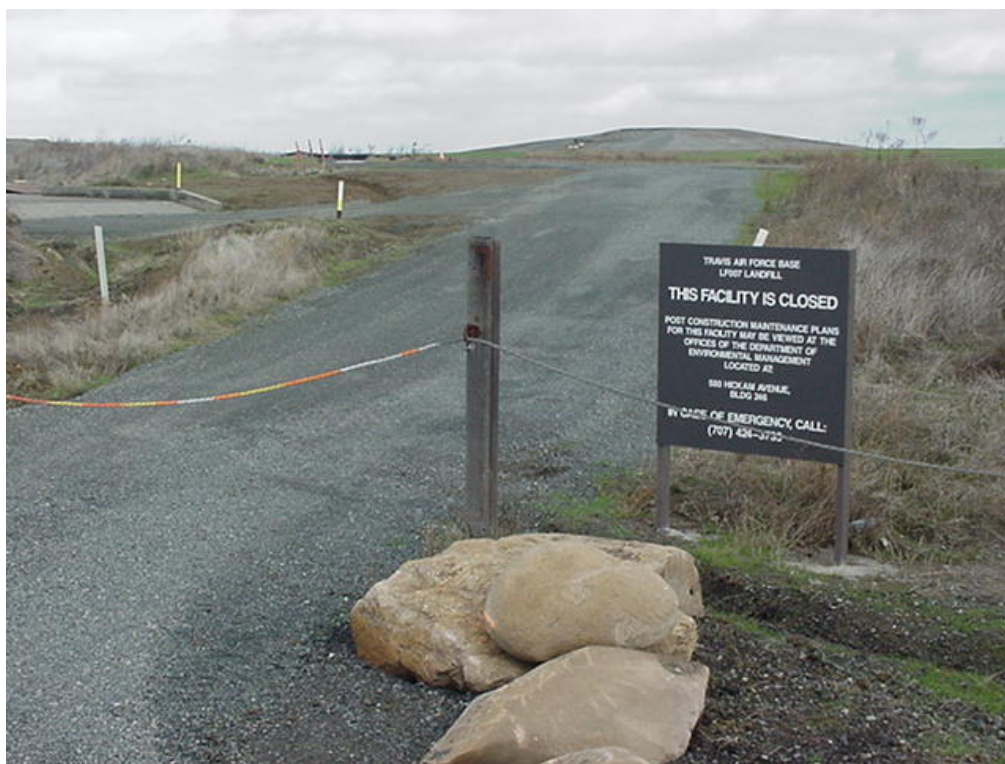
The 2003 inspection of the LUCs at the CAMU found that the current administrative and physical controls are adequate to enforce the restriction. There is no evidence that the contaminated soil in the CAMU or the closed landfill has been disturbed. Photograph 10 in Appendix B shows the warning sign that has been placed at the entrance to the CAMU and the locking chain that controls access to LF007. Photograph 11 provides a view of the CAMU infrastructure, and photograph 12 shows the CAMU tank meters.

Photograph 10: Entrance to Travis AFB CAMU.

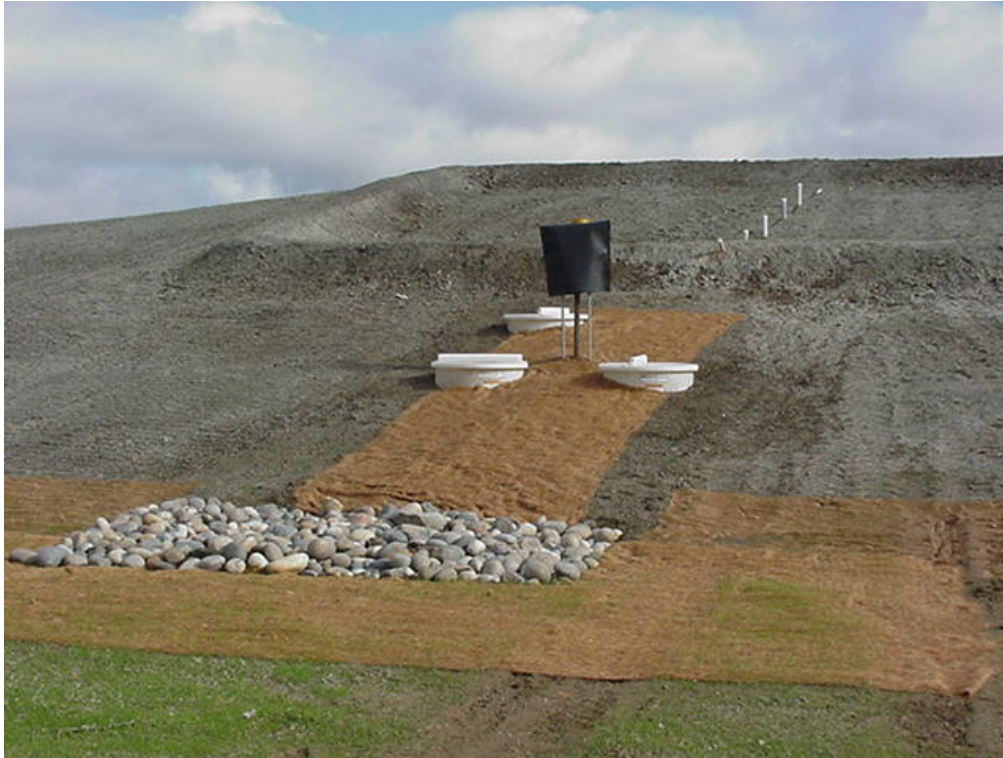
Photograph 11: View of CAMU Infrastructure.

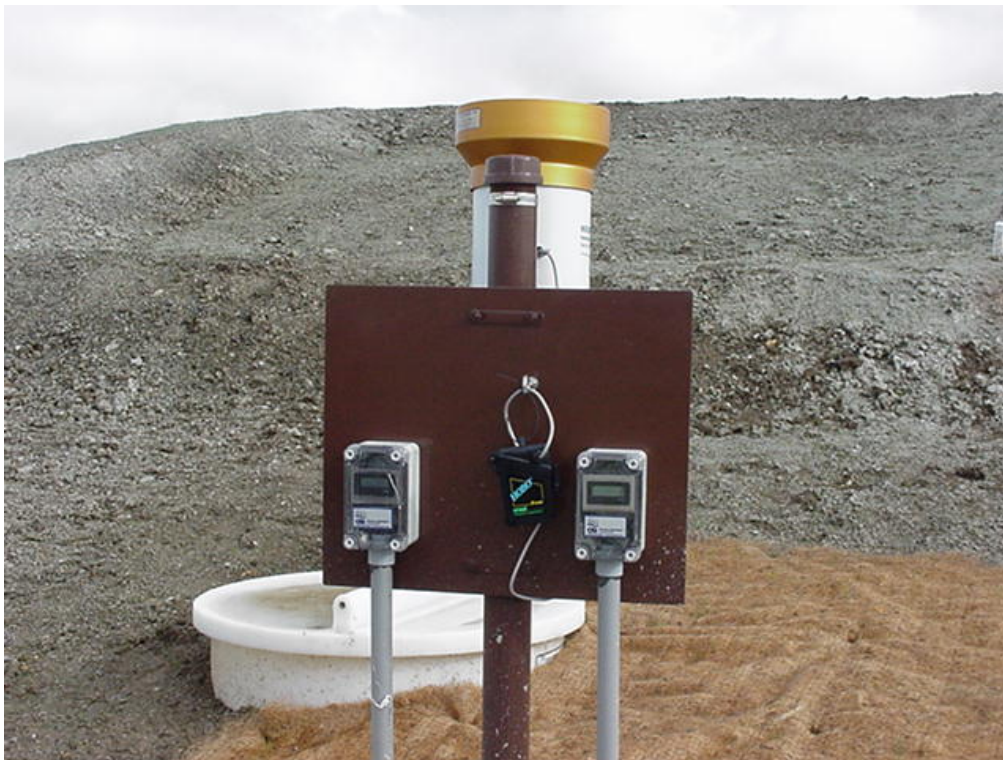
Photograph 12: Tank Meters at CAMU.
