TRAVIS AIR FORCE BASE  
ENVIRONMENTAL RESTORATION PROGRAM

**ANNUAL REPORT  
ON THE STATUS OF  
LAND USE CONTROLS  
ON RESTORATION SITES  
IN 2005**

FINAL

FEBRUARY 2006

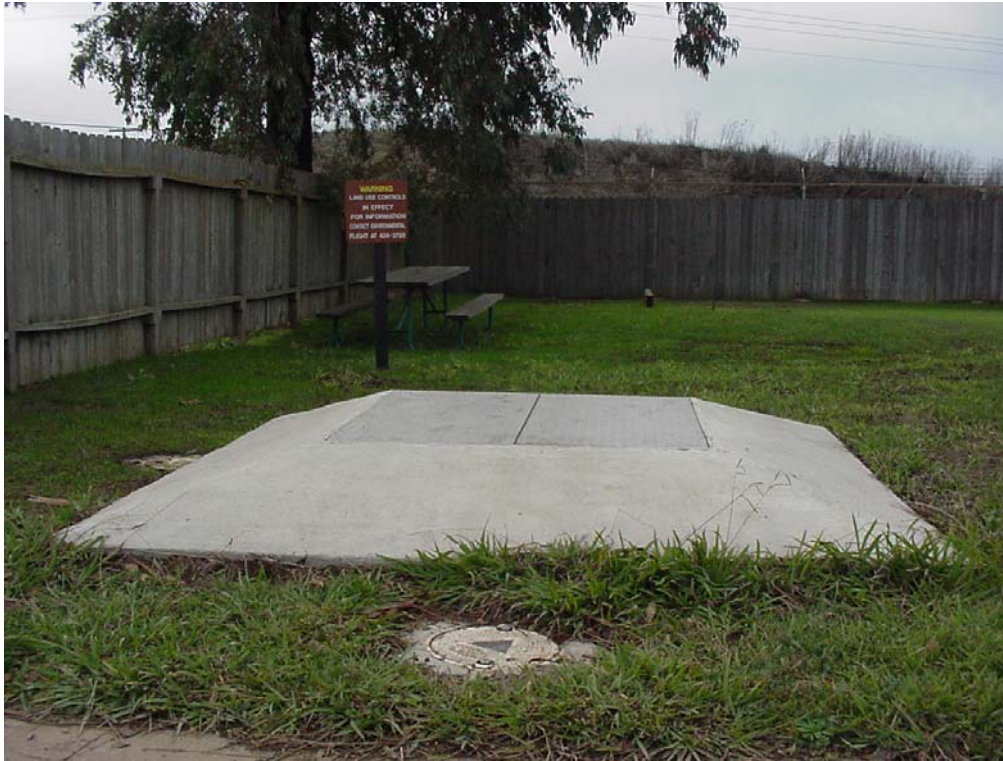
The 2005 inspection of the LUCs at DP039 found that administrative controls are adequate to enforce the restriction, so physical barriers (i.e., fences) are not needed. There is no evidence that the lead-impacted soil has been disturbed. Photograph 1 in Appendix A of this report shows the controlled area at DP039. The warning sign in the vicinity of the LUC area that ensures that visitors and occupants of Building 755 are aware of the presence of LUCs can be seen in the background. There are identical signs in the other LUC areas in the WABOU.

Photograph 1: Controlled Area at DP039.

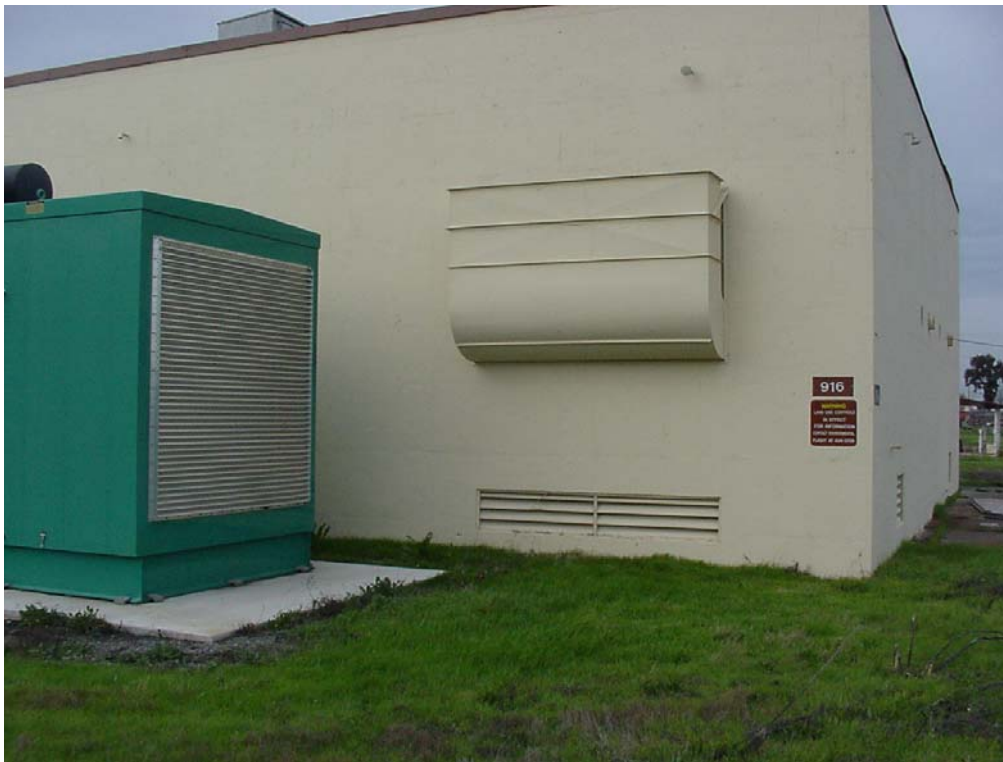
The 2005 inspection of the LUCs at SD043 found that administrative controls are adequately enforcing the restriction, so physical barriers (i.e., fences) are not needed. There is no evidence that any soil disturbances in the vicinity of the concrete pad and generator took place in 2005. Photograph 2 in Appendix A shows the east side of the generator and pad south of Building 916, and photograph 3 shows the warning signs in relation to the west side of the controlled area at SD043.

Photograph 2: Southeast Corner of Installed Generator at SD043.

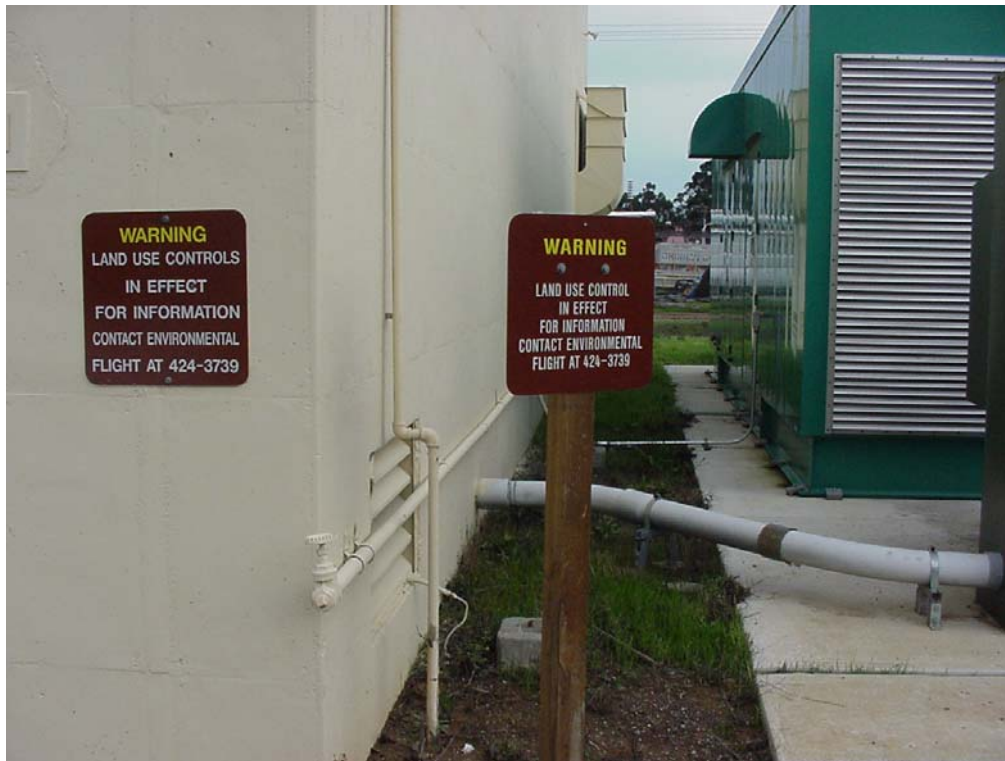
Photograph 3: Generator Pad and Warning Signs at SD043. Stanchion of Former Pad with Leaking Transformers is visible in the foreground.

The inspectors noted the improvements to the signs that were completed in early 2005 by Shaw E&I. This environmental contractor placed an additional sign on the southeast side of Building 916. The sign is identical in appearance to the existing two signs and ensures that base workers who approach the site from the east are aware of the presence of the LUC restrictions. Shaw E&I also attached one of the existing signs to a more durable post and used larger anchor bolts to secure the second sign to the outer concrete wall of the building.

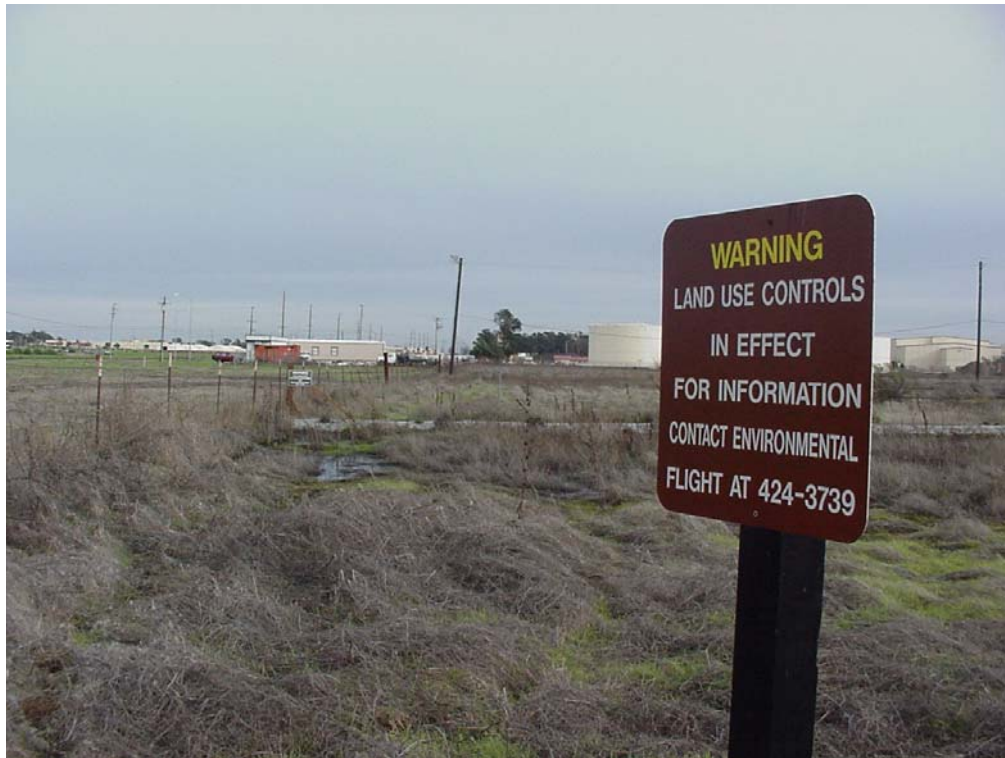
The 2005 inspection of the LUCs at LF044 found the fence and signs to be in excellent physical condition. There is no evidence to suggest that the property is being used for other than industrial purposes. Both gates were locked, and the Environmental Flight keeps a copy of the keys. Photograph 4 of Appendix A shows the warning sign at the north access gate, and photograph 5 shows the warning signs on the fence and behind the south access gate. Shaw E&I installed the sign behind the south access gate in early 2005. The gates are in excellent physical condition, and warning signs at each gate are clearly visible.

Photograph 4: Warning Signs at Entrance and on fence near the North Access Gate.

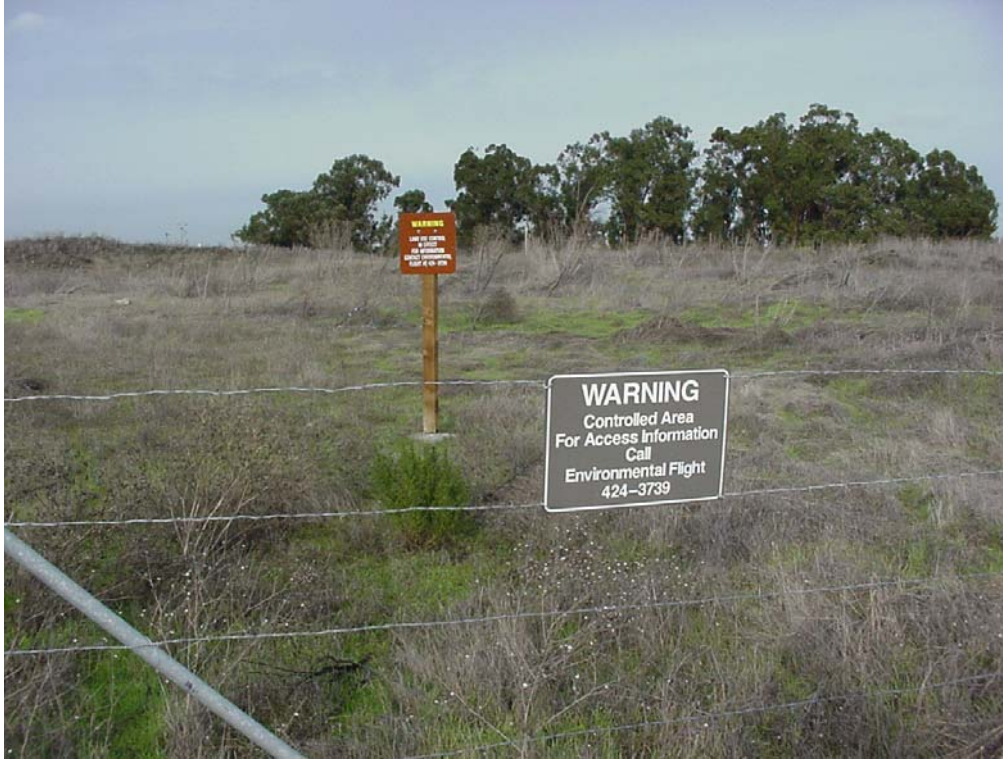
Photograph 5: Warning Signs on Fence and behind the South Access Gate.

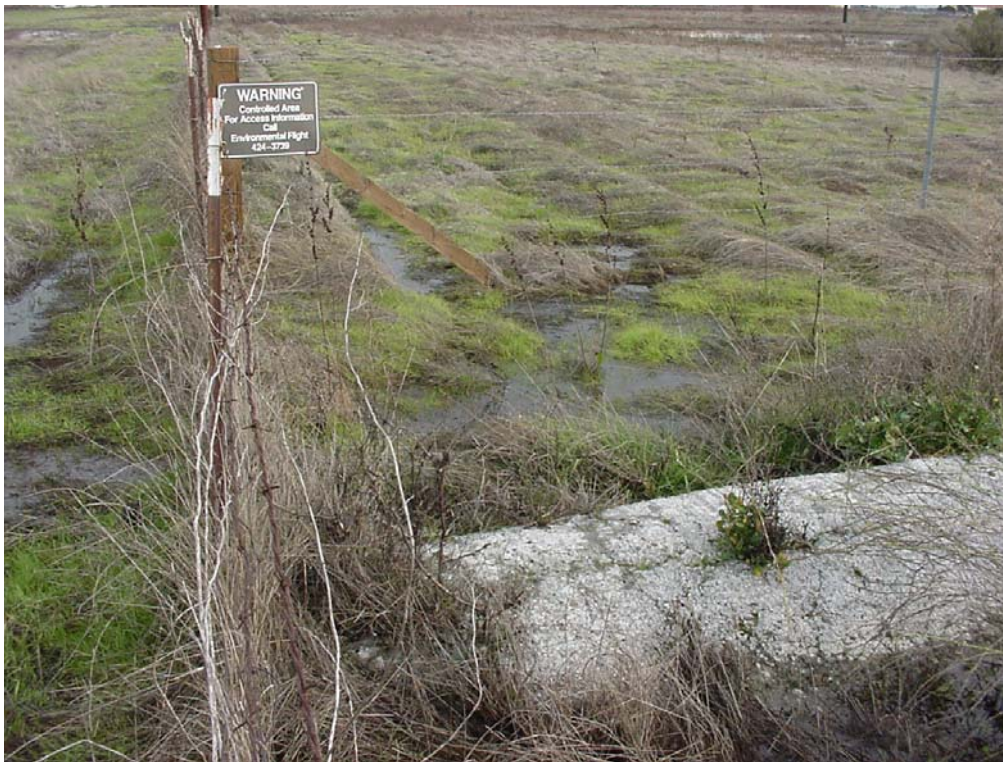
The 2005 inspection of the LUCs at LF044 found the berm to be in excellent physical condition. Small amounts of native grass have begun to grow over portions of the berm, which serves to increase its cohesiveness. There was no evidence of damage to the berm from base activities. Photographs 6, 7 and 8 of Appendix A were taken during the inspection of the LF044 berm.

Photograph 6: Start of LF044 Fencing and Berm.

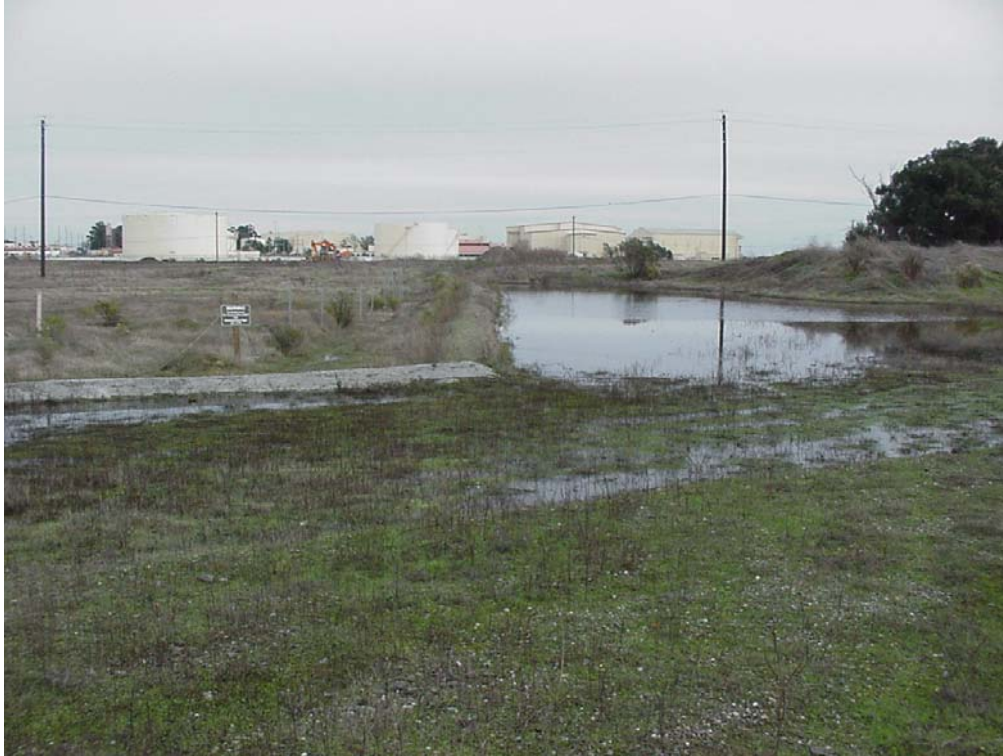
Photograph 7: LF044 Berm, Facing East.

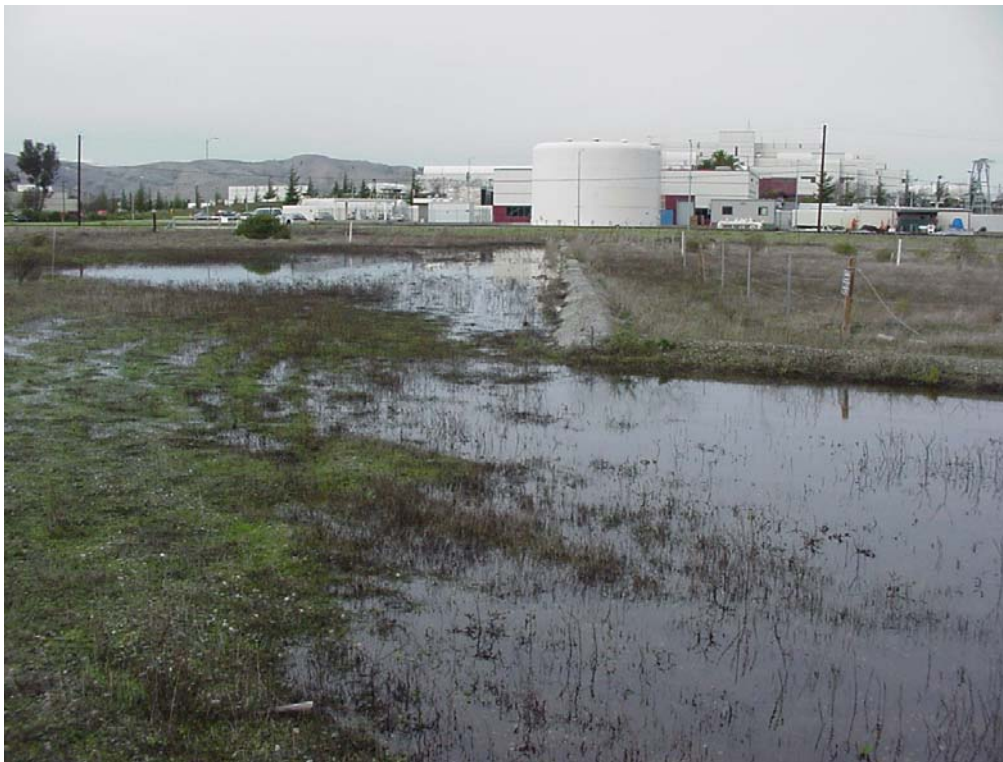
Photograph 8: LF044 Berm, Facing North.

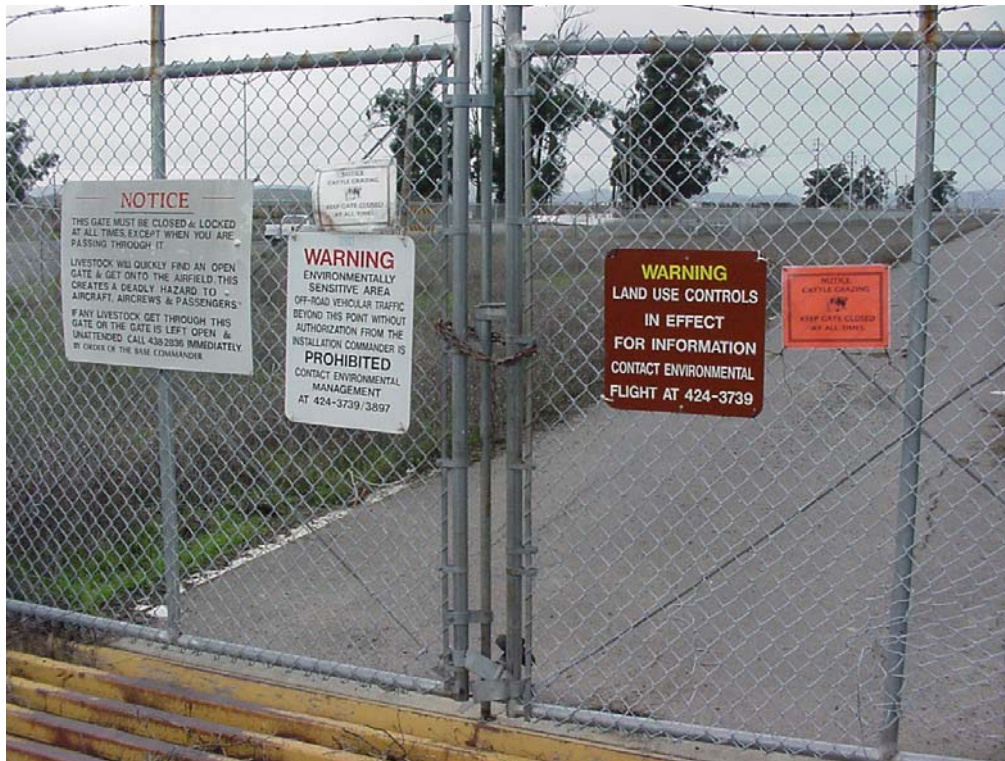
The 2005 inspection of the LUCs at SD045 found that the existing controls are adequate to prevent unauthorized use of the property. There is no evidence that the metals-impacted soil has been disturbed. A sign at the entrance to the GMU notifies visitors and base workers of the presence of ecologically sensitive areas in the vicinity of SD045 as well as the controlled area. Photograph 9 of Appendix A of this report shows the access gate that leads to SD045.

Photograph 9: Fence Access to SD045. Warning sign is posted on gate entry.

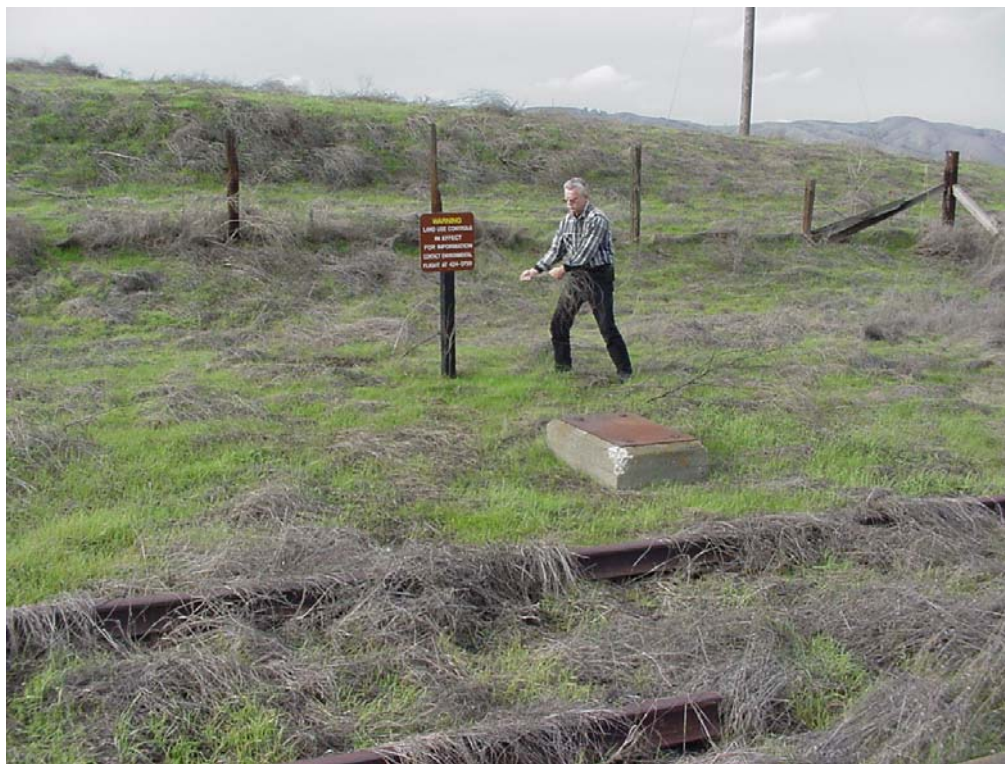
The 2005 inspection of the LUCs at SS046 found that administrative controls are adequate to enforce the restriction, so additional physical barriers (i.e., fences not associated with the Grazing Management Unit) are not needed. There is no evidence that the contaminated soil has been disturbed. Photograph 10 of Appendix A of this report shows the east side of the controlled area at SS046, and photograph 11 shows the west side of the controlled area. Shaw E&I installed a second warning sign in the west side of the LUC area in early 2005 to improve the awareness of the controlled area by site visitors and base workers.

Photograph 10: Warning Sign at East Side of SS046.

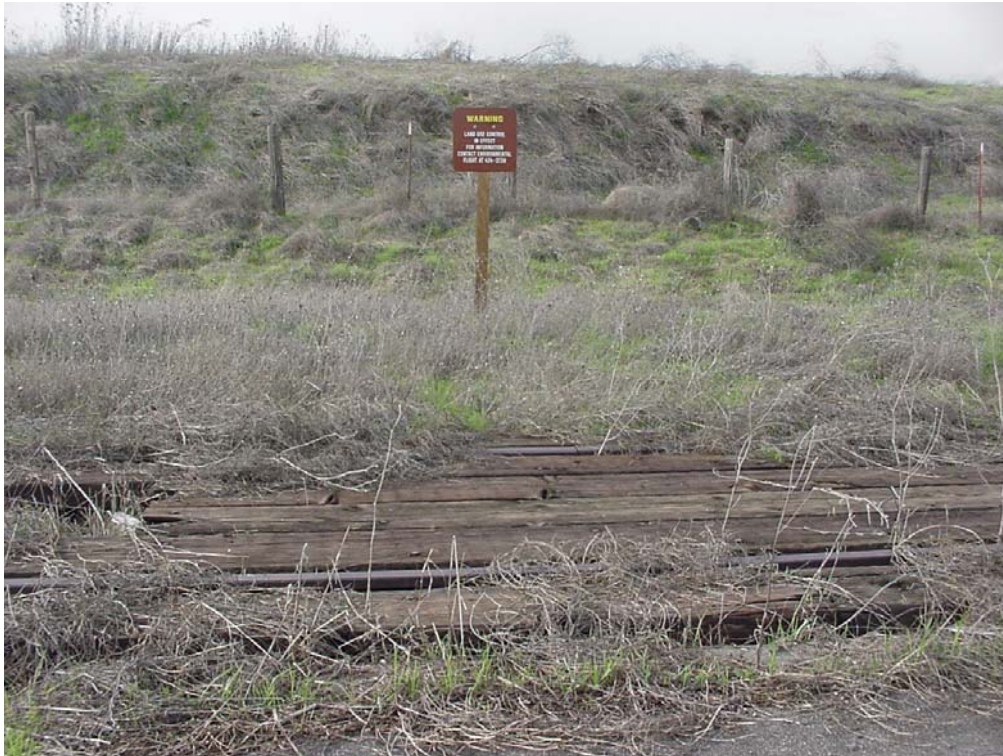
Photograph 11: Warning Sign at West Side of SS046.

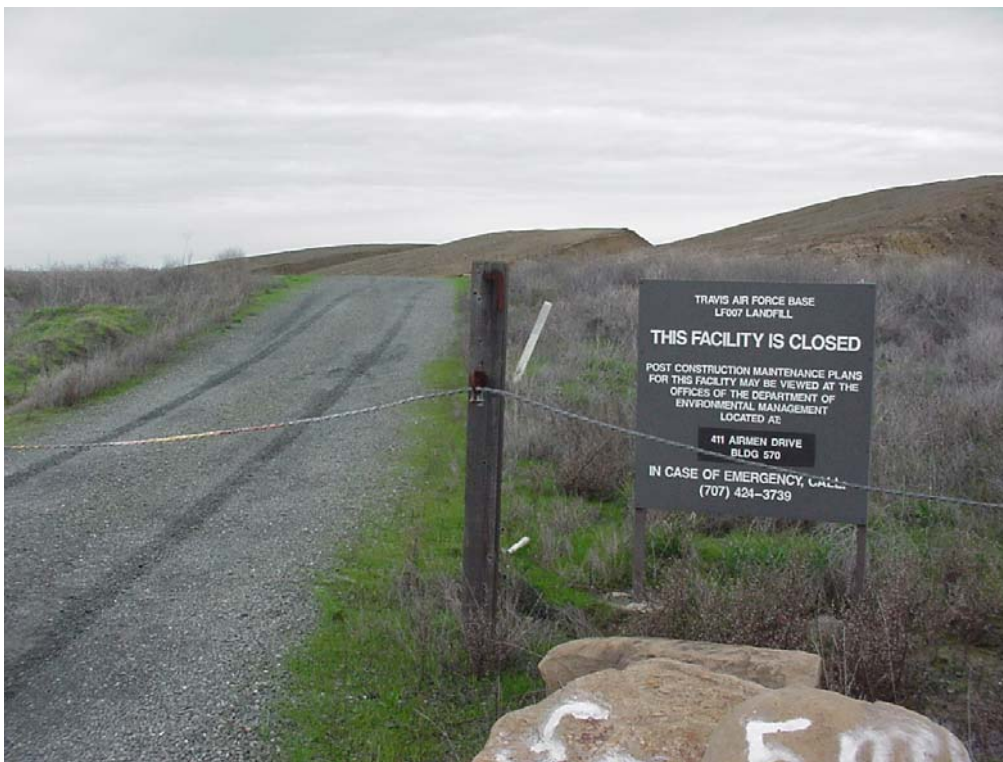
The 2005 inspection of the LUCs at the CAMU found that the current administrative and physical controls are adequate to enforce the restrictions. There is no evidence that the contaminated soil in the CAMU or the closed landfill has been disturbed. Photograph 12 in Appendix A of this report shows the warning sign that has been placed at the entrance to the

Photograph 12: Entrance to Travis AFB CAMU.

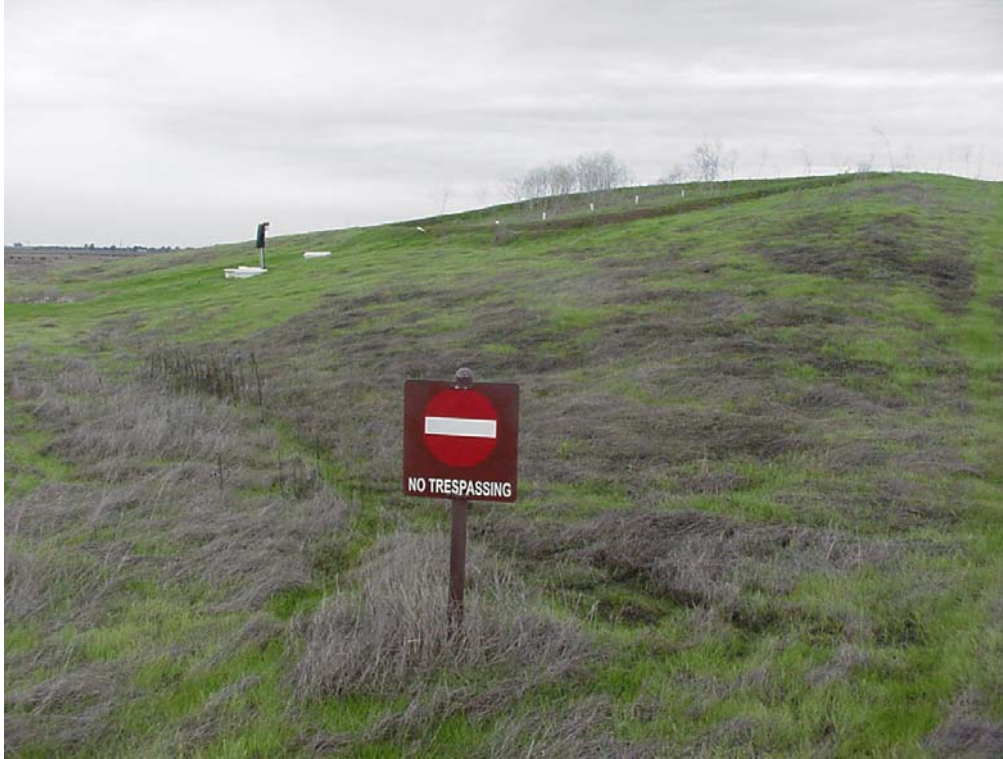
Photograph 13: No Trespassing Sign at CAMU.
