Guardian

A Publication of the Environmental Restoration Program

Travis Air Force Base, California

January 2004

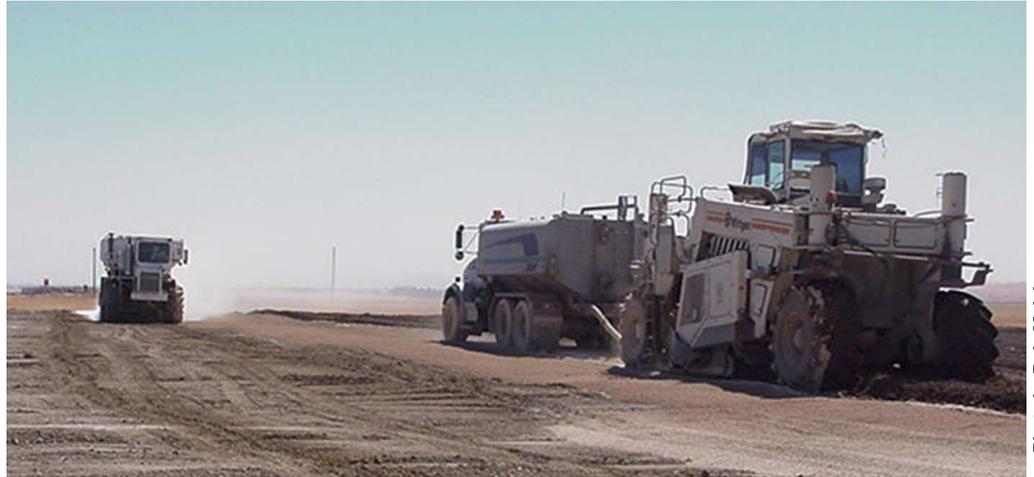
One Big Mixing Bowl: A team of heavy equipment vehicles mix bentonite, a dense clay, with clean soil to produce the processed soil needed to build a cap for the Corrective Action Management Unit (CAMU). The spreader on the left places bentonite onto the clean soil, while the tiller on the right follows a water truck and mixes the soil, water and bentonite until it is suitable to be placed on top of contaminated soil.

The CAMU design accommodates an estimated maximum volume of 111,000 cubic yards of contaminated soil. The cap selected for the CAMU is a 4-foot thick evapotranspiration (ET) cover that relies on deep-rooted plants to use and expel most of the rainwater that is absorbed into the cap. This design feature limits the amount of water that passes through to the contaminated soil below.

Once the contaminated soil was in place, it was covered with the cap. "Fortunately, Travis had stockpiled almost 100,000 cubic yards of excess clean soil from various construction projects over the last 8 years," said Steve Stopher, Travis Environmental Field Manager. "We did not have to buy clean soil and truck it on base to support the CAMU project." Shaw added bentonite, a processed clay, to the clean soil to ensure that water flow through the cap would be restricted. This processed soil was used to add a 4-foot thick cap to the contaminated soil pyramid.

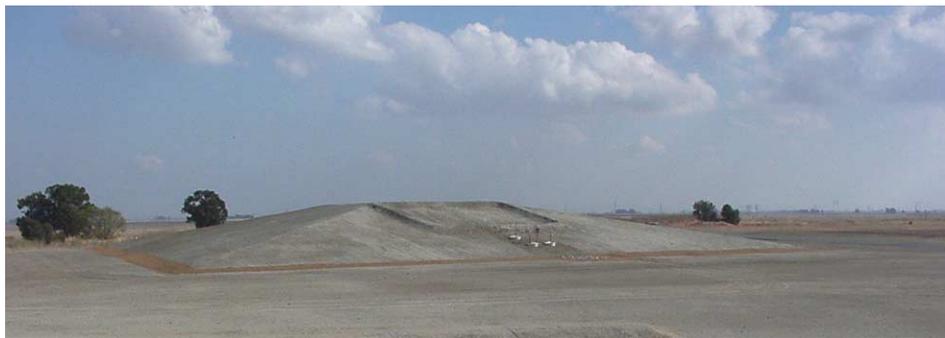
The Finished Product: Contaminated soil from other restoration sites lie beneath a 4-foot layer of clean soil. Installed sensors and local monitoring wells verify that contaminants are not moving into the local groundwater.

2. A lysimeter is buried under the western slope of the CAMU. It consists of a plastic liner that catches and measures the amount of water that passes through the ET cap to monitor cap performance.

3. Five gypsum blocks are also buried in the cap to measure soil moisture.

Gypsum blocks were added to the cap to monitor soil moisture conditions, and a rain gauge was installed nearby. This monitoring equipment will allow a thorough evaluation of cap performance.

In the final step, Shaw added fertilizer to the top 6 inches of the cap, a special seed mix to grow deep-rooted plants in the topsoil, and erosion control matting around the lower edges of the pyramid.

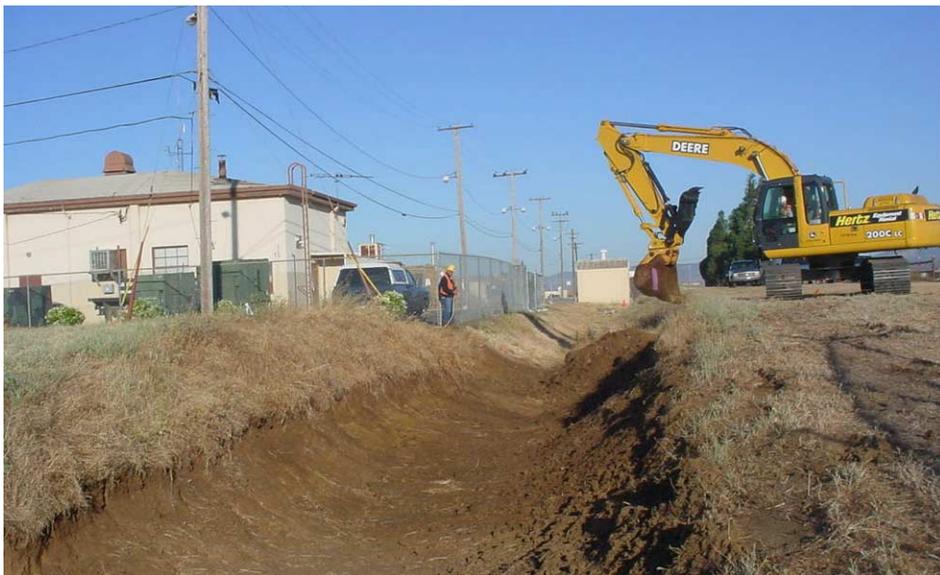
Scraping Away: A backhoe removes contaminated soil from a drainage ditch, one scrape at a time. All of the contaminated soil was placed in the Corrective Action Management Unit (CAMU).

Shaw needed only a week in early July to complete the cleanup action. By using a backhoe to scrape the bottom of the ditch, the contaminated sediment was excavated and moved by truck to the Corrective Action Management Unit (CAMU). The CAMU is a designated area on the base

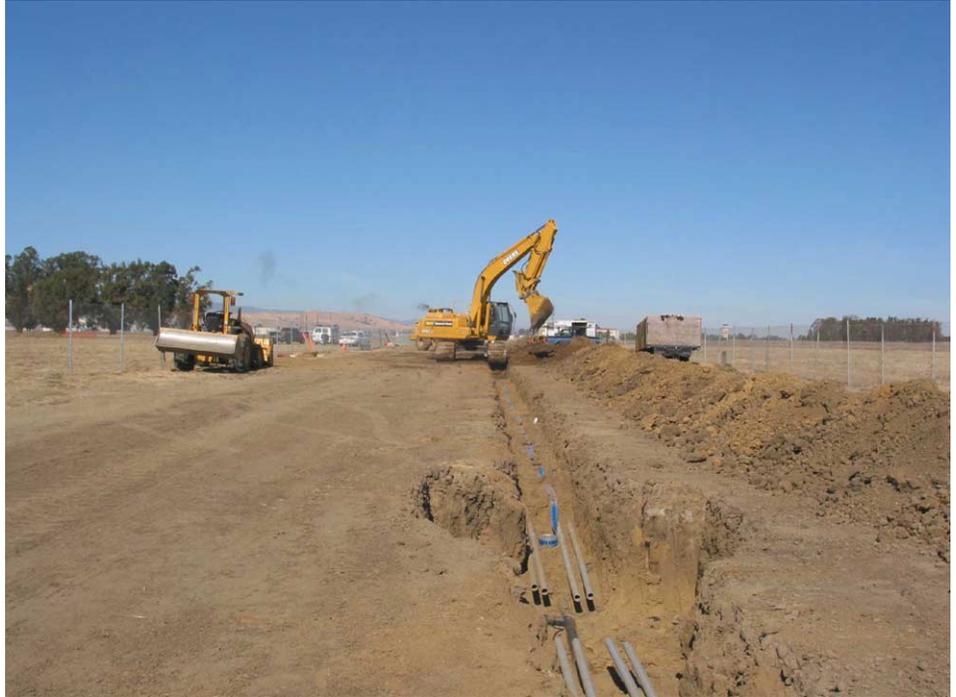
Installation in Progress: A backhoe digs a trench on off-base property to bury approximately 3,600 feet of conveyance piping. The piping connects a series of extraction wells to a groundwater treatment plant on the south side of the base. The wells surround a body of contaminated groundwater that has moved beyond the base boundary.

extraction wells that starts at the base boundary and extends over 1800 feet in a southern direction. The extracted water is conveyed in a series of connecting underground pipes to the South Base Boundary Groundwater Treatment Plant where it is run through an air stripper. The air stripper uses agitated air movement to tear the solvents away from the water molecules. The solvents are expelled in very low concentrations into the atmosphere, and the treated water is discharged into Union Creek or used to irrigate base property. Occasionally, when the air stripper requires maintenance, the groundwater is treated in 6,000-pound vessels containing granular activated carbon. The sides of an activated carbon granule act as sticky surfaces, grabbing onto the solvent molecules while letting the cleaned water flow through the system.

Phase 2 ended in 2000 and consisted of three additional on-base extraction wells to prevent off-base groundwater flow. Phase 3 was finished last autumn and added nine new extraction wells and conveyance pipelines onto off-base property to capture the portion of the FT005 plume that has already migrated off-base.

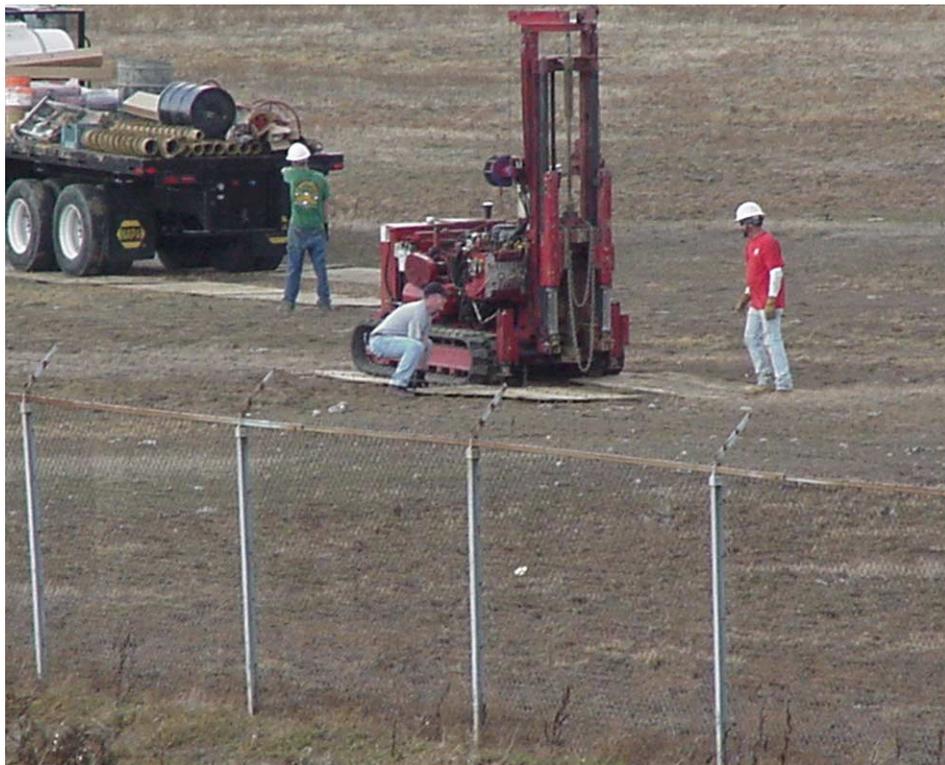
A Road Less Travelled: Field team members use planks of plywood to bring heavy equipment onto off-base property for the installation of several monitoring wells. The plywood helps to protect a large dried-up vernal pool that lies north of the base fenceline from damage.

To complicate the project even further, special precautions had to be taken to protect a large vernal pool in the area where the wells were going to be placed. A vernal pool is a sensitive wetlands habitat where protected plants and animals often make their home. Fieldwork did not start until the pool was completely dry, and wooden planks were placed over the pool area to prevent damage from vehicles.
