TRAVIS AIR FORCE BASE
ENVIRONMENTAL RESTORATION PROGRAM

ANNUAL REPORT
ON THE STATUS OF
LAND USE CONTROLS
ON RESTORATION SITES
IN 2006

FINAL

60TH CIVIL ENGINEER SQUADRON
Travis Air Force Base, California

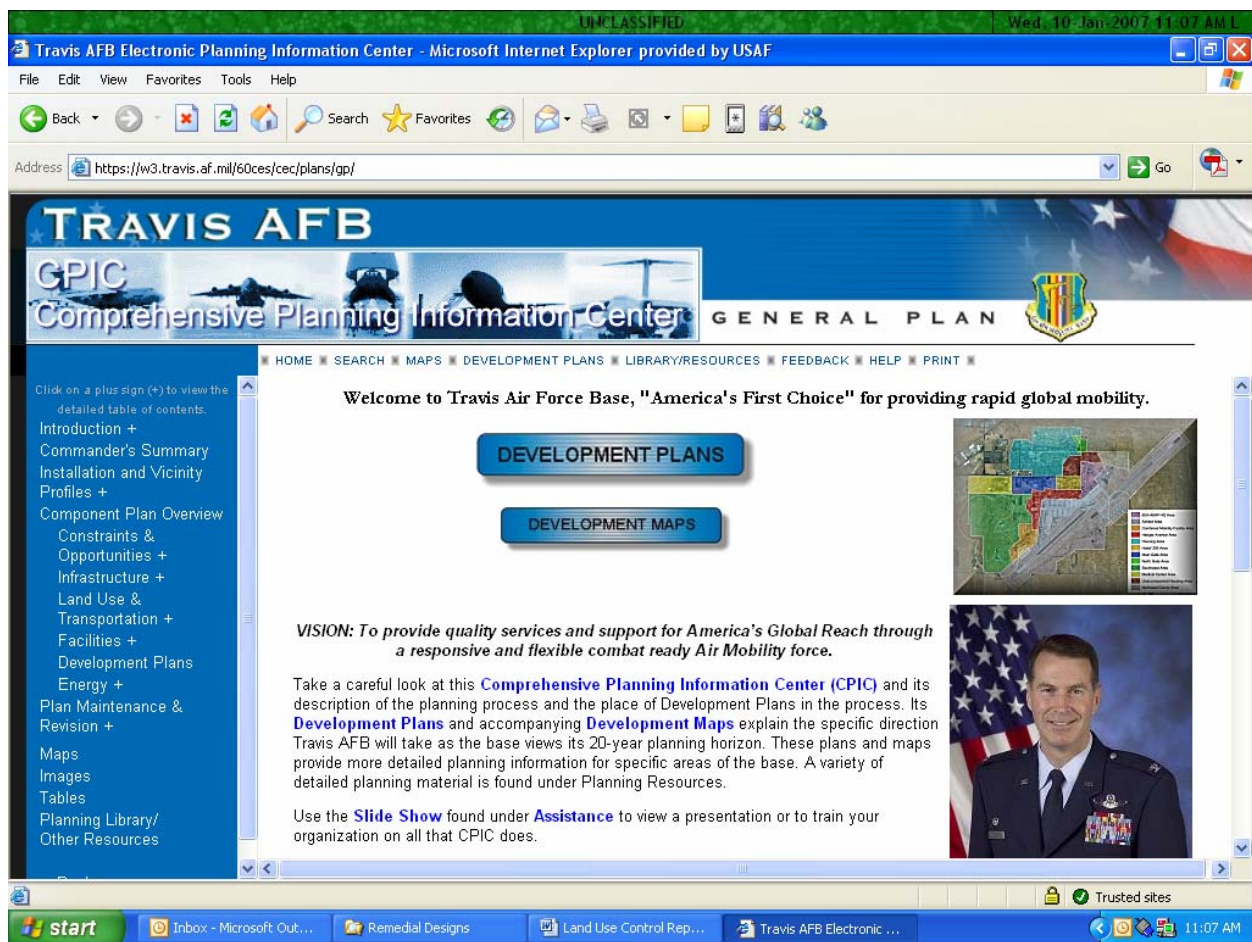
2. Composite Constraints and Opportunities

All data on land use restrictions on Travis AFB that are due to the presence of soil contaminants in concentrations above residential cleanup levels can be accessed via the Composite Constraints and Opportunities section of the CPIC. By scrolling down the page, the reviewer can identify three categories of constraints: Natural & Cultural, Environmental, and Operational (not shown). An Installation Restoration Program (IRP) Sites link takes the reviewer to the sites section.

The Composite Constraints and Opportunities section describes the IRP Sites link as the only Environmental Constraint that prohibits certain development in affected area of Travis AFB.

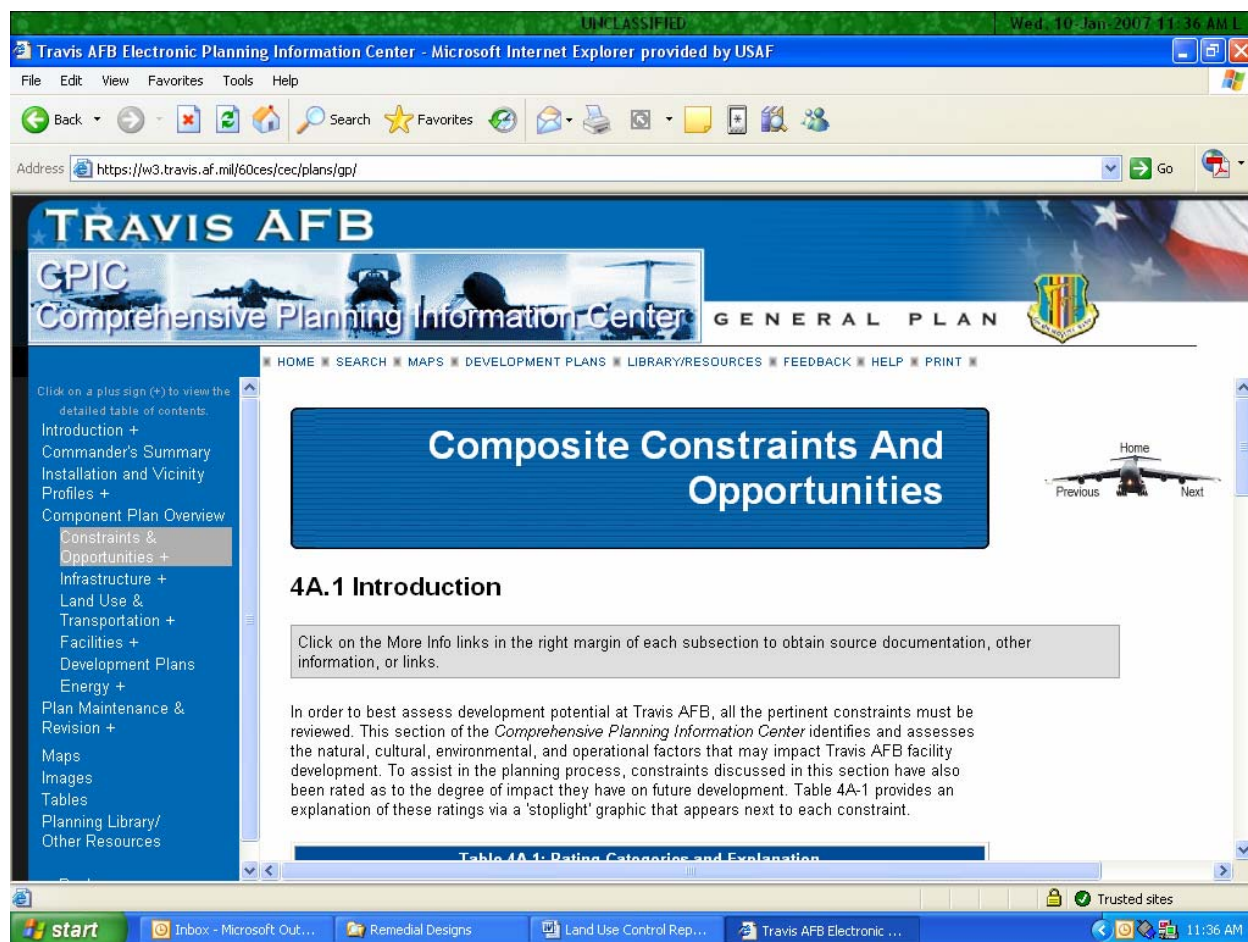
3. Table 4A-3 ERP Sites

The IRP Sites link takes the reviewer to Section 4A.3.4 (Environmental Restoration Program [ERP]). This section provides a summary of the ERP, its history, and a table with links to all ERP sites. Table 4A-3 also provides a brief description of the land use control status at each site.

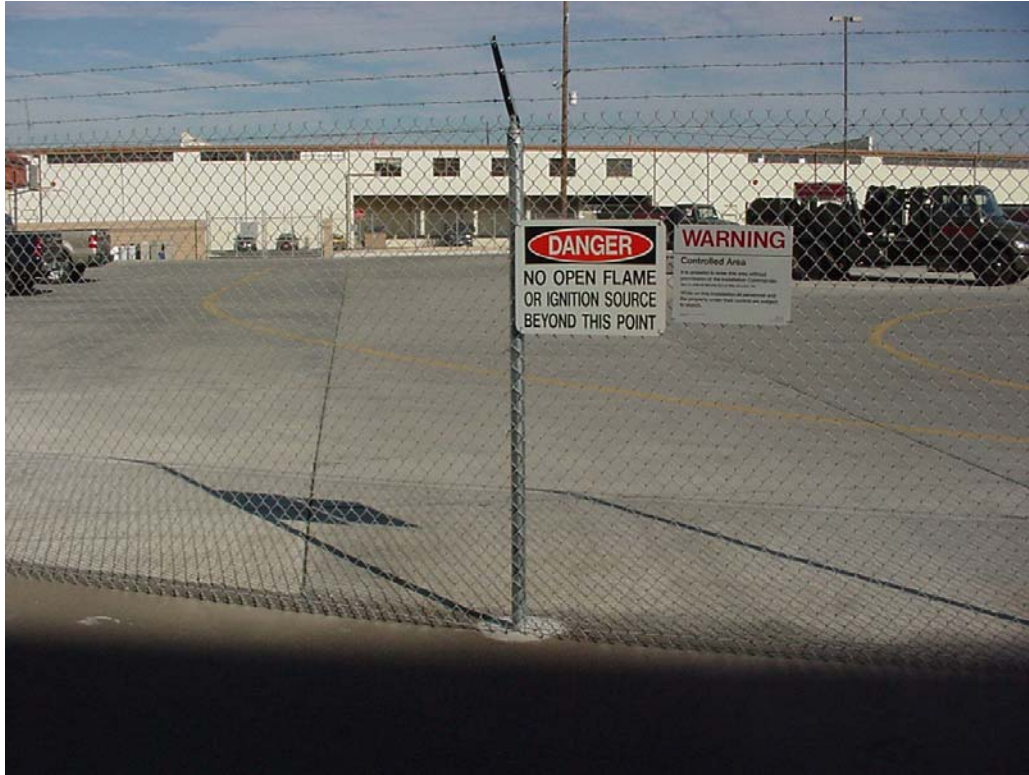
The 2006 inspection of the LUCs at SS015 found that administrative controls are adequate to enforce the restriction, so additional physical barriers (i.e., fences) are not needed. There is no

Photograph 1: Controlled Area at SS015.

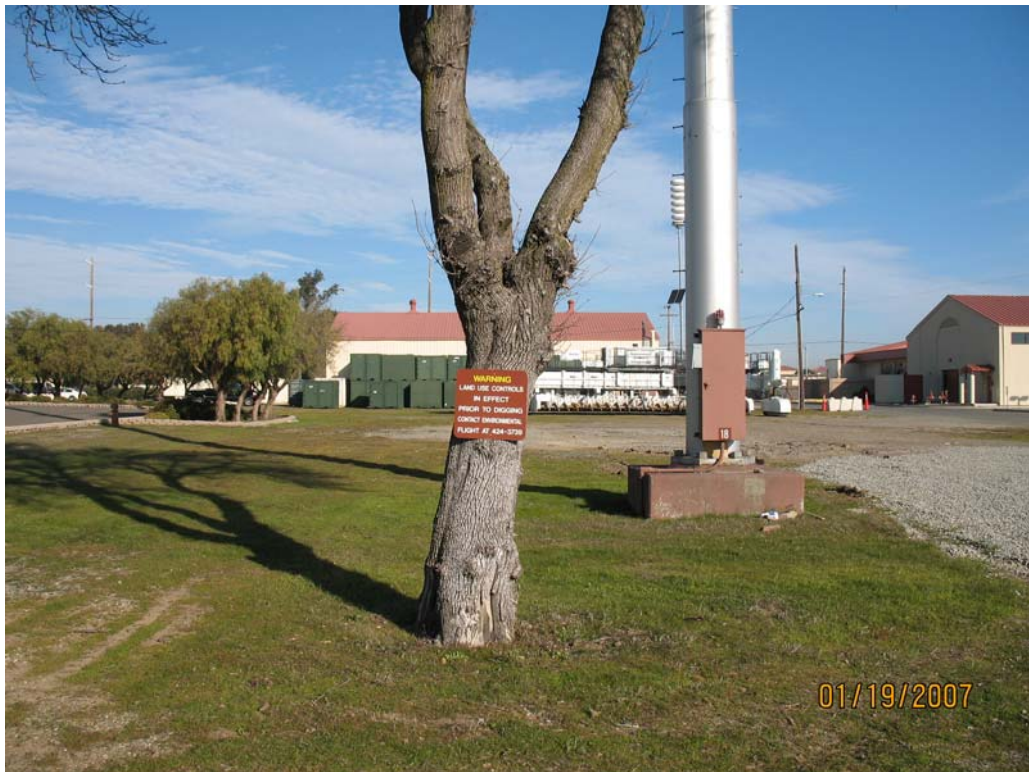
The 2006 inspection of the LUCs at SS016 found that administrative controls are adequate to enforce the restriction, so physical barriers (i.e., fences) are not needed. There is no evidence that the PAH-impacted soil has been disturbed either with or without proper authorization. A warning sign has been posted on a tree in the middle of the site to notify base worker of the

Photograph 2: Controlled Area at SS016.

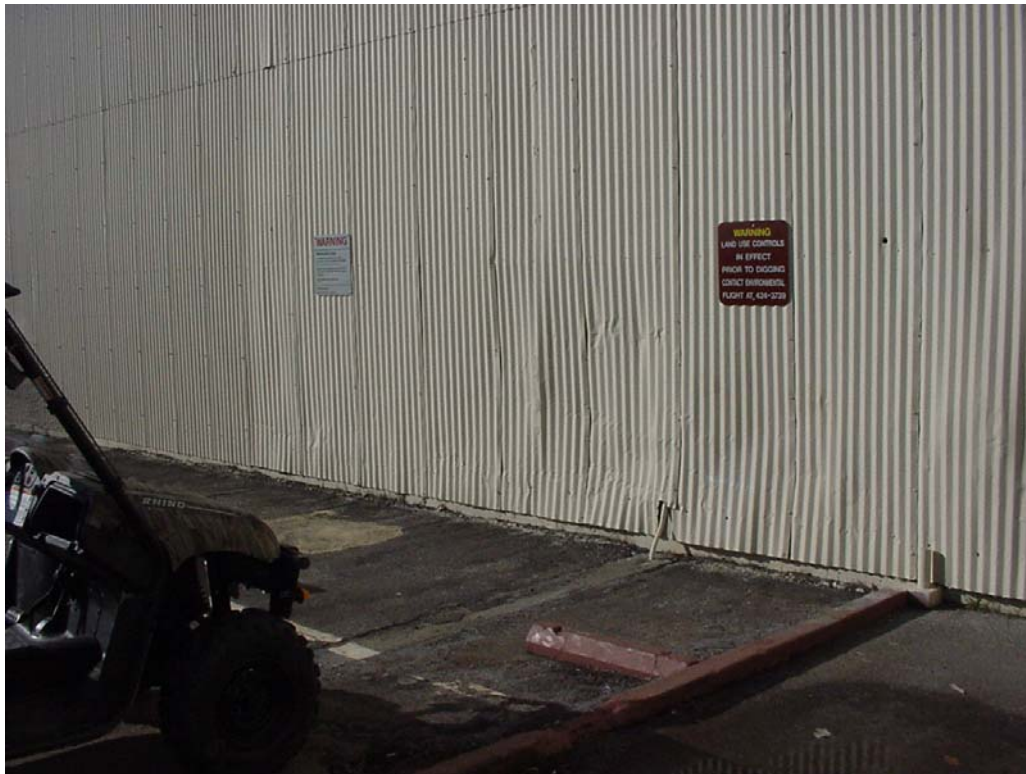
The 2006 inspection of the LUCs at SD033 found that administrative controls are adequate to enforce the restriction, so physical barriers (i.e., fences) are not needed. There is no evidence that the cadmium- and benzo(a)pyrene-impacted soil has been disturbed. Warning signs have been posted on both sides of Facility 810 to notify base worker of the presence of the controlled area. Photographs 3 and 4 in Appendix B of this report show the controlled areas at SD033.

Photograph 3: Warning Sign at Controlled Area on East Side of SD033.

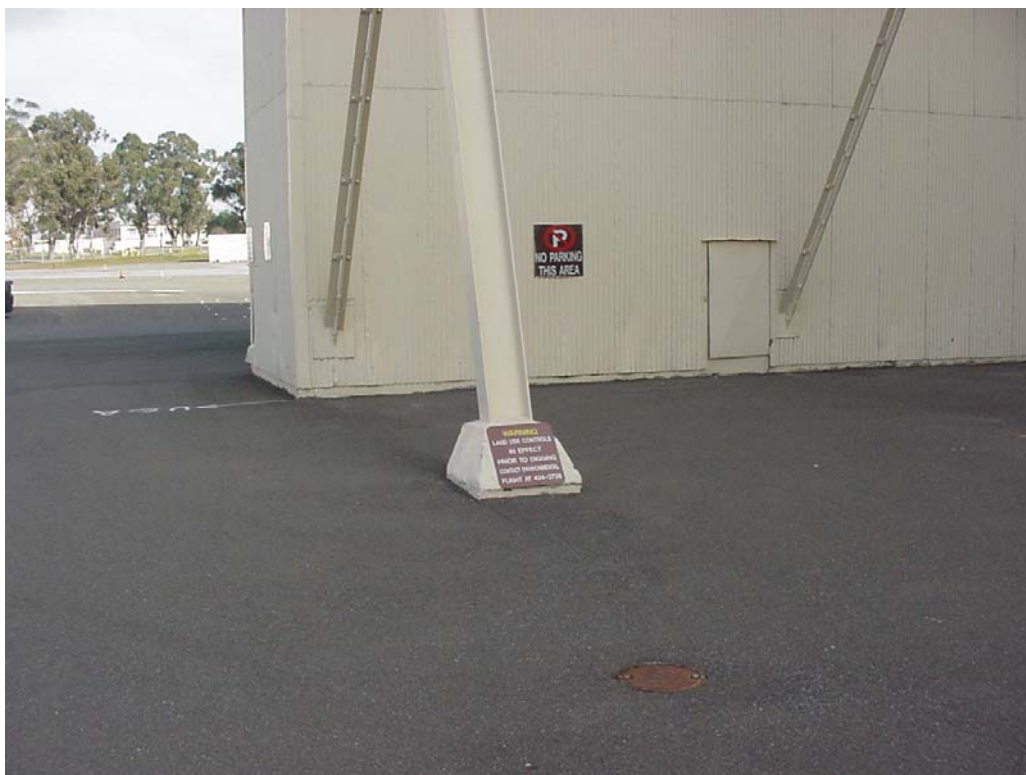
Photograph 4: Warning Sign at Controlled Area on West Side of SD033.

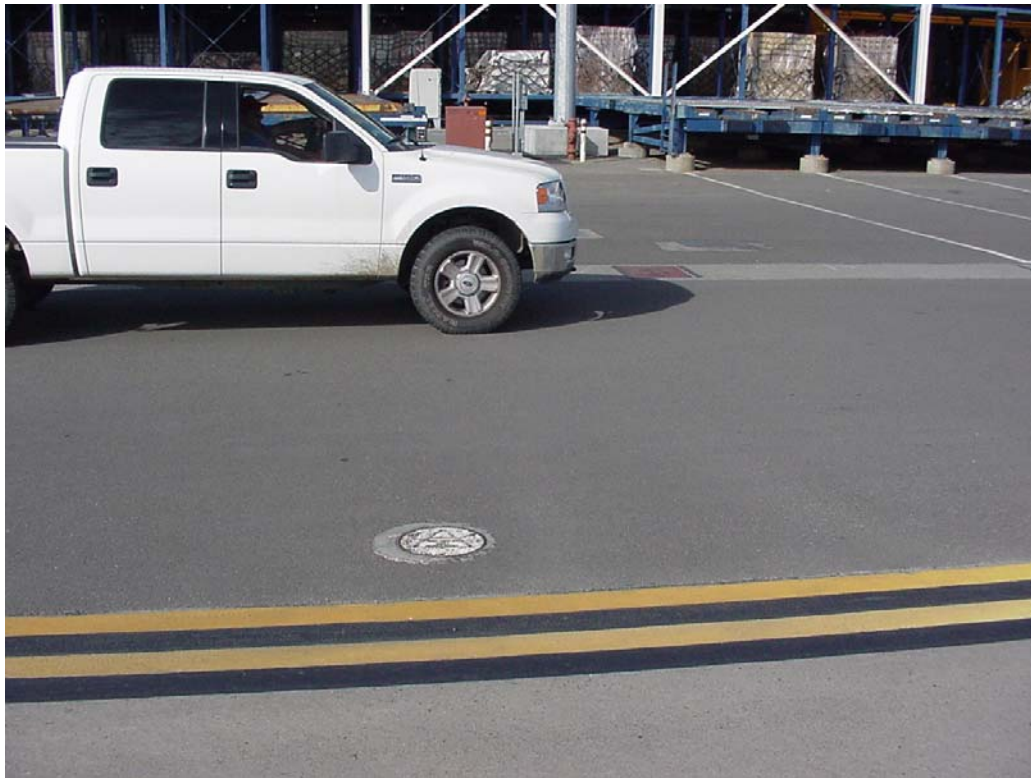
The 2006 inspection of the LUCs at SD037 found that administrative controls are adequate to enforce the restriction, so physical barriers (i.e., fences) are not needed. There is no evidence that the PAH-, lead-, and TPH-impacted soil has been disturbed. Due to the nature of operations at the air freight terminal, it is not practical or safe to post warning signs to warn base personnel of the presence of the controlled areas. Photographs 5 and 6 in Appendix B of this report show the controlled areas at SD037.

Photograph 5: Controlled Area on Southeast Side of SD037

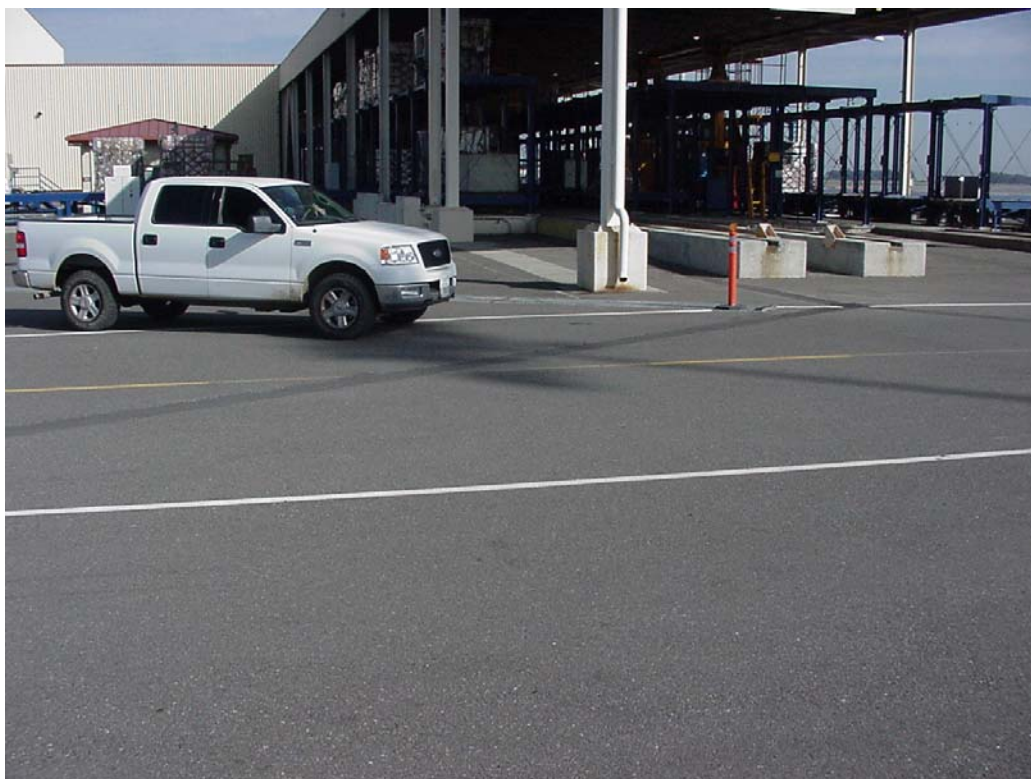
Photograph 6: Controlled Area on Southwest Side of SD037

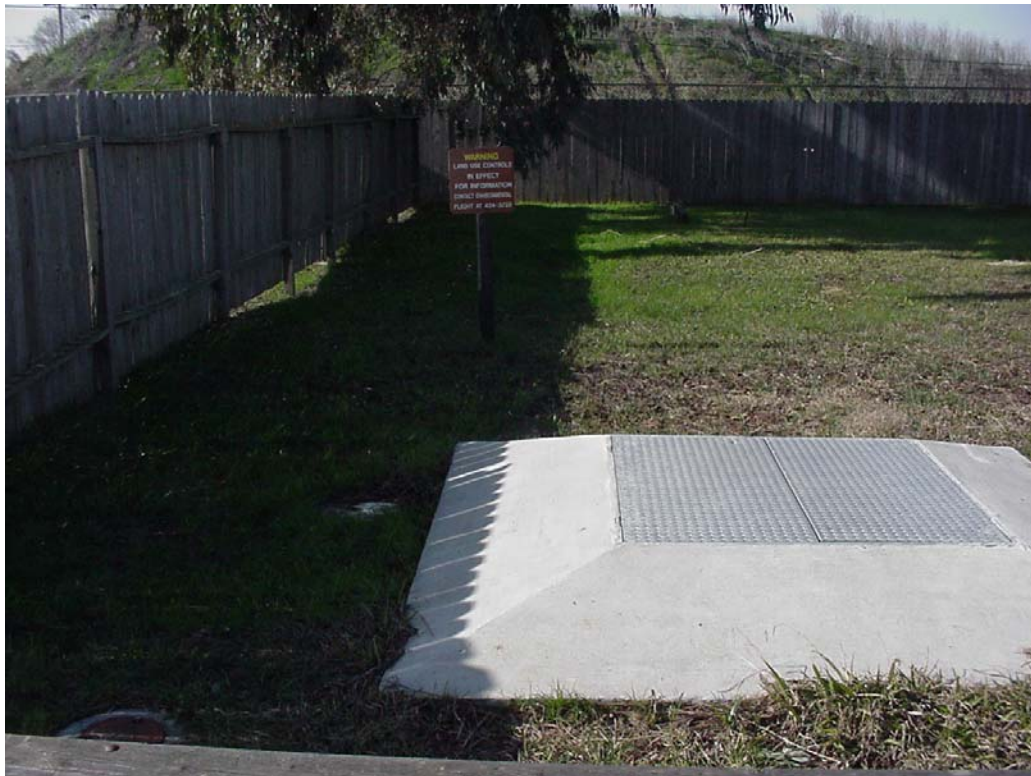
The 2006 inspection of the LUCs at DP039 found that administrative controls are adequate to enforce the restriction, so physical barriers (i.e., fences) are not needed. There is no evidence that the lead-impacted soil has been disturbed. Photograph 7 in Appendix B of this report shows the controlled area at DP039. The warning sign in the vicinity of the LUC area that ensures that visitors and occupants of Building 755 are aware of the presence of LUCs can be seen in the background.

Photograph 7: Controlled Area at DP039

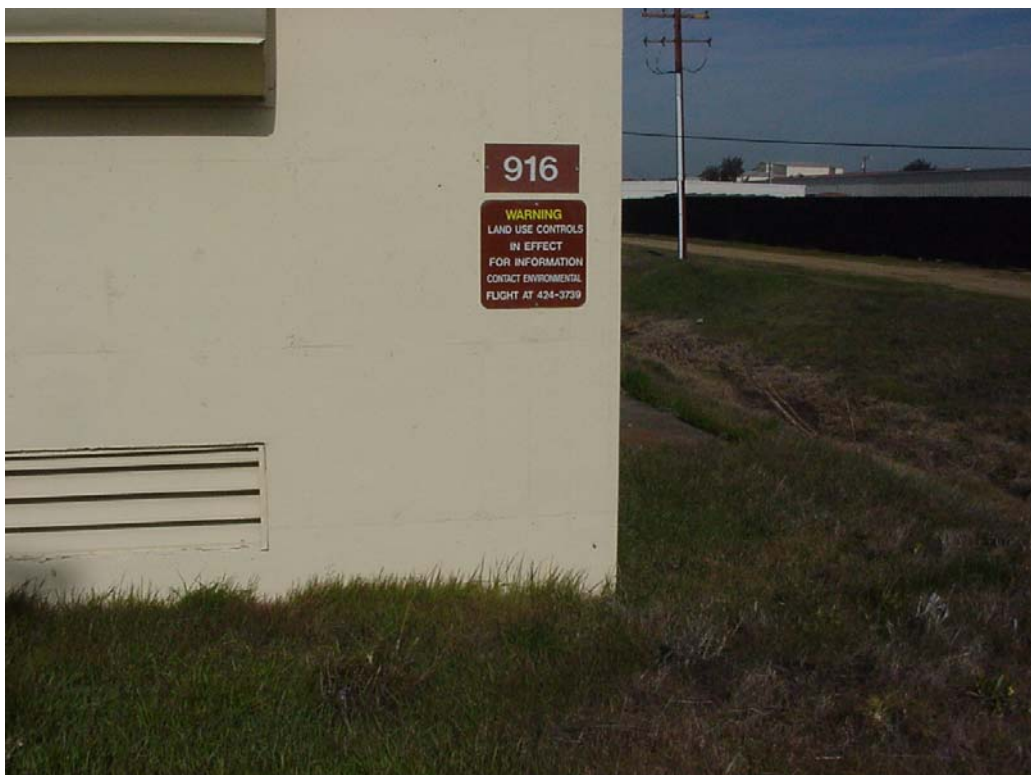
The 2006 inspection of the LUCs at SD043 found that administrative controls are adequately enforcing the restriction, so physical barriers (i.e., fences) are not needed. There is no evidence that any soil disturbances in the vicinity of the concrete pad and generator took place in 2006. Photograph 8 in Appendix B shows the east side of the generator and pad south of Building 916, and photograph 9 shows the warning signs in relation to the west side of the controlled area at SD043.

Photograph 8: Southeast Corner of Installed Generator at SD043

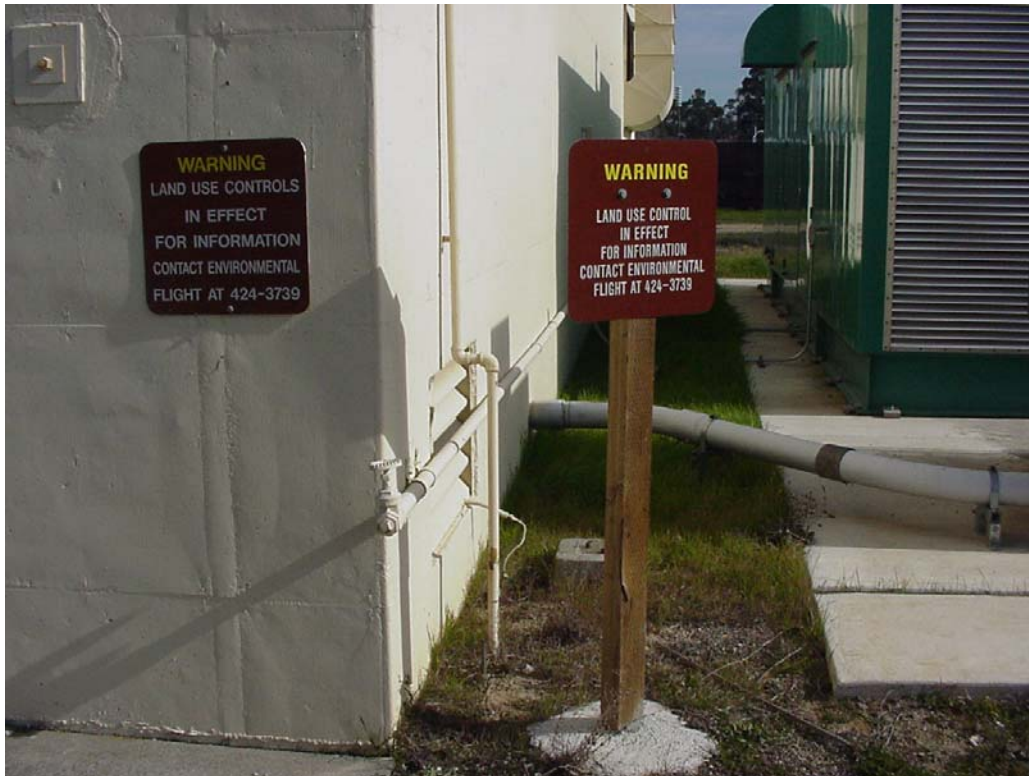
There had been a fenced and graveled electrical transformer area on the southwest corner of the building. This area contained three liquid-filled transformers on top of a concrete pad. In 1992, one of the transformers developed a leak onto the concrete pad and ground surface. The base removed the transformers and pad in 1993.

Photograph 9: Generator Pad and Warning Signs at SD043. Stanchion of Former Pad with Leaking Transformers is visible in the foreground.

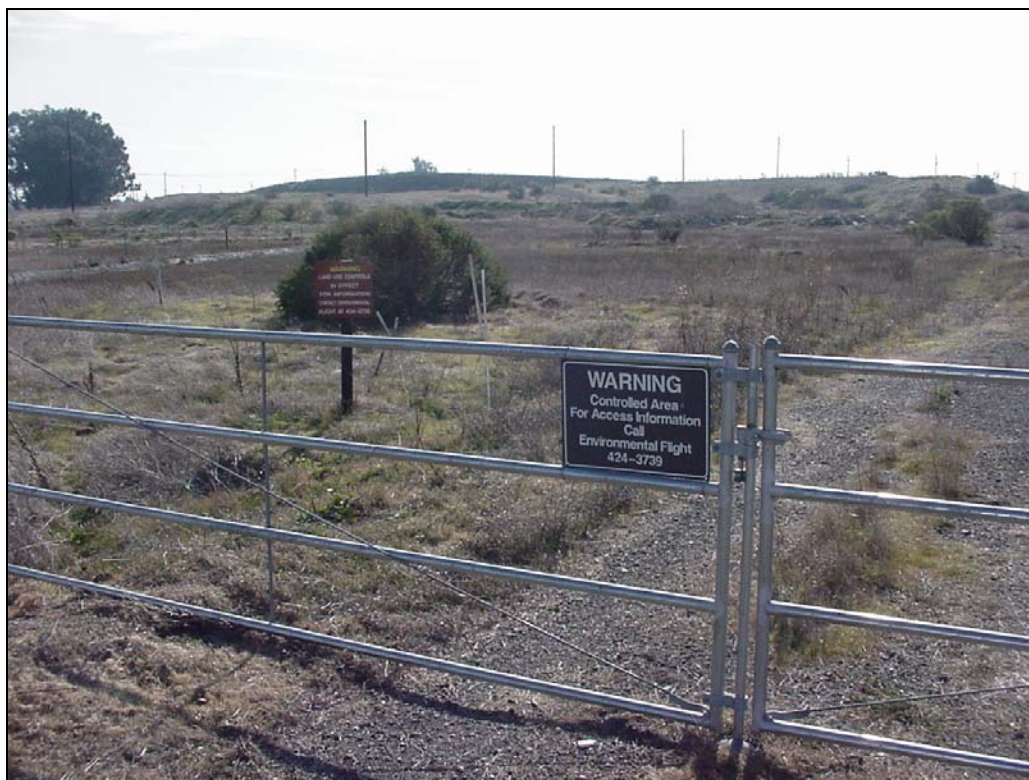
The 2006 inspection of the LUCs at LF044 found the fence and signs to be in excellent physical condition. There is no evidence to suggest that the property is being used for other than industrial purposes. Both gates were locked, and the Environmental Flight keeps a copy of the keys. Photograph 10 of Appendix A shows the warning sign at the north access gate, and photograph 11 shows the warning signs on the fence and behind the south access gate. The gates are in excellent physical condition, and warning signs at each gate are clearly visible.

Photograph 10: Warning Signs at Entrance and on fence near the North Access Gate.

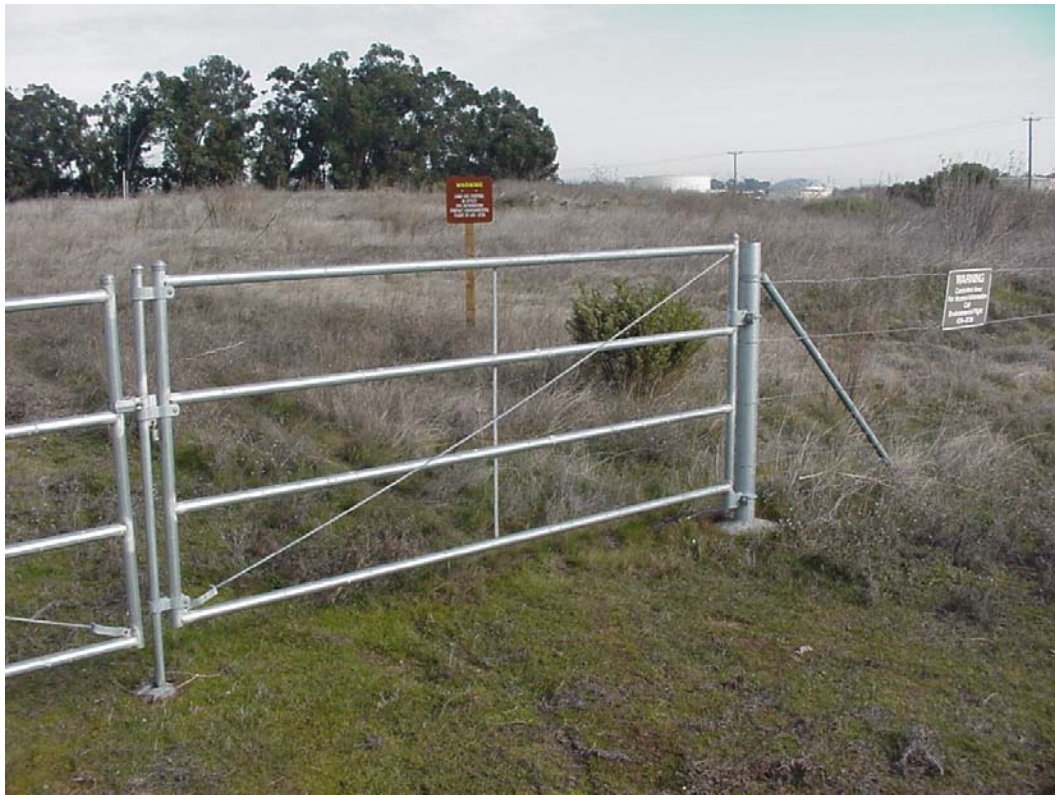
Photograph 11: Warning Signs on Fence and behind the South Access Gate.

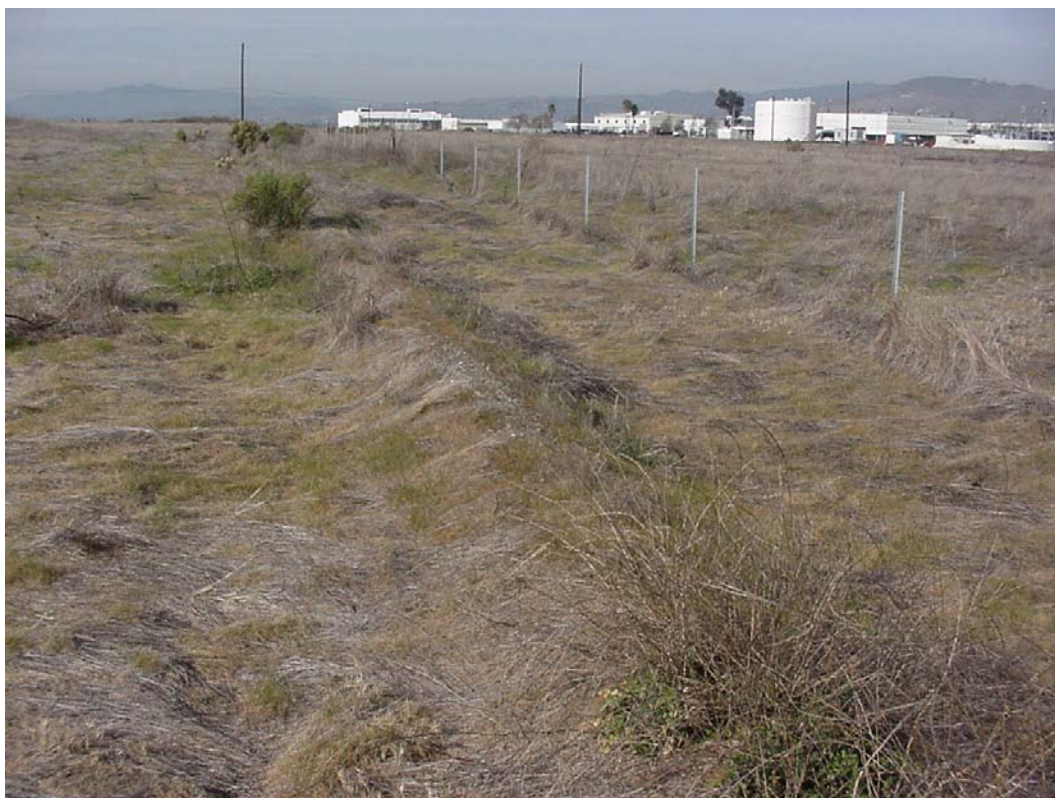
In December 2002, exceptionally heavy rains caused a low section of the berm to erode and fail. Pooled water on the northwest side of the berm began to flow over the top of the compacted soil, creating a small breach. To prevent a similar event from occurring again, ECC fortified the low section of the berm with cement. In future winter months that receive a substantial amount of rainfall, the base expects pooled water to gently flow over the low sections of the berm, allowing sediment to settle within the controlled area.

The 2006 inspection of the LUCs at LF044 found the berm to be in excellent physical condition. Native grass, weeds and small shrubs have grown over portions of the berm, which serves to increase its cohesiveness. The base has not received sufficient rainfall to demonstrate that the berm is performing as designed, but there was no evidence of damage to the berm from base activities. No accumulation of surface runoff was observed along the berm, and the adjacent wetlands are dry. Photograph 12 of Appendix B was taken during the inspection of the LF044 berm.

Photograph 12: Fencing and Berm on East Side of LF044.

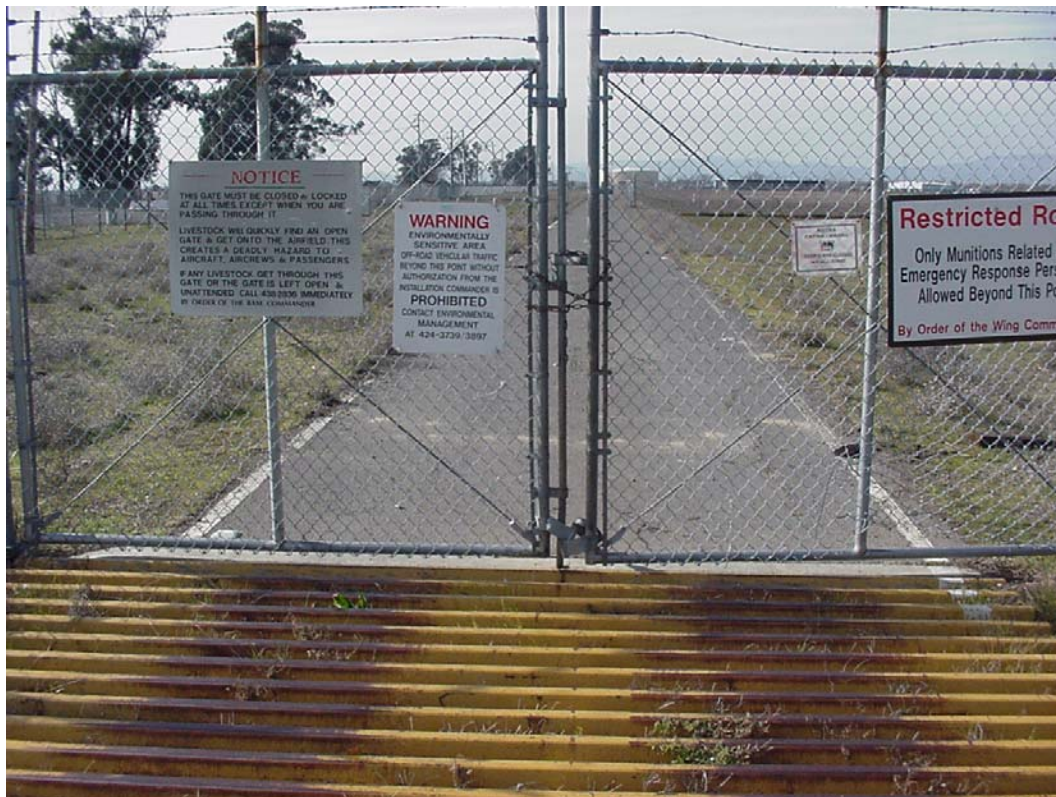
The 2006 inspection of the LUCs at SD045 found that the existing controls are adequate to prevent unauthorized use of the property. Other than the soil excavation areas that were the result of the ESTCP field work, there is no evidence that the metals-impacted soil has been disturbed. A sign at the entrance to the GMU notifies visitors and base workers of the presence of ecologically sensitive areas in the vicinity of SD045. However, the LUC sign was not present. It had been taken down in the May-June 2006 timeframe so that it could be used as a template to create additional signs for the NEWIOU sites, and it had not been reinstalled on the GMU gate. Once this discrepancy was identified, base environmental personnel attached an extra warning sign to the gate. Photograph 13 of Appendix B of this report shows the access gate that leads to SD045 as seen during the inspection.

Photograph 13: Fence Access to SD045. Warning sign is not posted on gate entry.

The inspection team found the controls at the eleven sites to be in place and effective at restricting land use to industrial purposes only. Also, corrective measures at site SD043 in response to a 2003 construction project within its LUC area are in place and working as designed. One warning sign at site SD045 was missing, but this discrepancy was corrected promptly.

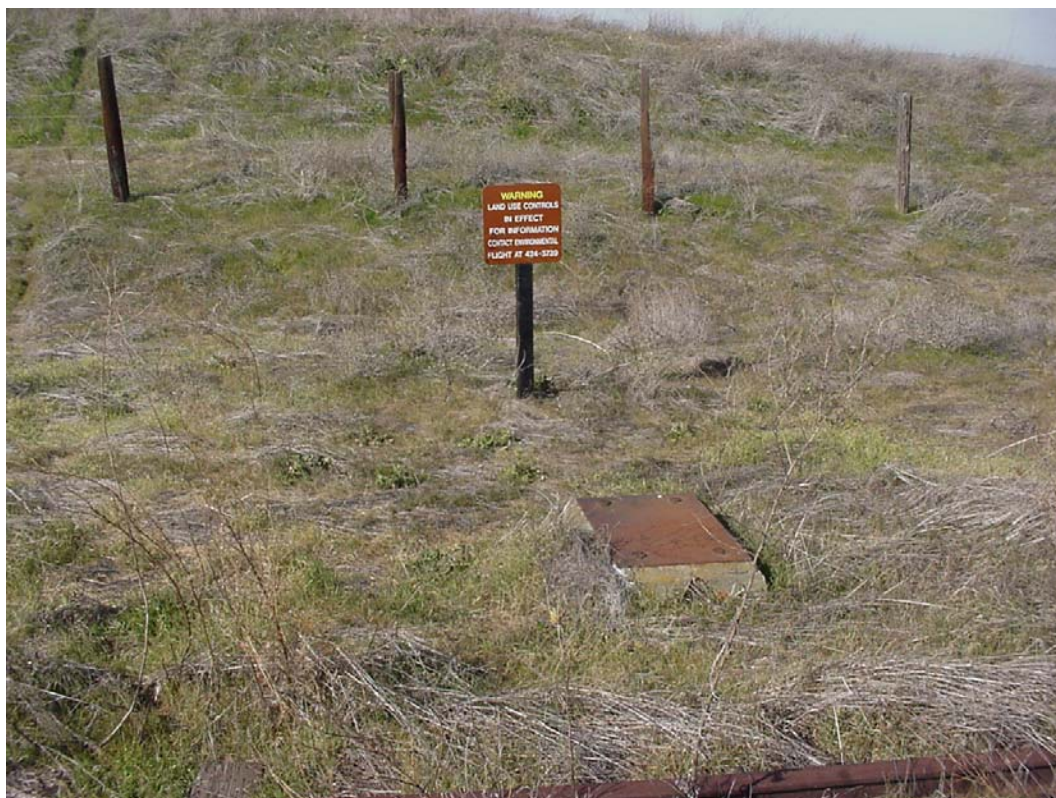
The 2006 inspection of the LUCs at SS046 found that administrative controls are adequate to enforce the restriction, so additional physical barriers (i.e., fences not associated with the Grazing Management Unit) are not needed. There is no evidence that the contaminated soil has been disturbed. Photograph 14 of Appendix B of this report shows the east side of the controlled area at SS046, and photograph 15 shows the west side of the controlled area.

Photograph 14: Warning Sign at East Side of SS046.

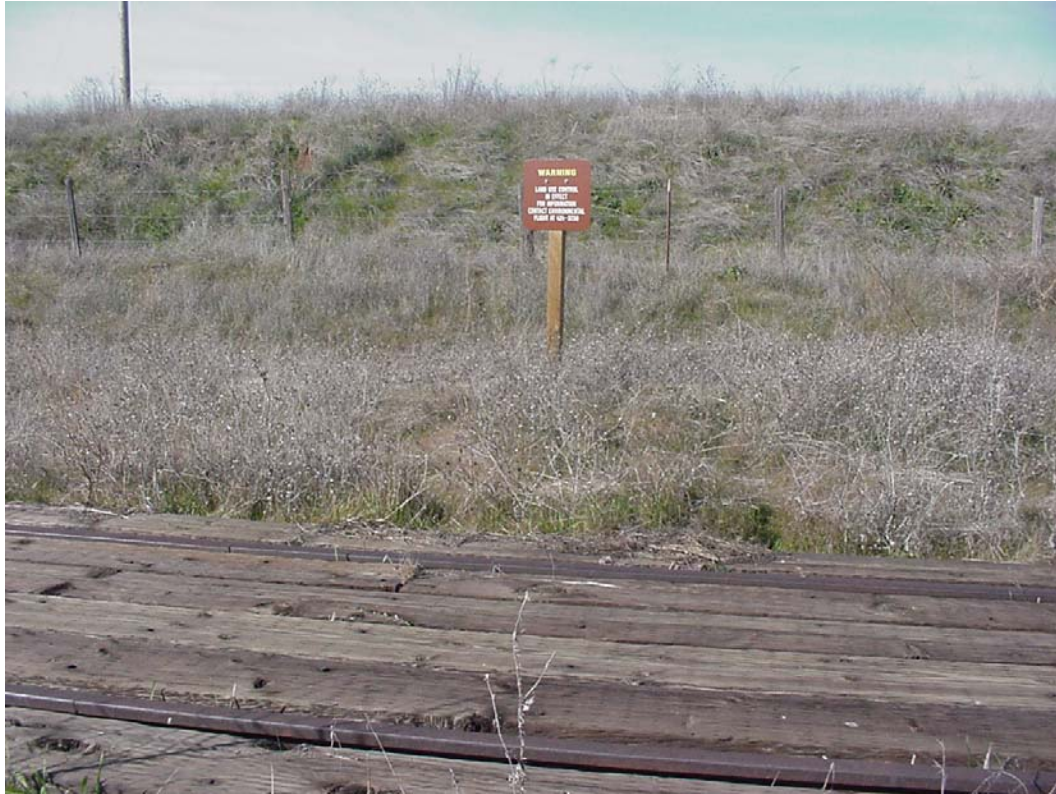
Photograph 15: Warning Sign at West Side of SS046.

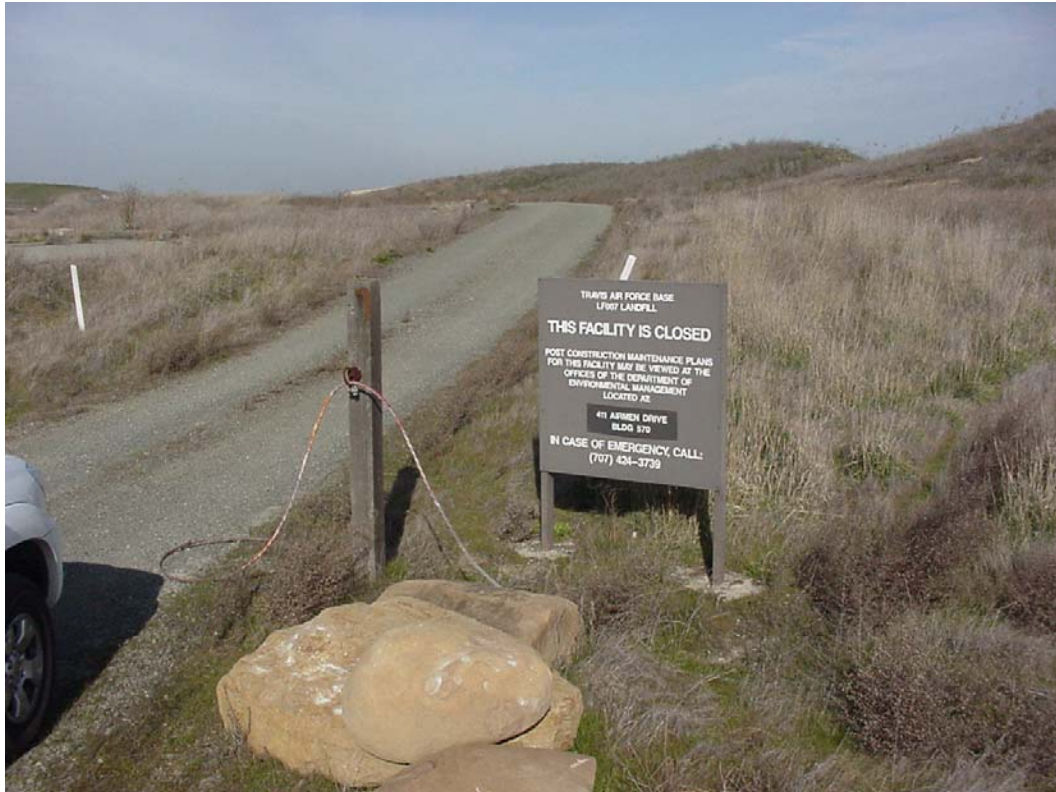
The 2006 inspection of the LUCs at LF007 found that the current administrative and physical controls are adequate to enforce the restrictions. There is no evidence that the contaminated soil at LF007 has been disturbed. Photograph 16 in Appendix B of this report shows the warning sign that has been placed at the entrance to the CAMU, which controls access to the CAMU, the Landfill 2 cover, and the locking chain that controls access. Photograph 17 shows the warning sign along the path toward the CAMU, and photograph 18 shows one of the four No Trespassing signs that mark the four corners of the CAMU. There is also no evidence that the active operations at Buildings 1360, 1365 and 1370 are compromising the land use controls in place on the portions of LF007 discussed above.

Photograph 16: Entrance to Travis AFB CAMU.

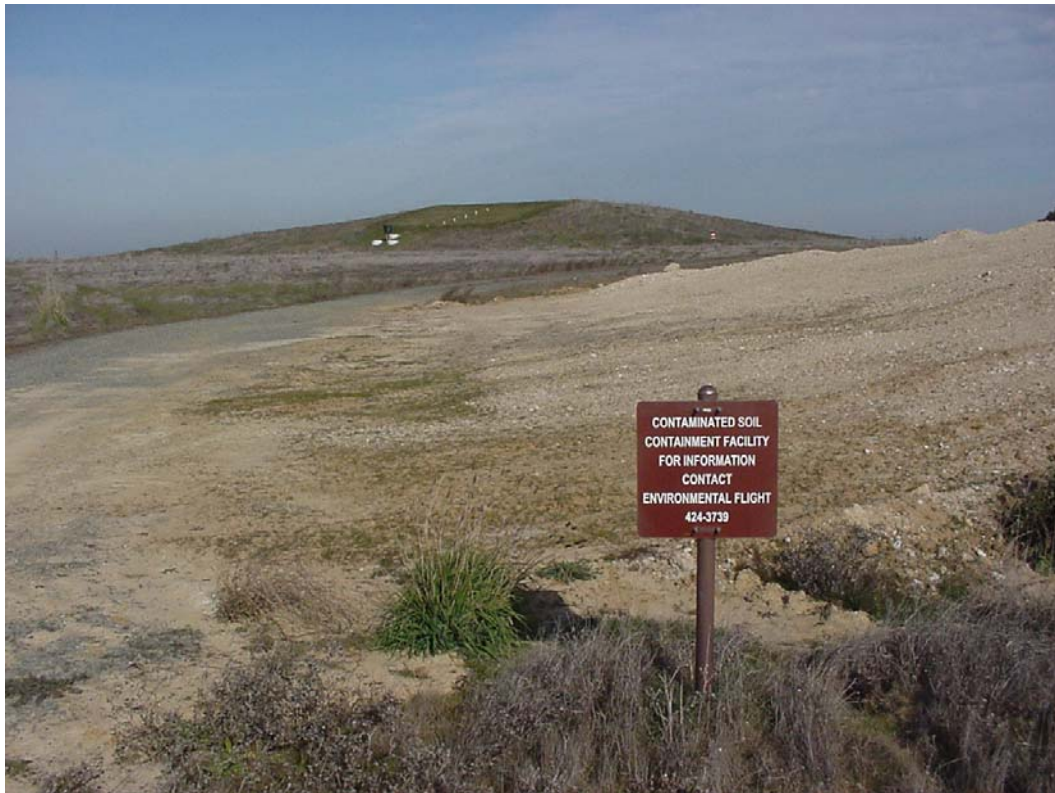
Photograph 17: Warning Sign at CAMU.

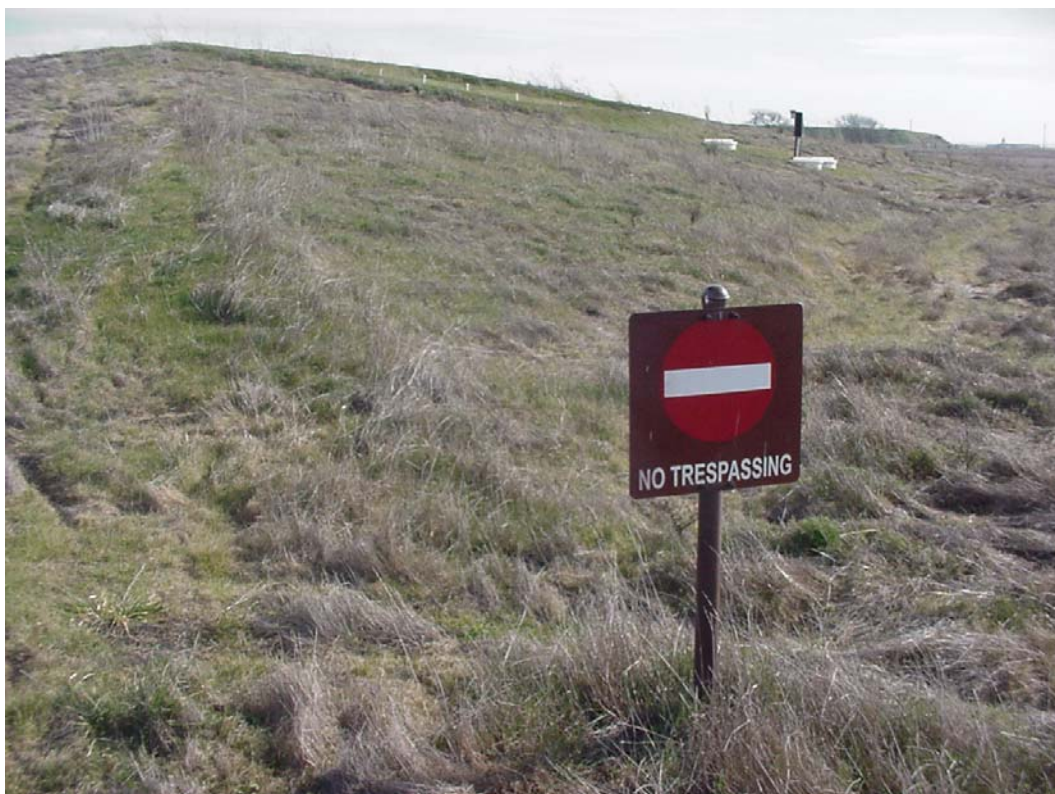
Photograph 18: No Trespassing Sign at CAMU.
