TRAVIS AIR FORCE BASE
ENVIRONMENTAL RESTORATION PROGRAM

**ANNUAL REPORT
ON THE STATUS OF
LAND USE CONTROLS
ON RESTORATION SITES
IN 2007**

JANUARY 2008

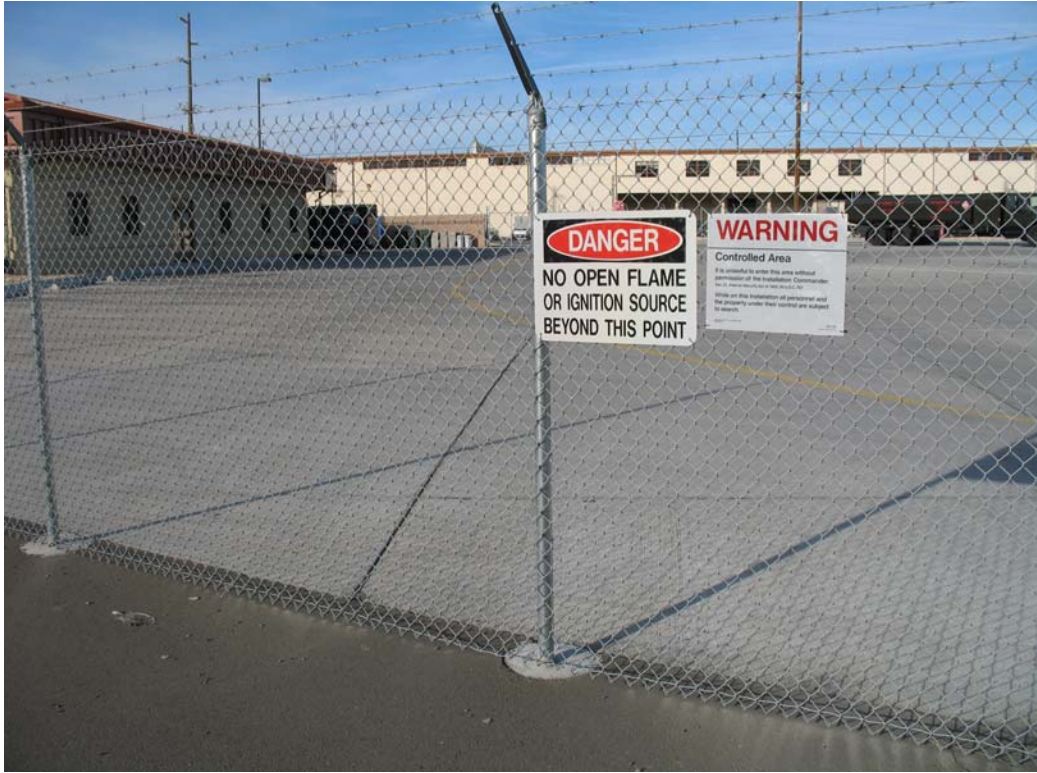
Photograph 1: Controlled Area at SS015.

The 2007 inspection of the LUCs at SS015 found that administrative controls are adequate to enforce the restriction, so additional physical barriers (i.e., fences) are not needed. There is no

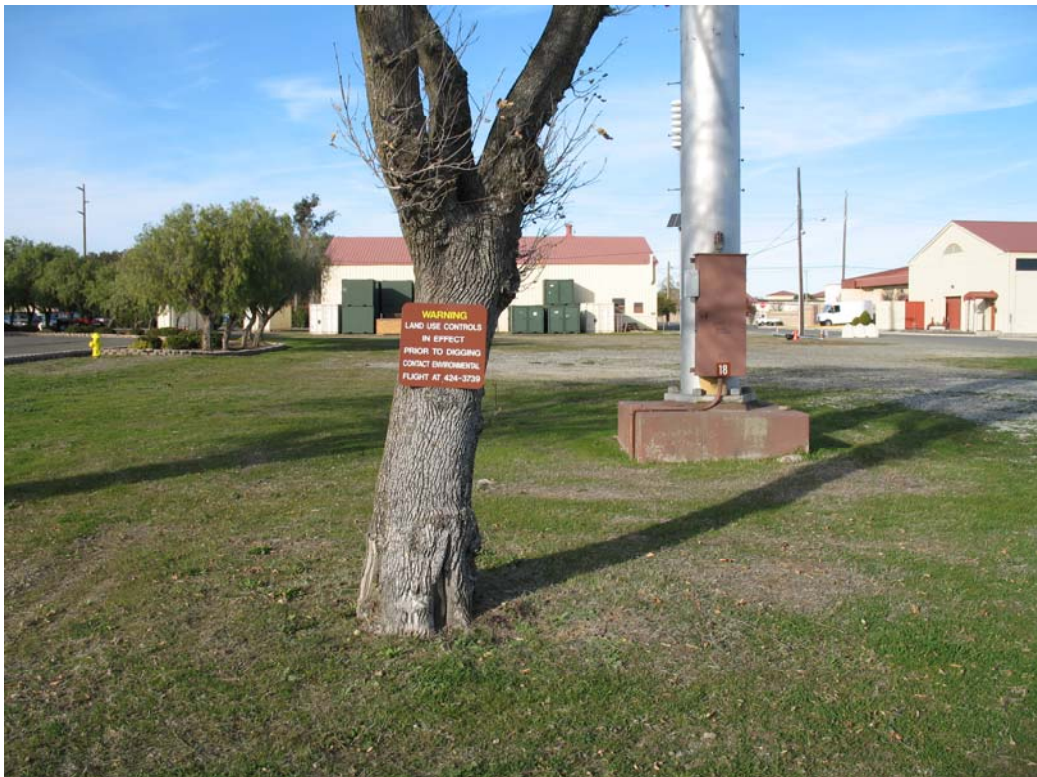
Photograph 2: Controlled Area at SS016.

The 2007 inspection of the LUCs at SS016 found that administrative controls are adequate to enforce the restriction, so physical barriers (i.e., fences) are not needed. There is no evidence that the PAH-impacted soil has been disturbed either with or without proper authorization. A warning sign has been posted on a tree in the middle of the site to notify base workers of the

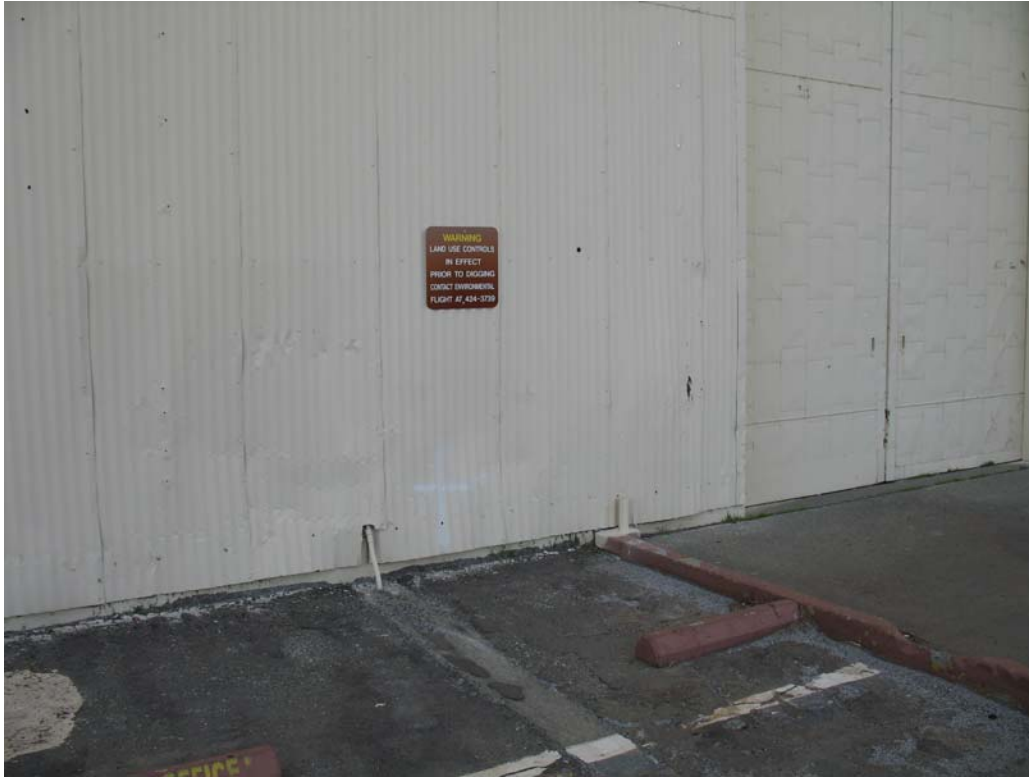
Photograph 3: Warning Sign at Controlled Area on East Side of SD033.

The 2007 inspection of the LUCs at SD033 found that administrative controls are adequate to enforce the restriction, so physical barriers (i.e., fences) are not needed. There is no evidence that the cadmium- and benzo(a)pyrene-impacted soil has been disturbed. Warning signs have been posted on both sides of Facility 810 to notify base workers of the presence of the controlled area. Photographs 3 and 4 in Appendix B of this report show the controlled areas at SD033.

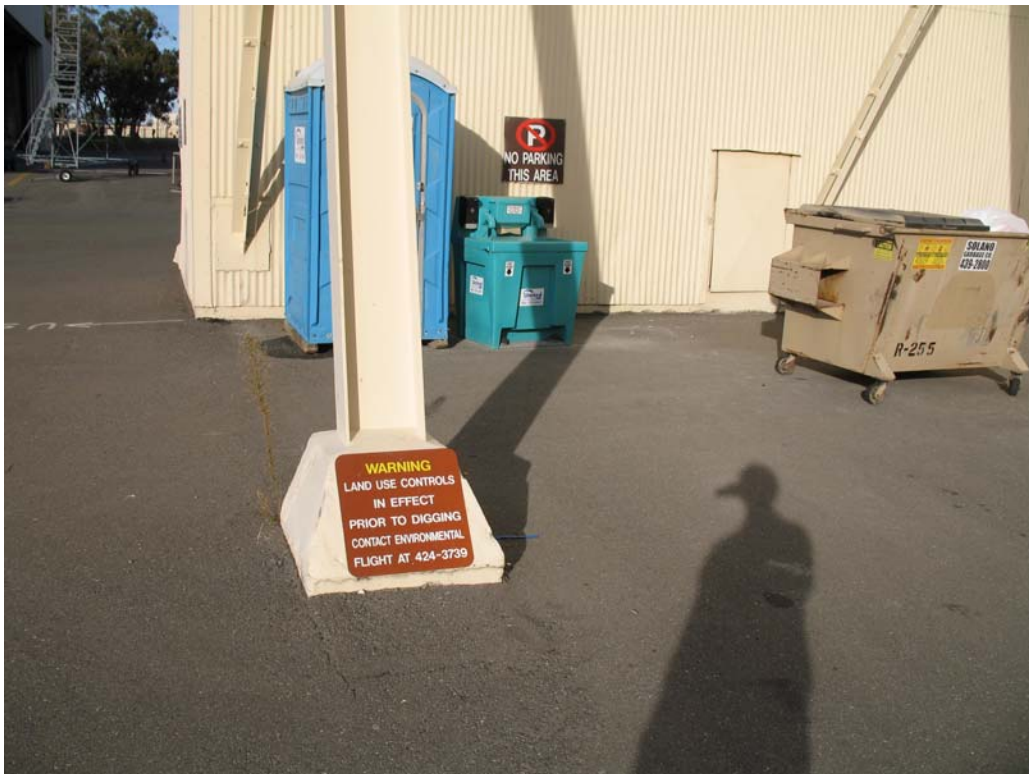
Photograph 4: Warning Sign at Controlled Area on West Side of SD033.

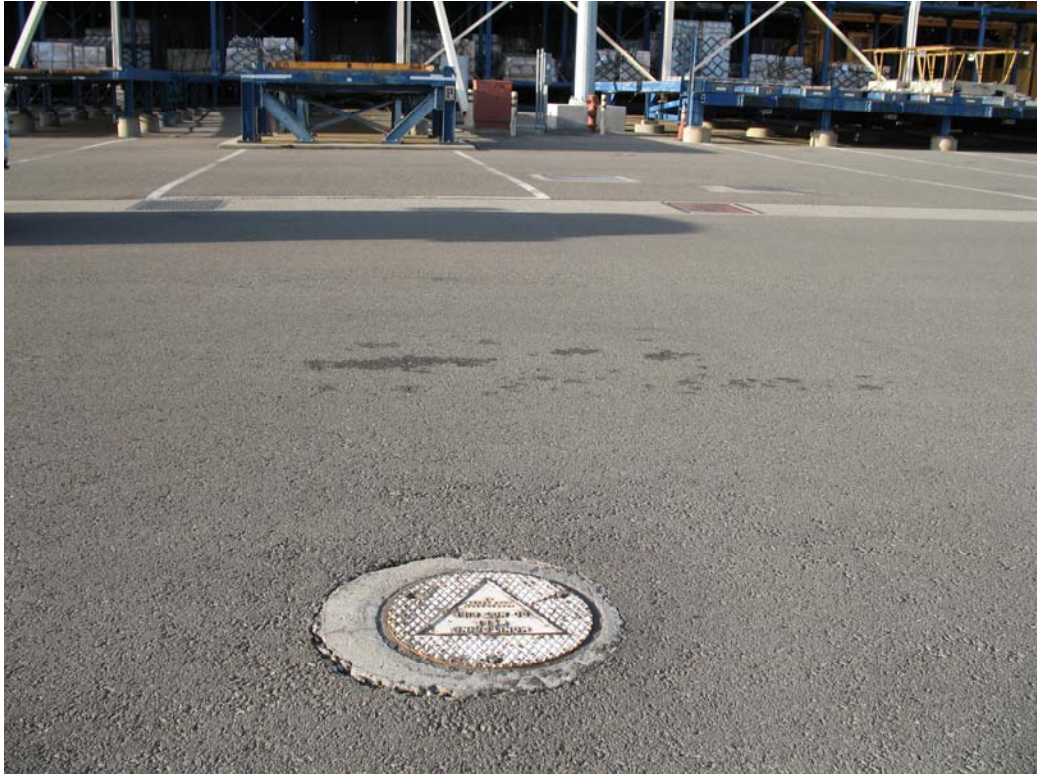
Photograph 5: Controlled Area on Southeast Side of SD037

The 2007 inspection of the LUCs at SD037 found that administrative controls are adequate to enforce the restriction, so physical barriers (i.e., fences) are not needed. There is no evidence that the PAH-, lead-, and TPH-impacted soil has been disturbed. Due to the nature of operations at the air freight terminal, it is not practical or safe to post warning signs to warn base personnel of the presence of the controlled areas. Photographs 5 and 6 in Appendix B of this report show the controlled areas at SD037.

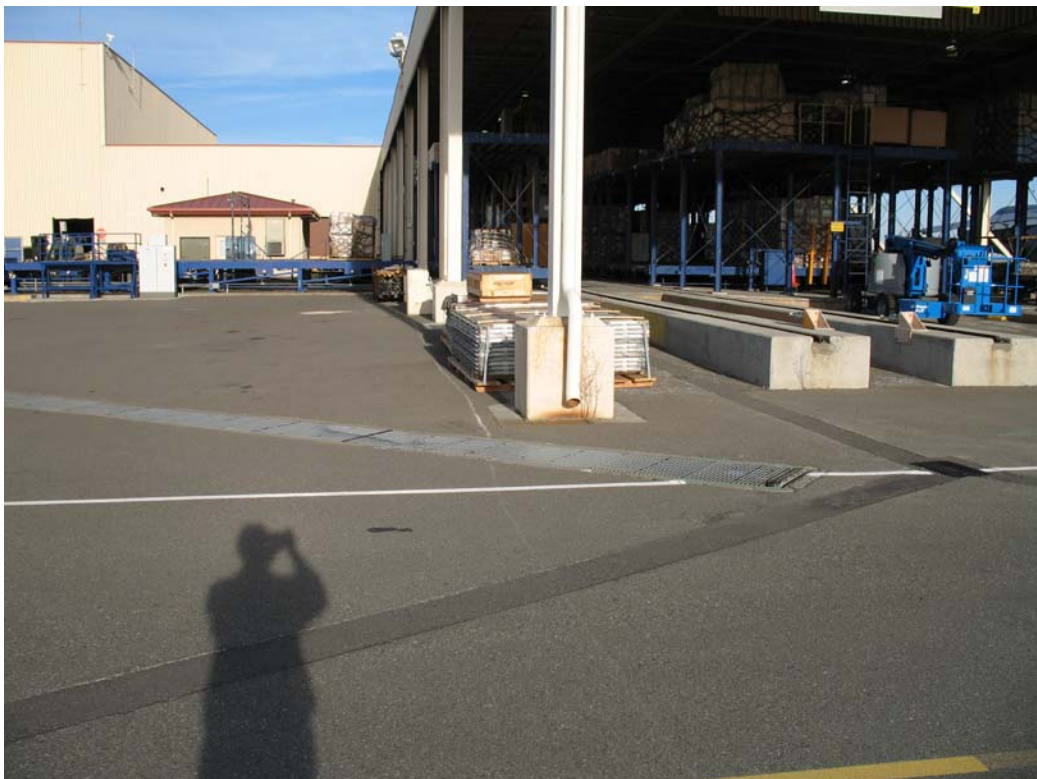
Photograph 6: Controlled Area on Southwest Side of SD037

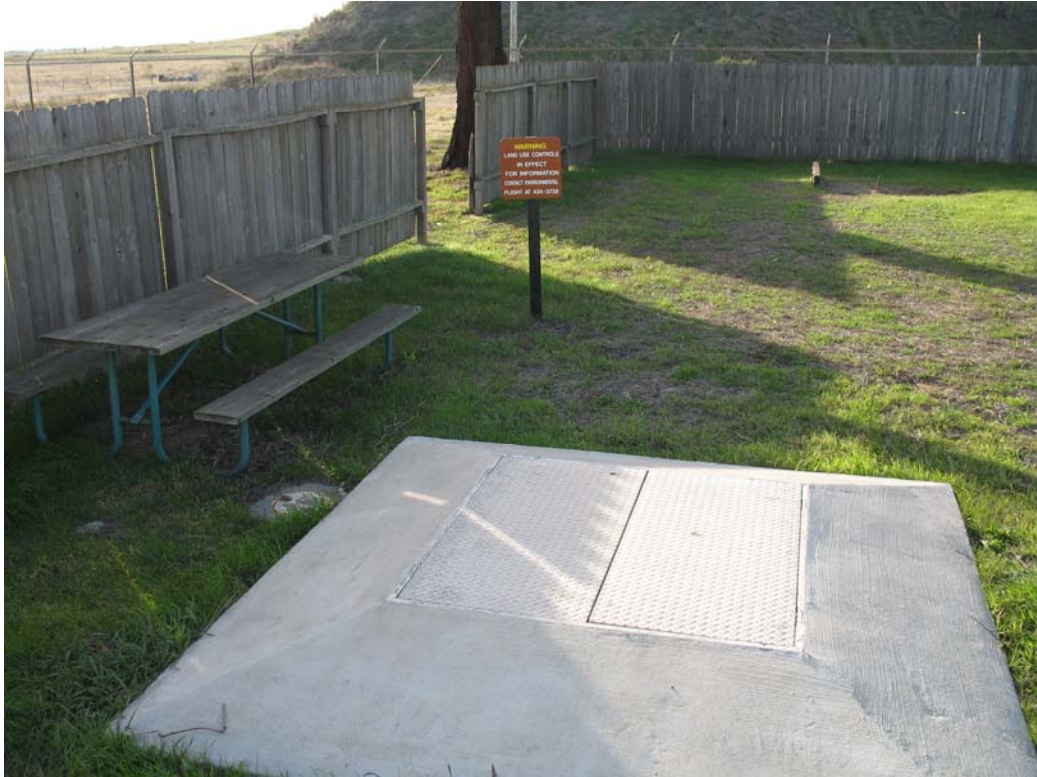
Photograph 7: Controlled Area at DP039

The 2007 inspection of the LUCs at DP039 found that administrative controls are adequate to enforce the restriction, so physical barriers (i.e., fences) are not needed. There is no evidence that the lead-impacted soil has been disturbed. Photograph 7 in Appendix B of this report shows the controlled area at DP039. The warning sign in the vicinity of the LUC area that ensures that visitors and occupants of Building 755 are aware of the presence of LUCs can be seen in the background.

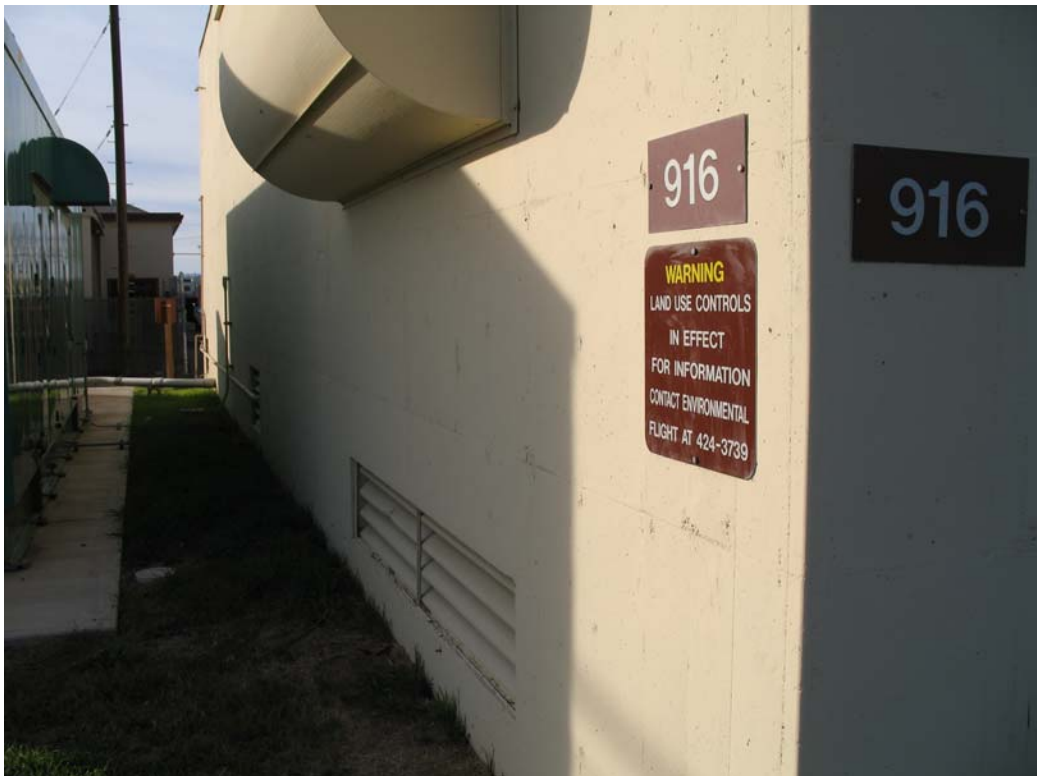
Photograph 8: Southeast Corner of Installed Generator at SD043

The 2007 inspection of the LUCs at SD043 found that administrative controls are adequately enforcing the restriction, so physical barriers (i.e., fences) are not needed. There is no evidence that any soil disturbances in the vicinity of the concrete pad and generator took place in 2007. Photograph 8 in Appendix B shows the east side of the generator and pad south of Building 916, and photograph 9 shows the warning signs in relation to the west side of the controlled area at SD043.

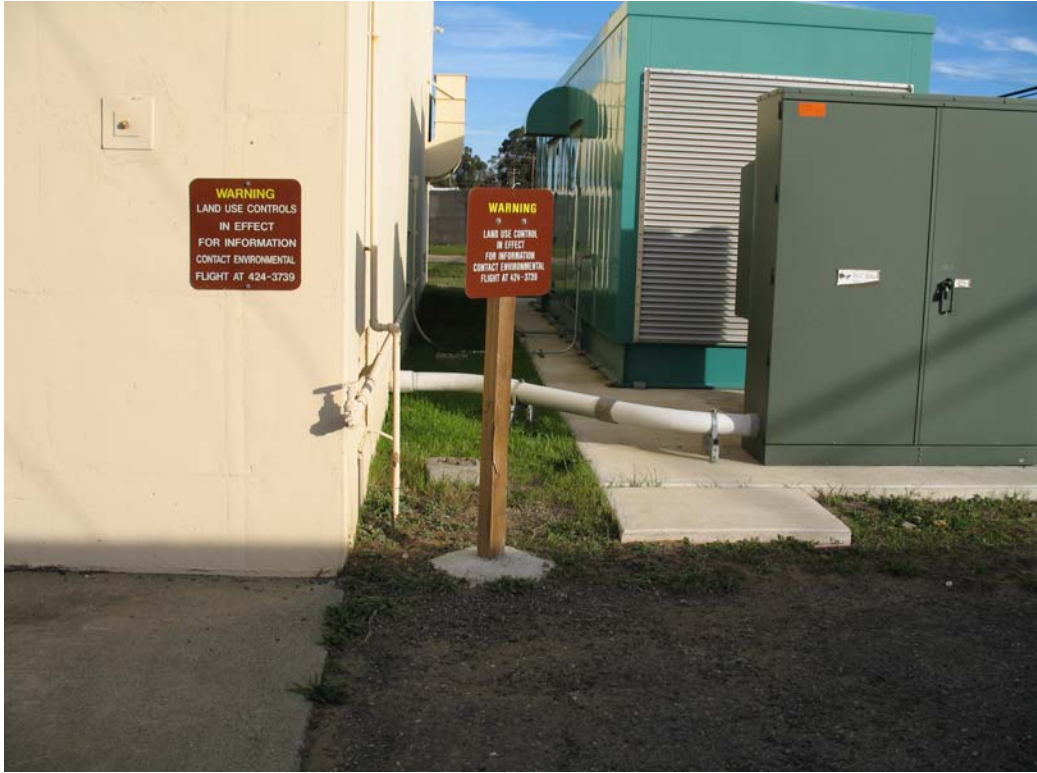
There had been a fenced and graveled electrical transformer area on the southwest corner of the building. This area contained three liquid-filled transformers on top of a concrete pad. In 1992, one of the transformers developed a leak onto the concrete pad and ground surface. The base removed the transformers and pad in 1993.

Photograph 9: Generator Pad and Warning Signs at SD043. Stanchion of Former Pad with Leaking Transformers is visible in the foreground.

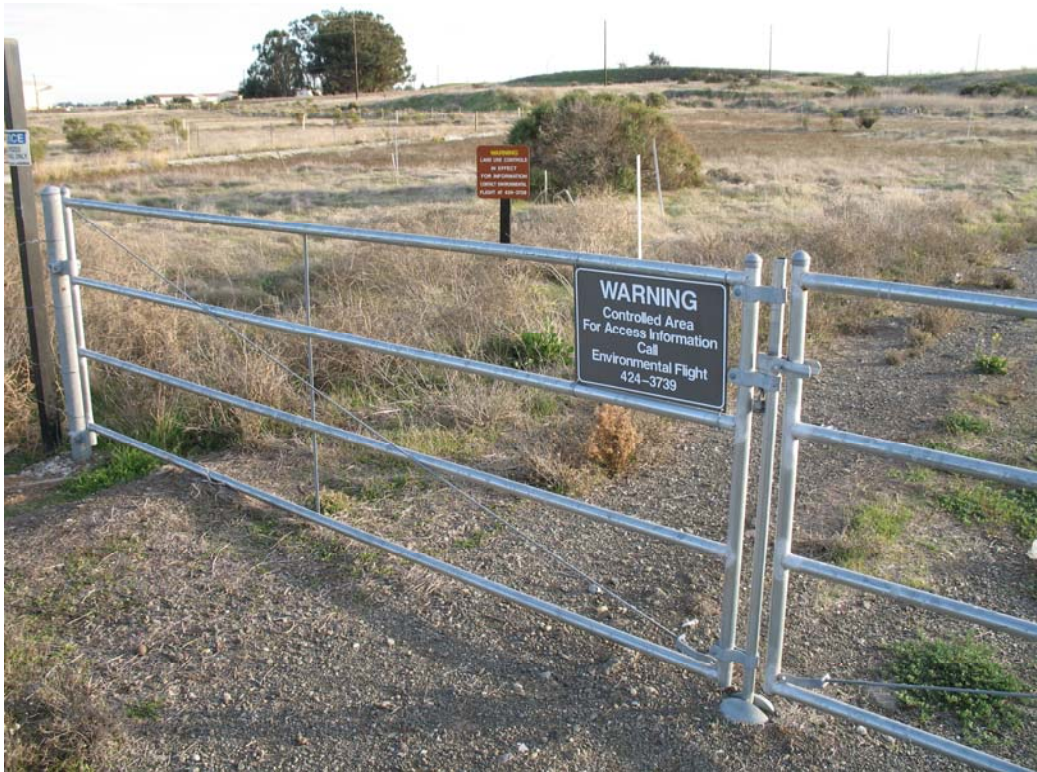
The 2007 inspection of the LUCs at LF044 found the fence and signs to be in excellent physical condition. There is no evidence to suggest that the property is being used for other than industrial purposes. Both gates were locked, and the Environmental Flight keeps a copy of the keys. Photograph 10 of Appendix A shows the warning sign at the north access gate, and photograph 11 shows the warning signs on the fence and behind the south access gate. The gates are in excellent physical condition, and warning signs at each gate are clearly visible.

Photograph 10: Warning Signs at Entrance and on fence near the North Access Gate.

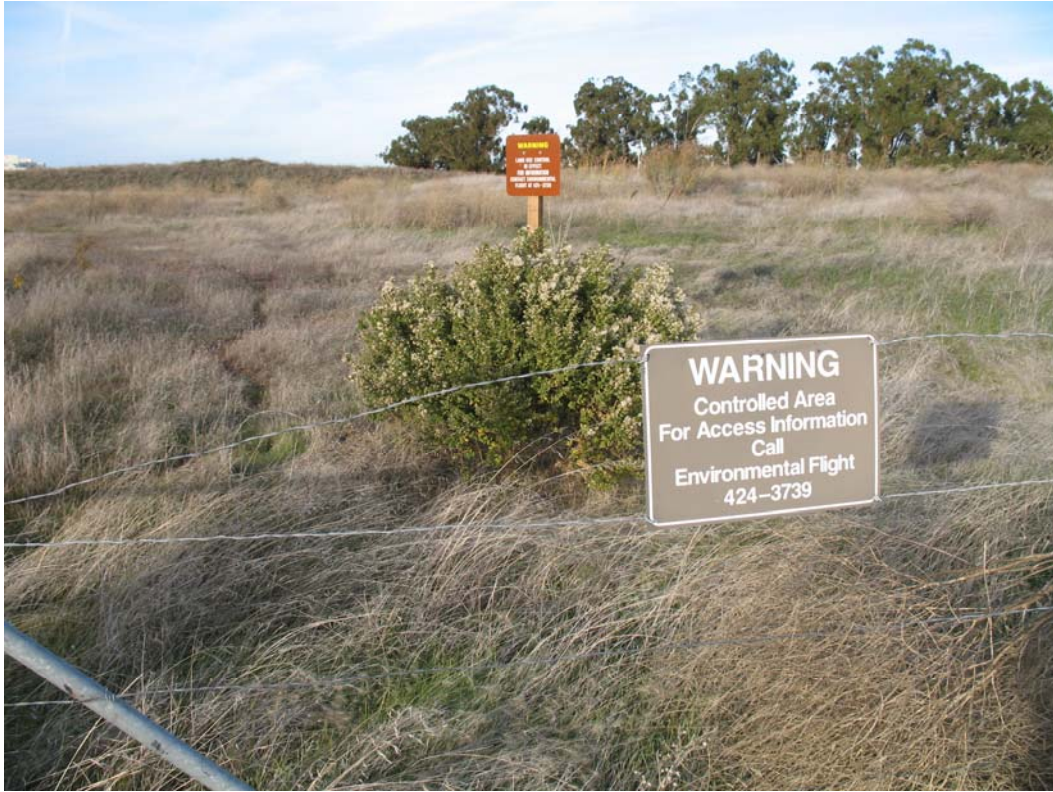
Photograph 11: Warning Signs on Fence and behind the South Access Gate.

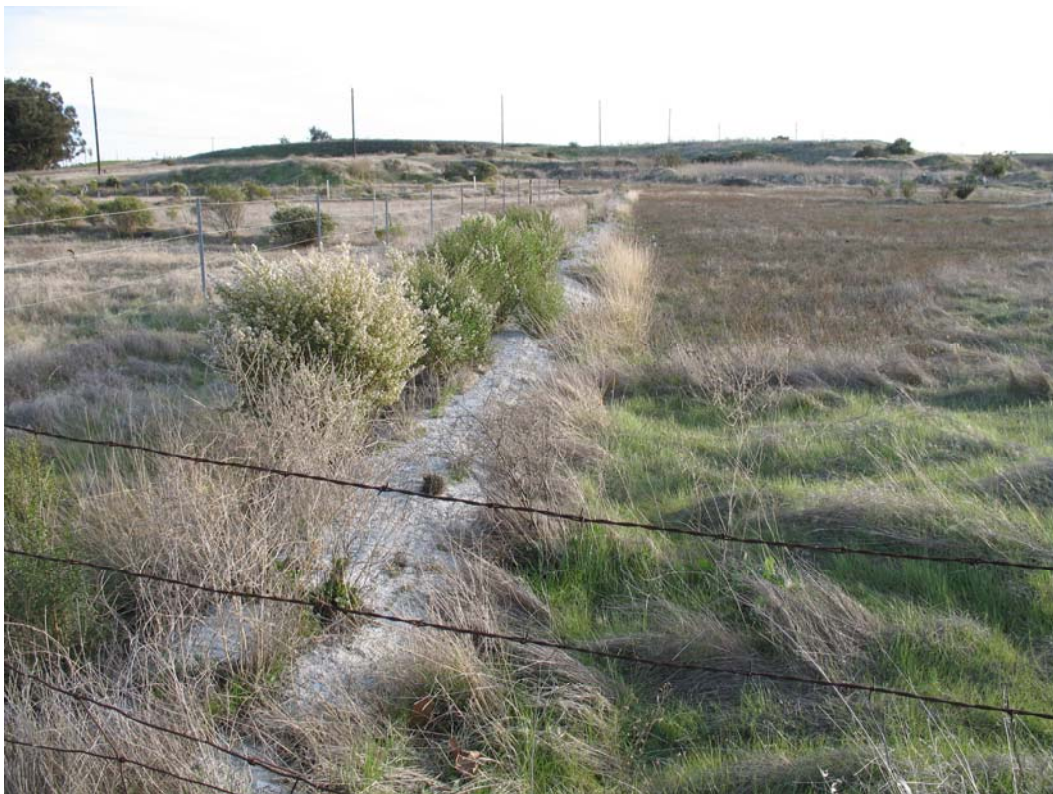
The 2007 inspection of the LUCs at LF044 found the berm to be in excellent physical condition. Native grass, weeds and small shrubs have grown over portions of the berm, which serves to increase its cohesiveness. The base has not received sufficient rainfall to demonstrate that the berm is performing as designed, but there was no evidence of damage to the berm from base activities. No accumulation of surface runoff was observed along the berm, and the adjacent wetlands are dry. Photograph 12 of Appendix B was taken during the inspection of the LF044 berm.

Photograph 12: Fencing and Berm on East Side of LF044.

In December 2002, exceptionally heavy rains caused a low section of the berm to erode and fail. Pooled water on the northwest side of the berm began to flow over the top of the compacted soil, creating a small breach. To prevent a similar event from occurring again, ECC fortified the low section of the berm with cement. In future winter months that receive a substantial amount of rainfall, the base expects pooled water to gently flow over the low sections of the berm, allowing sediment to settle within the controlled area.

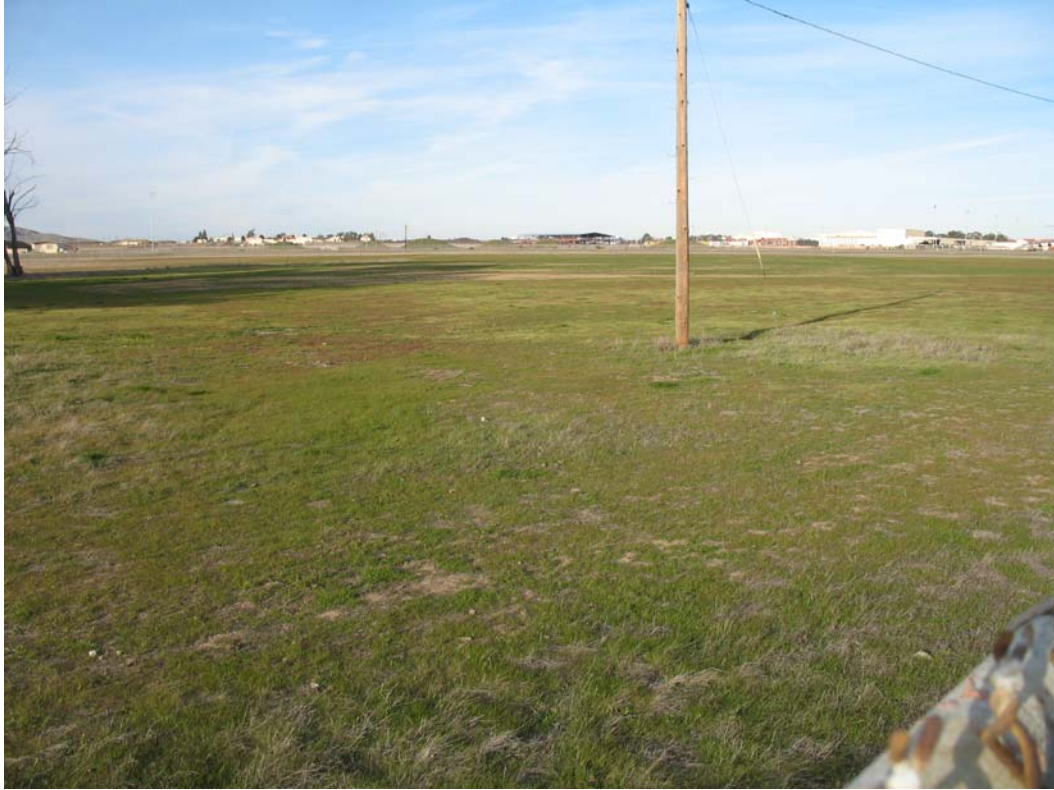
The 2007 inspection of the LUCs at SD045 found that the existing controls are adequate to prevent unauthorized use of the property. The SD045 remediation is complete, and the site has been restored. Photograph 13 of Appendix B of this report shows the restored site.

Photograph 13: Site SD045 Post-Remediation.

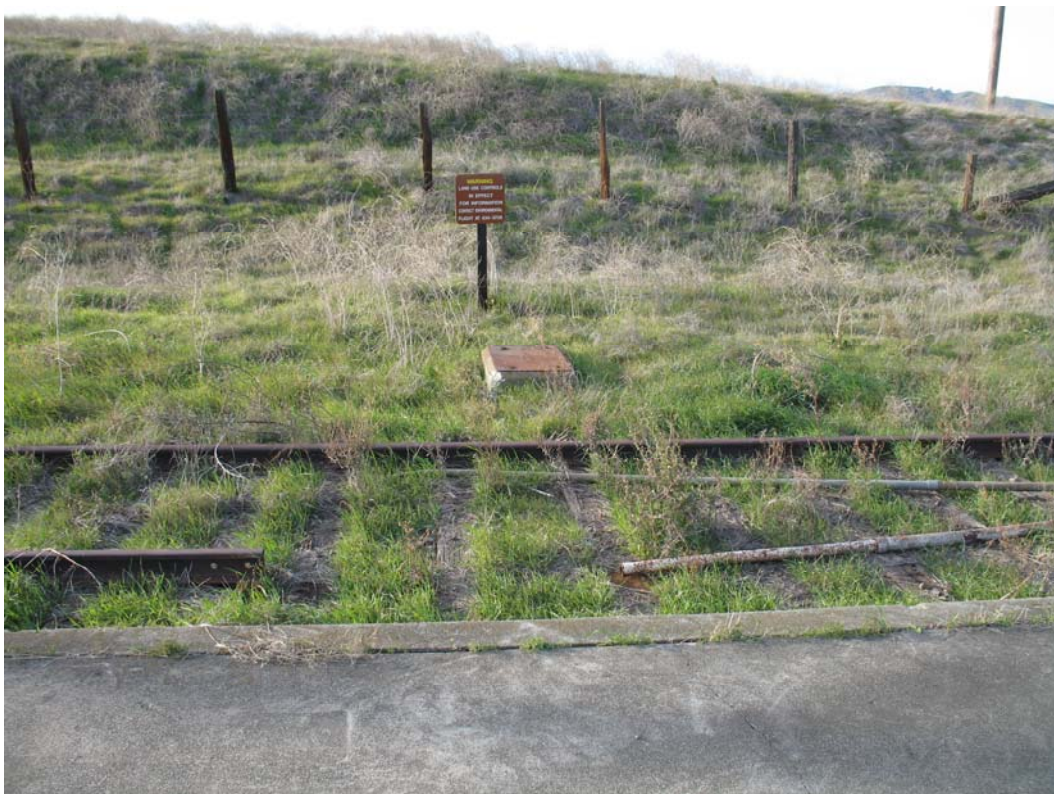
The 2007 inspection of the LUCs at SS046 found that administrative controls are adequate to enforce the restriction, so additional physical barriers (i.e., fences not associated with the Grazing Management Unit) are not needed. There is no evidence that the contaminated soil has been disturbed. Photograph 14 of Appendix B of this report shows the east side of the controlled area at SS046, and photograph 15 shows the west side of the controlled area.

Photograph 14: Warning Sign at East Side of SS046.

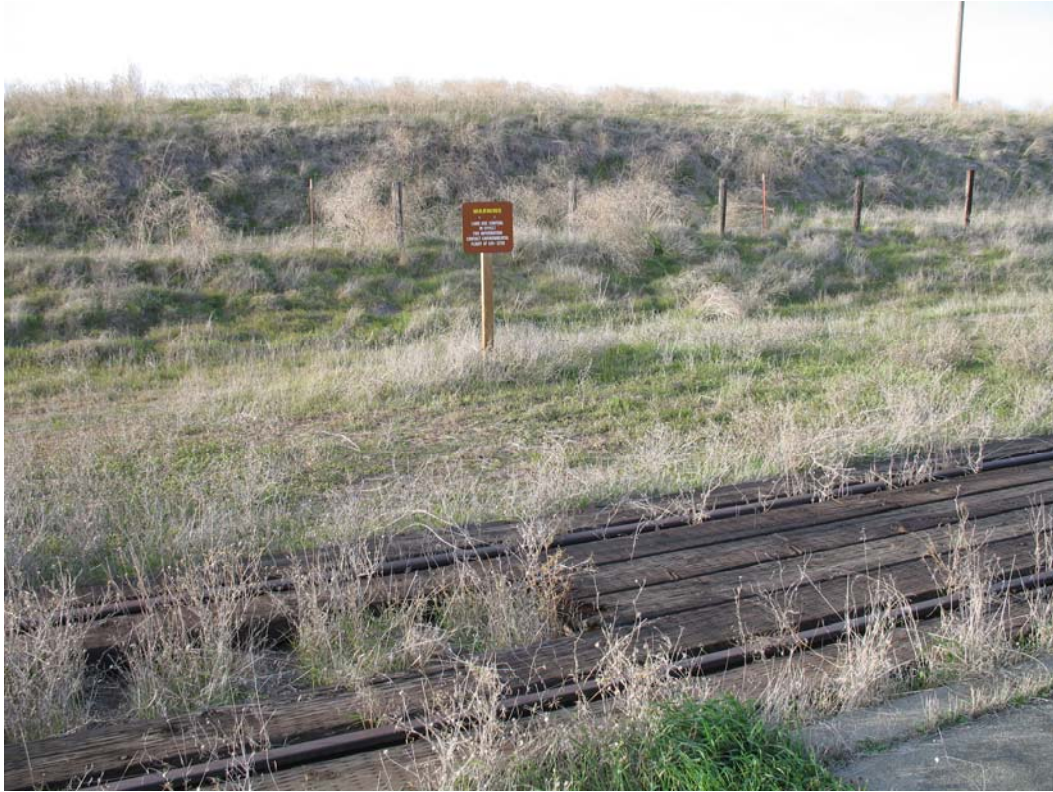
Photograph 15: Warning Sign at West Side of SS046.

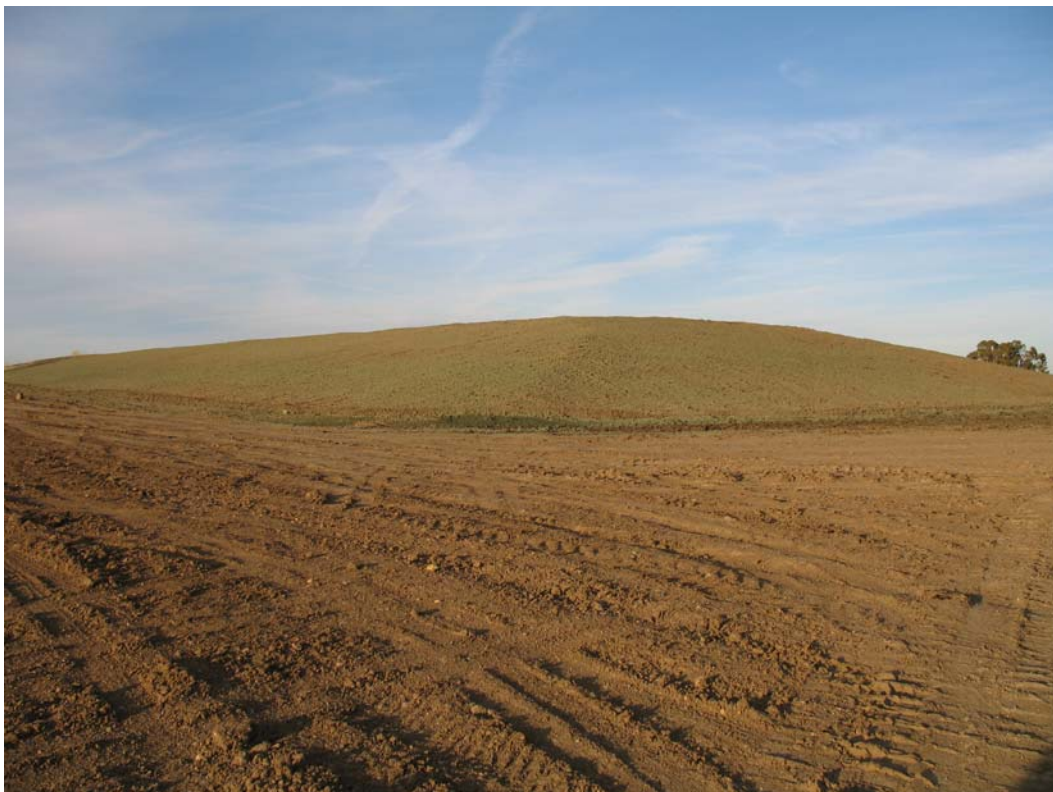
Photograph 16: South Side of Expanded Travis AFB CAMU.

The 2007 inspection of the LUCs at LF007 found that the current administrative and physical controls are adequate to enforce the restrictions. There is no evidence that the contaminated soil at LF007 has been disturbed, other than the field work associated with the 2007 soil cleanup actions. Photograph 16 in Appendix B of this report shows the south side of the expanded CAMU. Photographs 17 and 18 show the warning sign along the path toward the CAMU. Photograph 19 shows the field team that was completing the CAMU construction, and photograph 20 shows the erosion protection skirt that was placed around the base of the CAMU. There is also no evidence that the active operations at Buildings 1360, 1365 and 1370 are compromising the land use controls in place on the portions of LF007 discussed above.

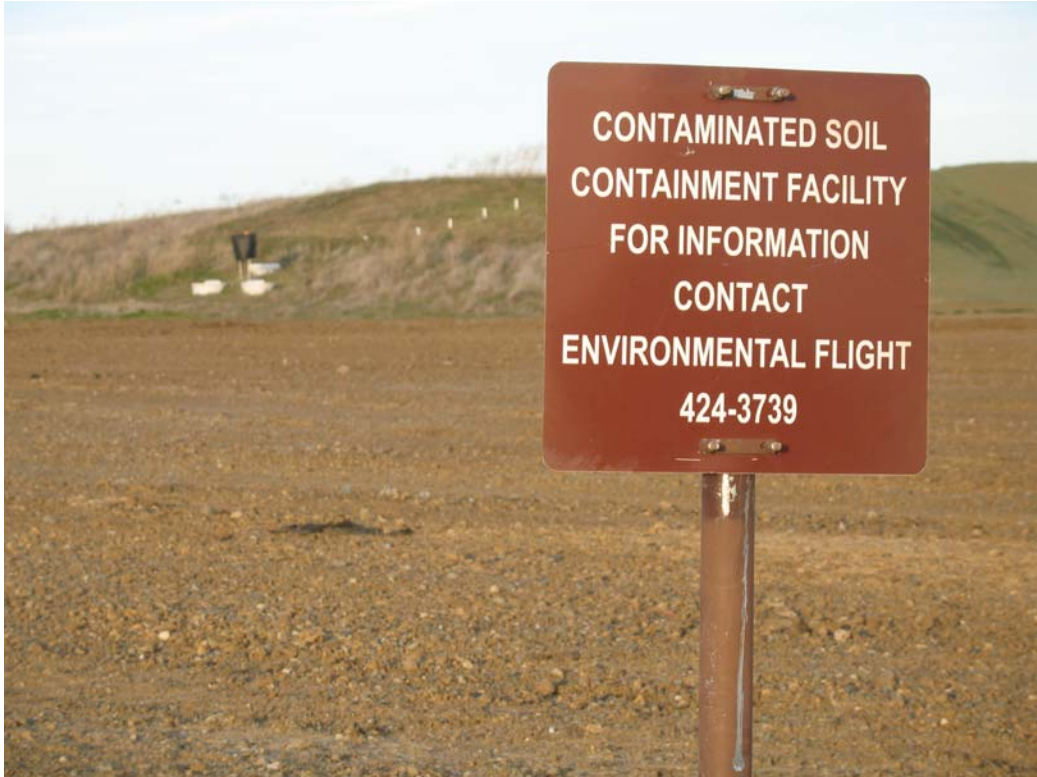
Photograph 17: Warning Sign at Expanded CAMU.

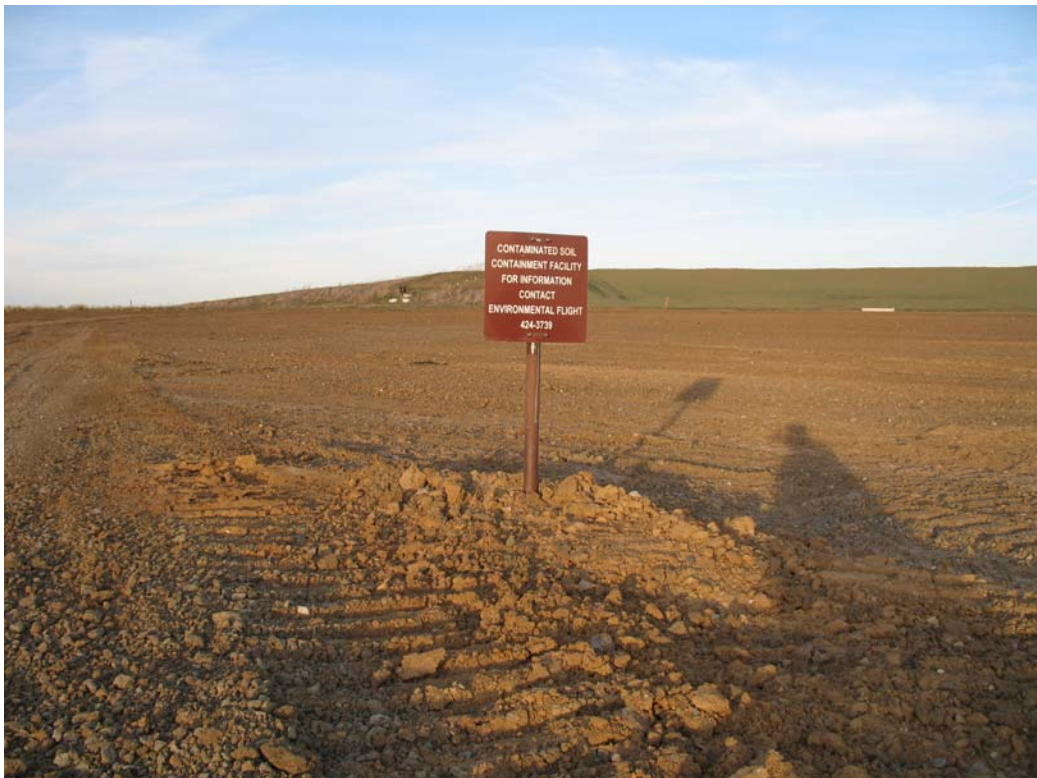
Photograph 18: Warning Sign at Expanded CAMU.

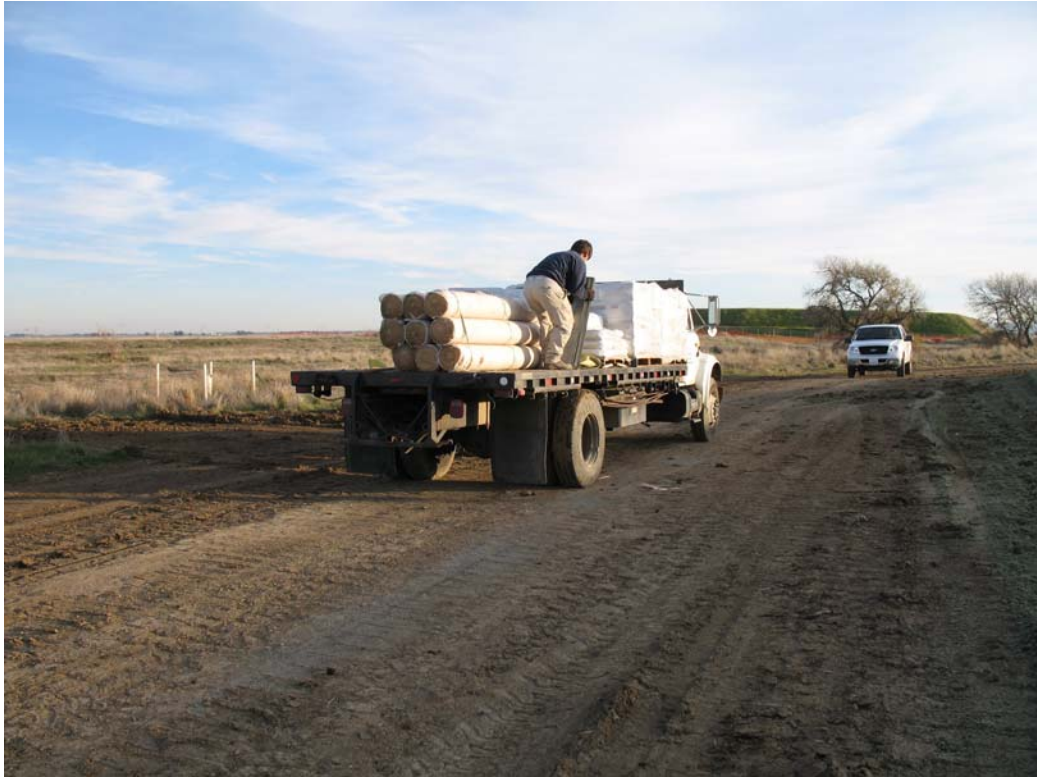
The CAMU was built in three phases. Phase 1 involved landfill maintenance and consisted of the placement of large quantities of clean soil into subsidence trenches that formed in the existing soil cap. The soil also serves as a foundation for the CAMU. Phase 2 involved the placement of contaminated soil from WABOU soil sites into the CAMU and the construction of an evapotranspiration cap over the consolidated soil. Travis AFB completed the field work for Phase 2 in November 2003. Phase 3 involved the placement of contaminated soil from NEWIOU and WABOU sites into the CAMU and the completion of the CAMU cap. The base completed the field work for Phase 3 in December 2007.

Photograph 19: Completion of CAMU Construction.

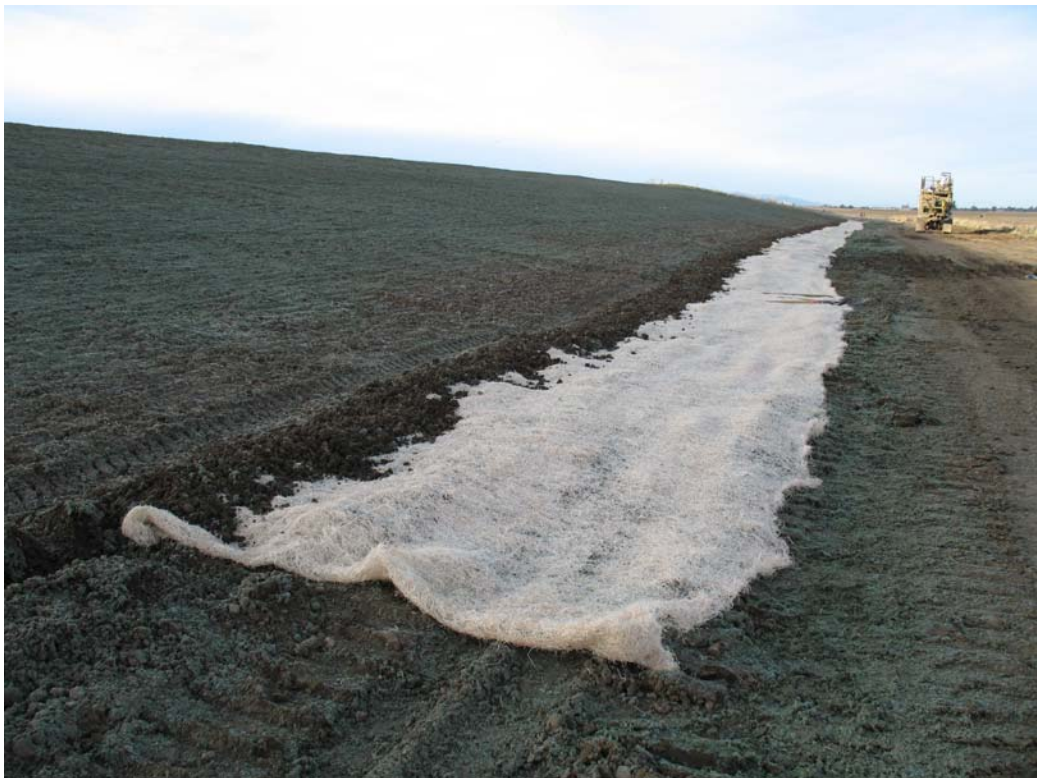
Photograph 20: Erosion Protection Skirt At Base of CAMU.
