TRAVIS AIR FORCE BASE  
ENVIRONMENTAL RESTORATION PROGRAM

ANNUAL REPORT  
ON THE STATUS OF  
LAND USE CONTROLS  
ON RESTORATION SITES  
IN 2009  
FINAL

60<sup>TH</sup> CIVIL ENGINEER SQUADRON  
Travis Air Force Base, California

APRIL 2010

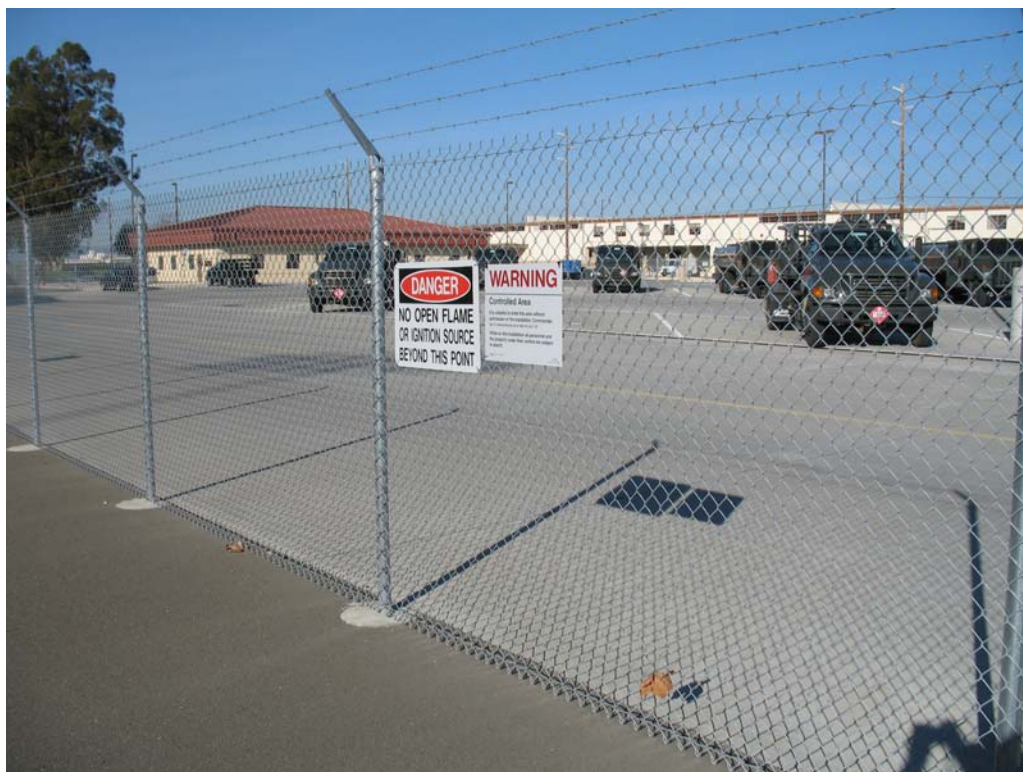
The 2009 inspection of the LUCs at SS015 found that administrative controls and existing physical infrastructure are adequate to enforce the environmental restriction. In addition, the inspectors noted a potential for additional physical barriers (i.e., fences) and signage to adversely impact vehicle operations. There is no evidence that the cadmium-impacted soil beneath the concrete parking area has been disturbed. Photograph 1 in Appendix B of this report shows the controlled area at SS015.

Photograph 1: Controlled Area at SS015.

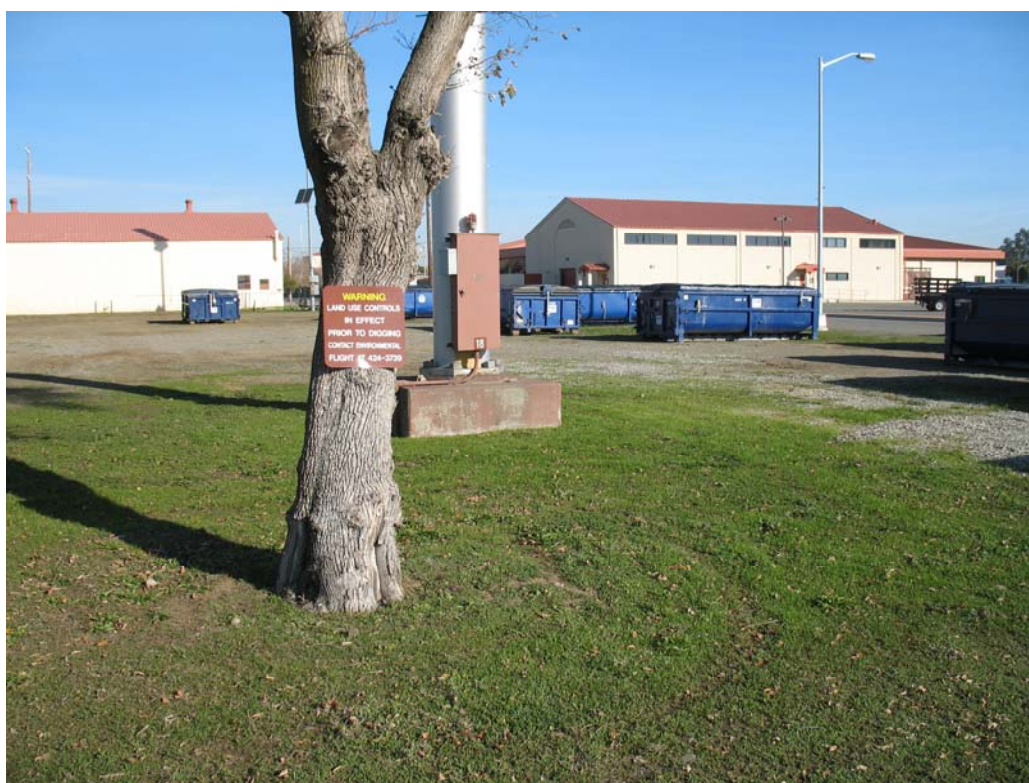
The 2009 inspection of the LUCs at SS016 found that administrative controls are adequate to enforce the restriction, so physical barriers (i.e., fences) are not needed. There is no evidence that the PAH-impacted soil has been disturbed either with or without proper authorization. A

Photograph 2: Controlled Area at SS016.

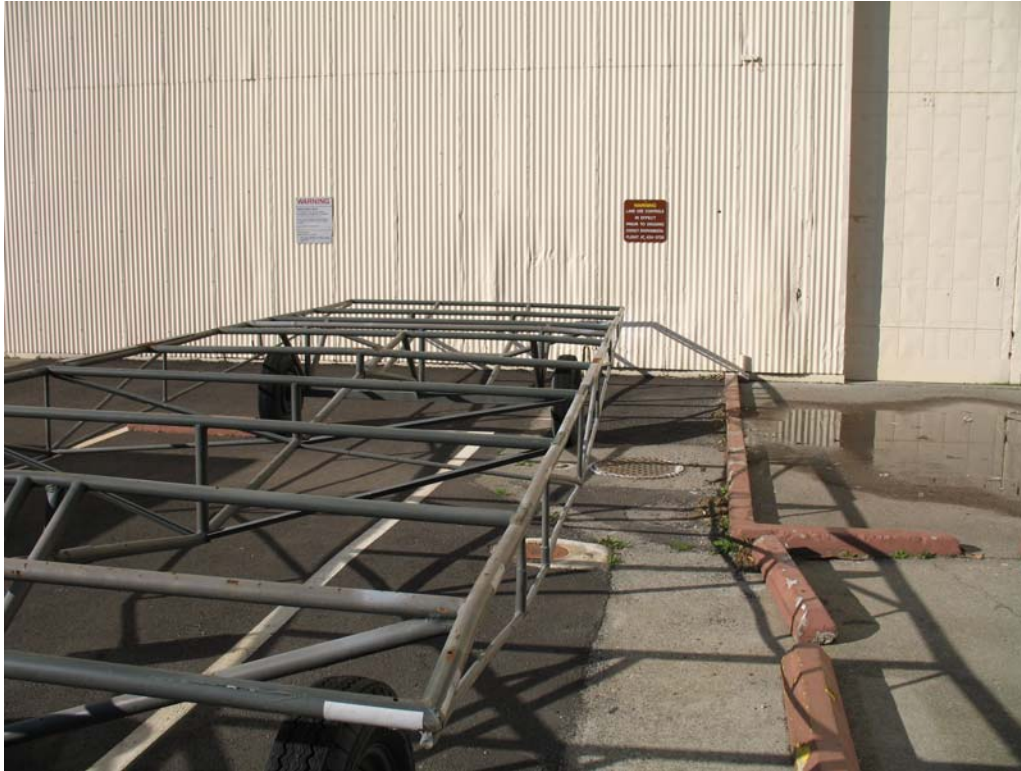
The 2009 inspection of the LUCs at the soil portion of SD033 found that administrative controls are adequate to enforce the restriction, so physical barriers (i.e., fences) are not needed. There is no evidence that the cadmium- and benzo(a)pyrene-impacted soil has been disturbed. Warning signs have been posted on both sides of Facility 810 to notify base workers of the presence of the controlled area. Photographs 3 and 4 in Appendix B of this report show the controlled soil areas at SD033.

Photograph 3: Warning Sign at Controlled Area on East Side of SD033 (soil).

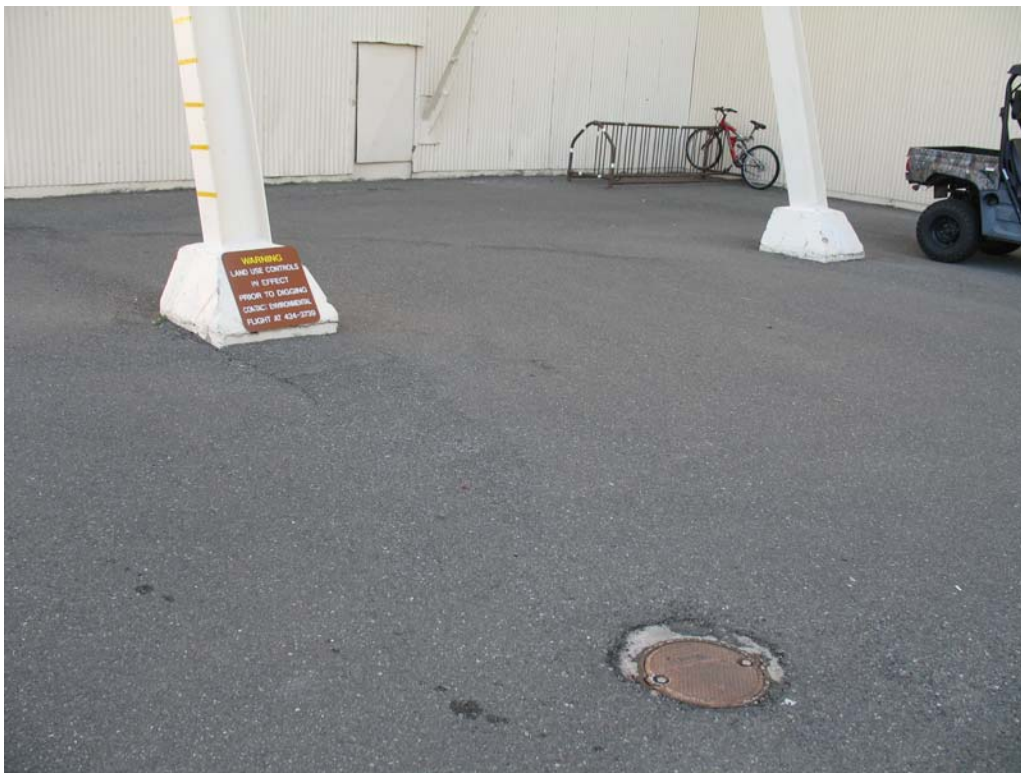
Photograph 4: Warning Sign at Controlled Area on West Side of SD033 (soil).

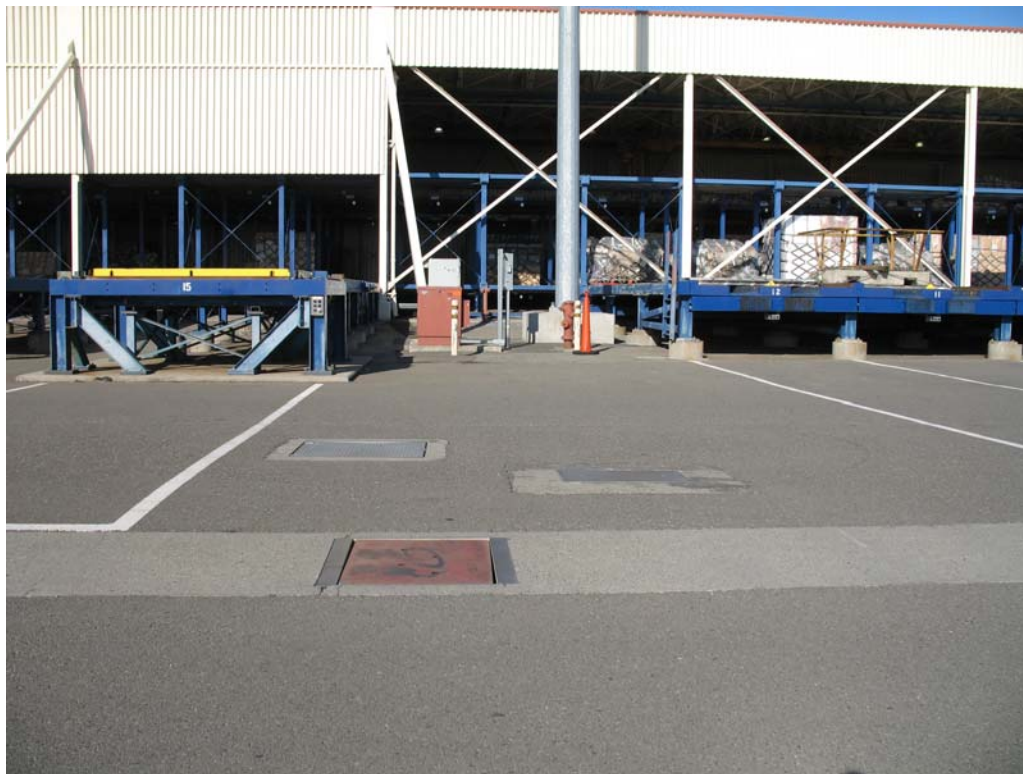
The 2009 inspection of the LUCs at SD037 found that administrative controls are adequate to enforce the restriction, so physical barriers (i.e., fences) are not needed. Although the contaminated soil cannot be seen (since it is covered with asphalt), the asphalt work area surrounding Building 977 is in excellent condition and has not required maintenance in the past year. So, there is no evidence that the PAH-, lead-, and TPH-impacted soil has been disturbed.

Due to the nature of operations at the air freight terminal, it is not practical or safe to post warning signs to notify base personnel of the presence of contaminated soil beneath the asphalt. Specifically, vehicles that are designed to transport large cargo pallets to and from both military and commercial aircraft require an open area free of physical hazards. The two small controlled areas lie in the middle of these open work areas, and there are no existing posts or structures that could be used to post signs that point out their location. Because of the high tempo of mission-critical operations associated with the air freight terminal, any obstructions would pose significant risk to both personnel and equipment. Photographs 5 and 6 in Appendix B of this report show the controlled areas within the open work areas at SD037.

Photograph 5: Controlled Area on Southeast Side of SD037

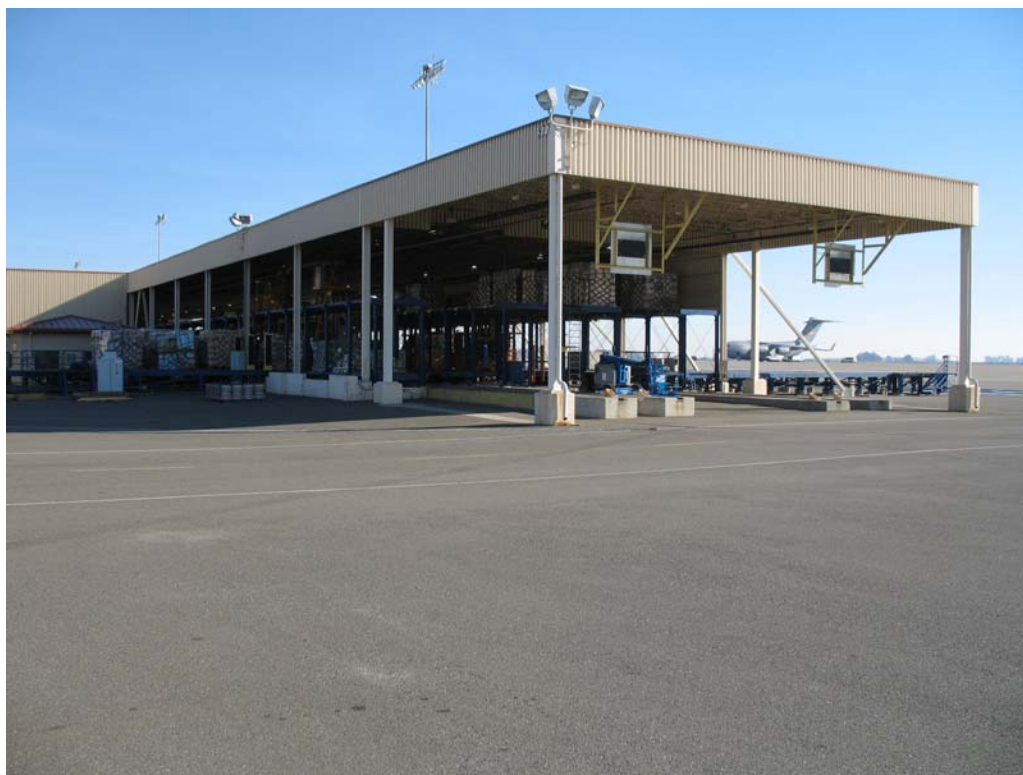
Photograph 6: Controlled Area on Southwest Side of SD037

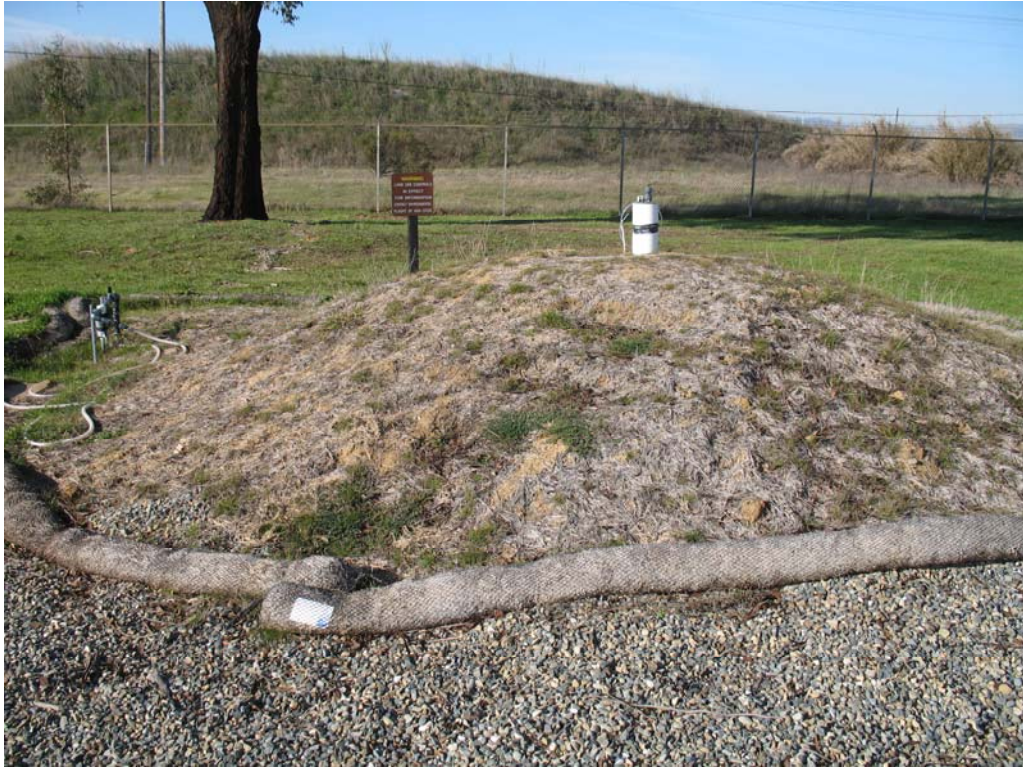
The 2009 inspection of the LUCs at DP039 found that administrative controls and a LUC warning sign are still adequate to enforce the restriction, so physical barriers (i.e., fences) are not needed. The lead-impacted soil has been excavated and sent by truck to an appropriate landfill as a result of the bioreactor demonstration project. Travis AFB will continue to enforce the DP039 controls until the upcoming bioreactor report has received regulatory review and the base receives permission to officially remove the controls. Photograph 7 in Appendix B of this report shows the surface of the bioreactor over the controlled area at DP039. The warning sign that notifies visitors to the site of the presence of LUCs can be seen in the background. Building 755 was vacated and demolished in 2009.

Photograph 7: Controlled Area at DP039 (Post Bioreactor Construction)

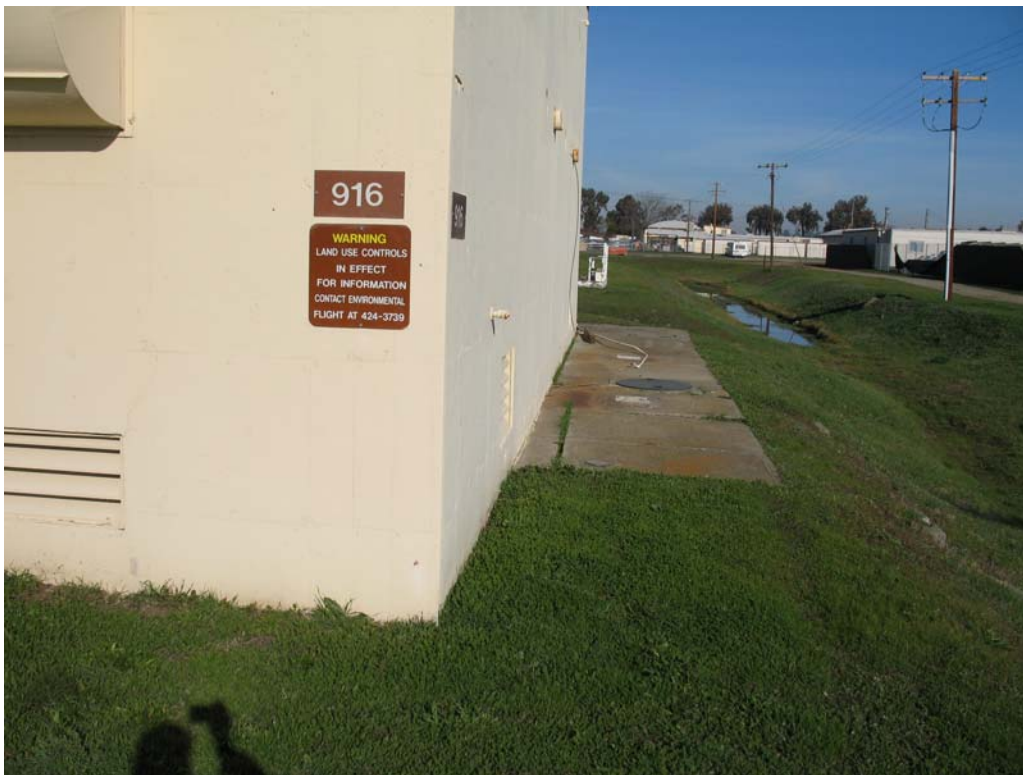
The 2009 inspection of the LUCs at SD043 found that administrative controls are adequately enforcing the restriction, so physical barriers (i.e., fences) are not needed. There is no evidence that any soil disturbances in the vicinity of the concrete pad and generator took place in 2009. Photograph 8 in Appendix B shows the east side of the generator and pad south of Building 916, and photograph 9 shows the warning signs in relation to the west side of the controlled area at SD043.

Photograph 8: Sign near East Side of Installed Generator at SD043

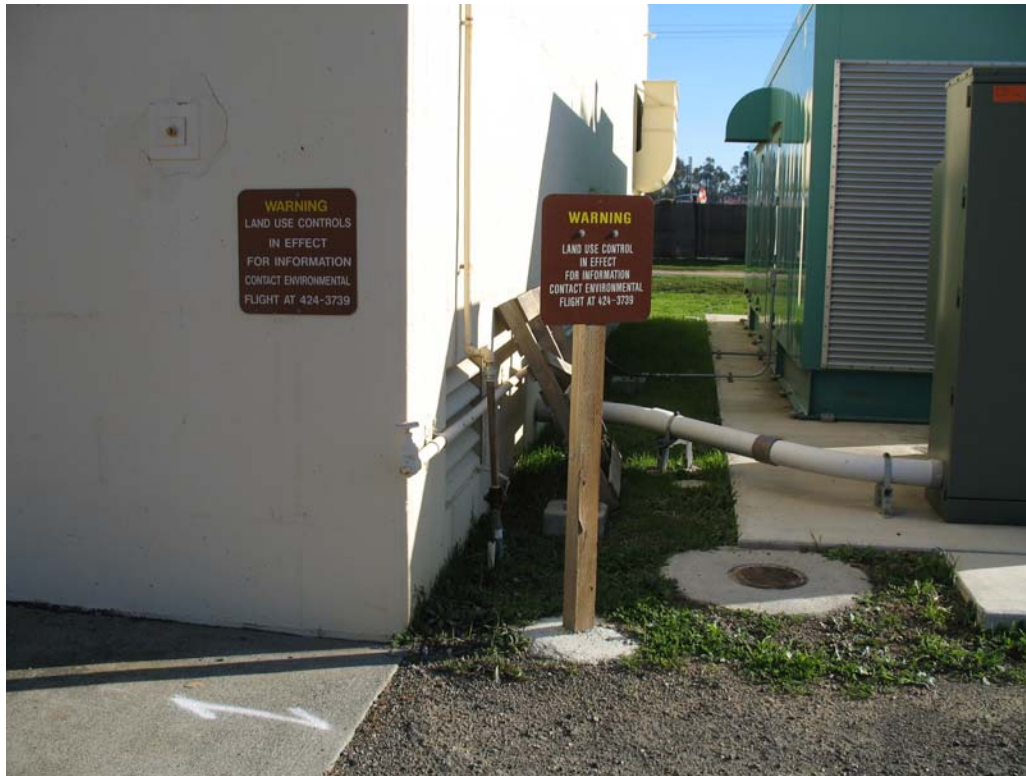
Photograph 9: Generator Pad and Warning Signs at SD043. Stanchion of Former Pad with Leaking Transformers is visible in the foreground.

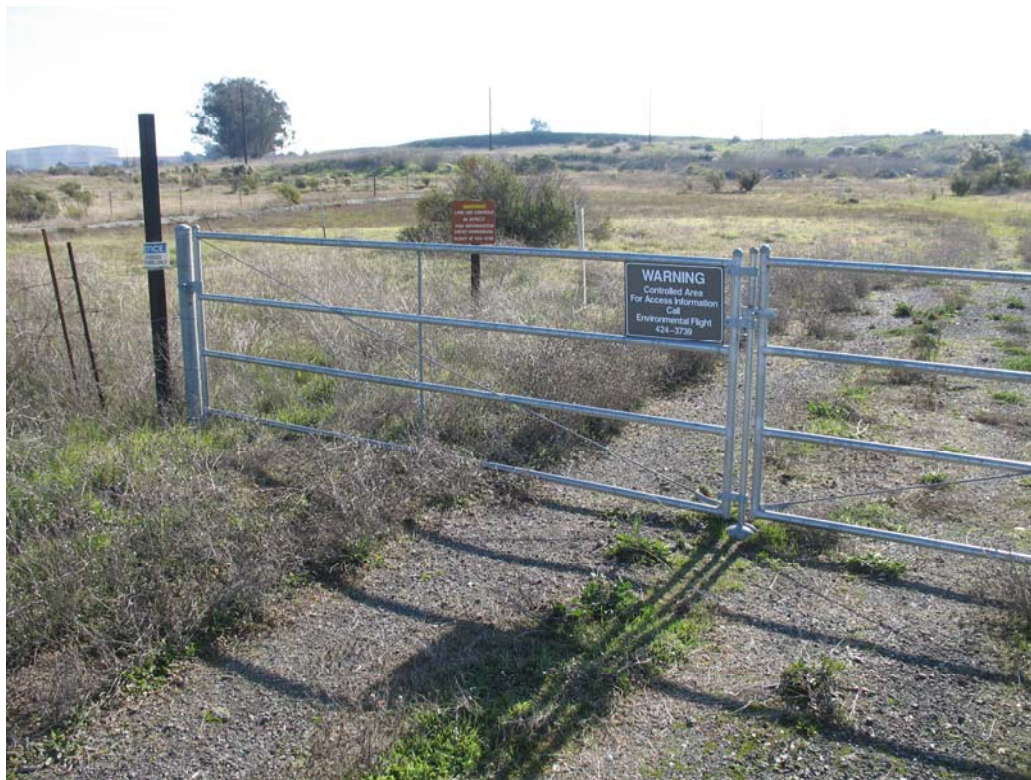
There is no evidence to suggest that the property is being used for other than industrial purposes. Both gates were locked, and the Asset Management Flight keeps a copy of the keys. Photograph 10 of Appendix B shows the warning signs at the north access gate, and photograph 11 shows the west side of the fence. Photograph 12 shows an example of a broken fence strand near the south access gate, and photograph 13 shows a sign that is warped from wind exposure. The gates are in good physical condition, and warning signs at each gate are visible.

Photograph 10: Warning Signs at LF044 Entrance near the North Access Gate.

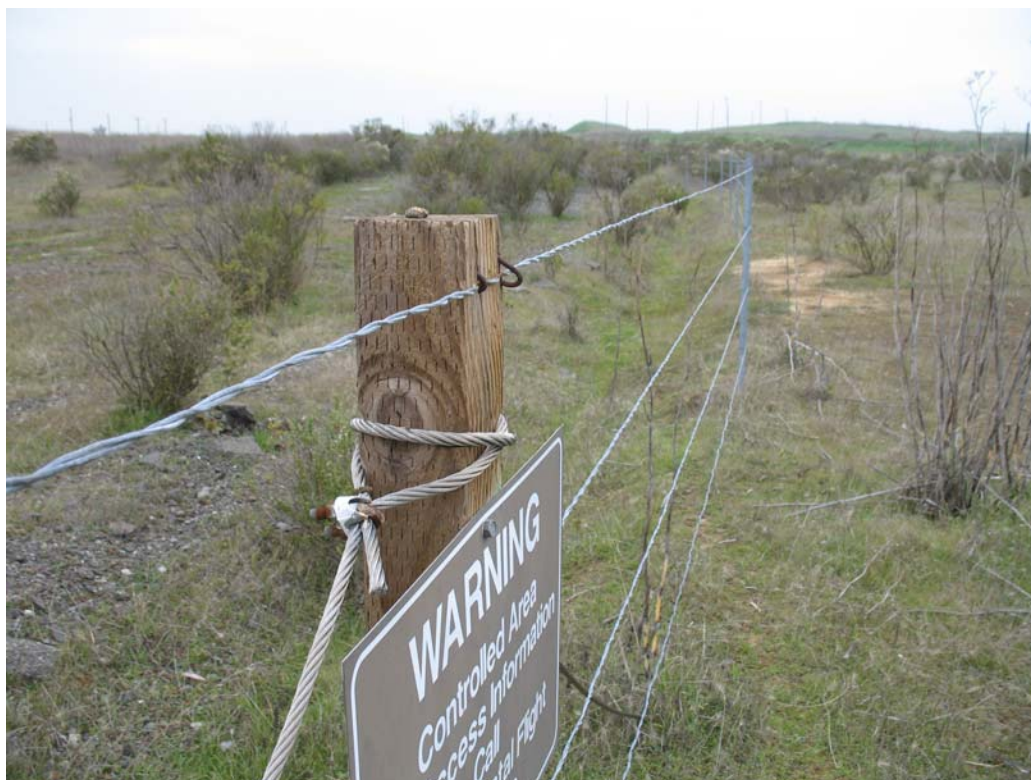
The 2009 inspection of the LUCs at LF044 found the fence and signs to be overall in good physical condition, although both have degraded since the last annual inspection. Along with a part of the fence that was cut by base firefighters during their response to a October 2008 fire, another larger section of fence was damaged when a branch from a eucalyptus tree fell on it. There are several fence sections with broken strands, possibly due to exposure to high winds over a long period of time.

Photograph 11: West Side of LF044 Fence.

To carry out permanent fence repairs and sign replacement, the base has assigned a small-business environmental contractor to return all physical controls up to their original condition and upgrade any controls where possible. This maintenance work will start in the summer of 2010.

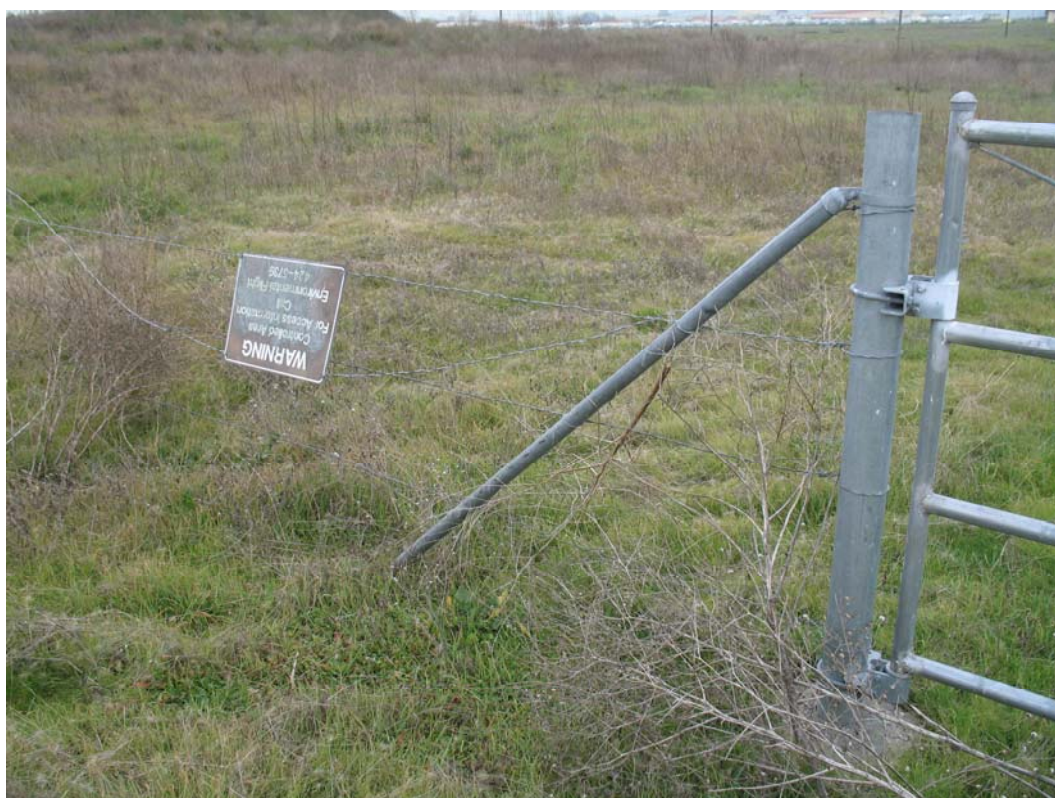
Photograph 12: Broken Fence Strand on South Side of LF044.

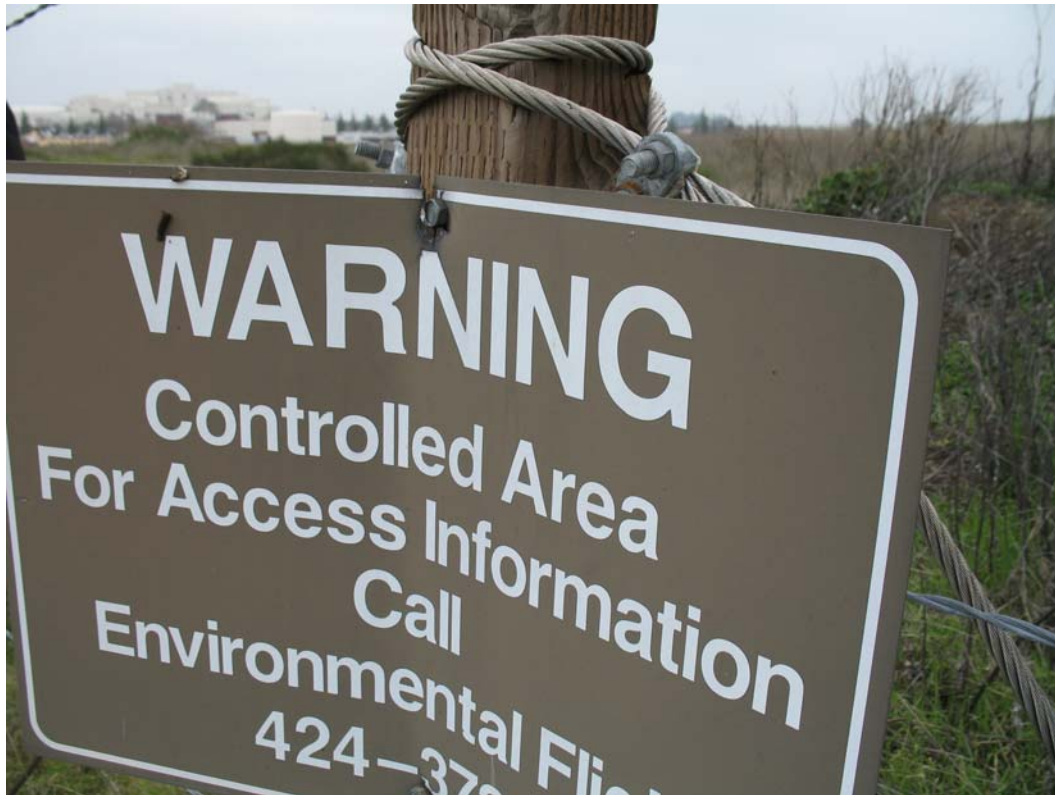
Several signs showed metal fatigue and were lying near the fence posts. The southwest portion of the fence is exposed to gusty winds throughout the year, and it appears that repetitive motion caused by the wind can cause metal fatigue and a separation of the sign from the attaching bolts.

Photograph 13: Warped Warning Sign.

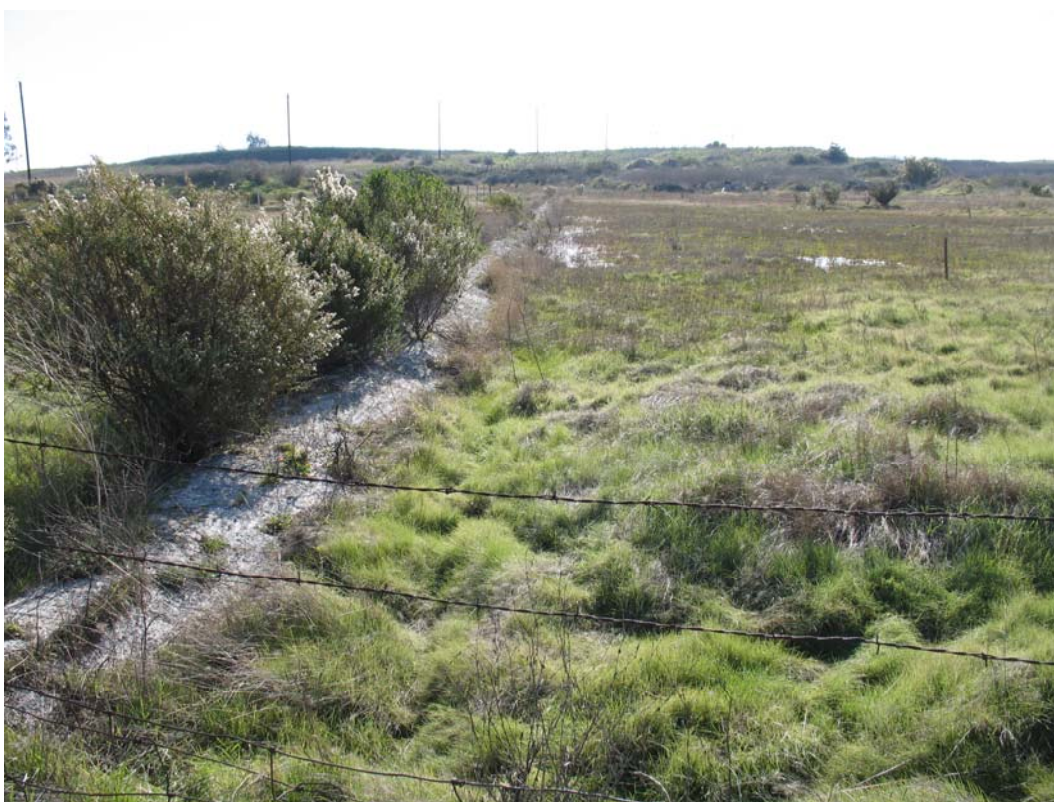
The 2009 inspection of the LUCs at LF044 found the berm to be in good to excellent physical condition. The responders to an October 2008 fire slightly damaged the berm surface in one small location with their firefighting equipment.

Native grass, weeds and small shrubs have grown over portions of the berm, which serves to increase its cohesiveness. The base received a fair amount of rainfall this year, and the standing water shows that the berm is performing as designed; the damage to the berm from the October 2008 firefighting response has not adversely impacted its ability to prevent contaminated sediment from entering the nearby wetlands. Photograph 14 of Appendix B was taken during the inspection of the berm and the north side of the fence.

Photograph 14: Fencing and Berm on East Side of LF044.

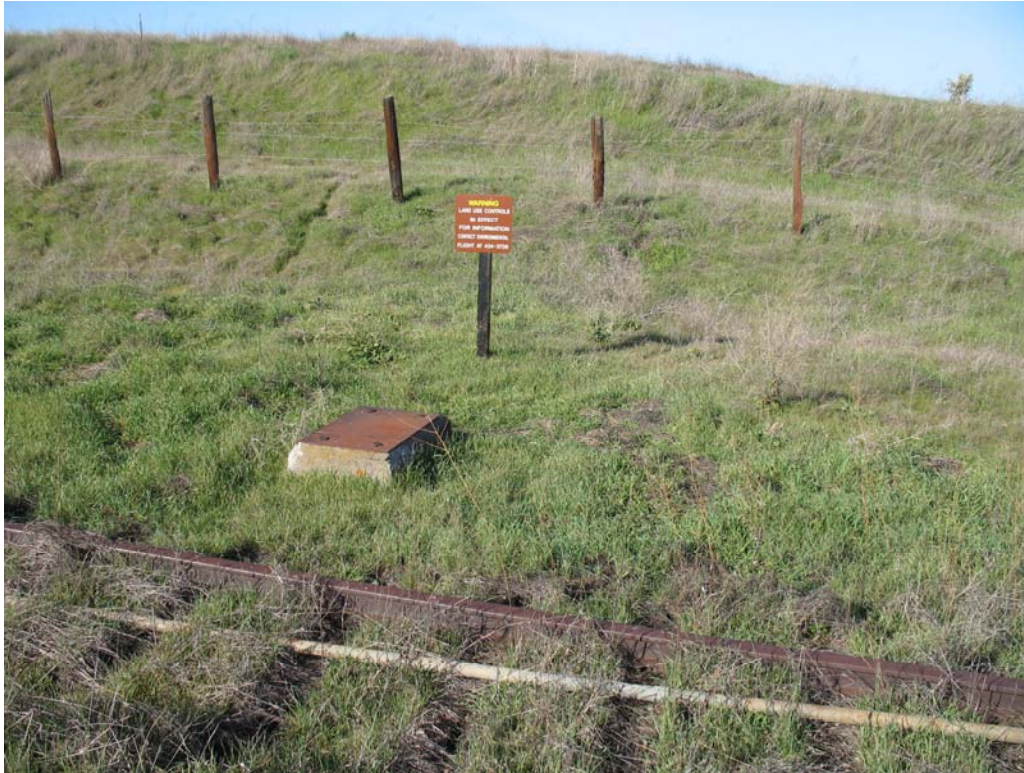
The 2009 inspection of the LUCs at SS046 found that administrative controls and two warning signs are adequate to enforce the restriction, so additional physical barriers (i.e., fences not associated with the Grazing Management Unit) are not needed. There is no evidence that the contaminated soil has been disturbed. Photograph 15 of Appendix B of this report shows the warning sign at the west end of the SS046 controlled area, and photograph 16 shows the warning sign at the east end of the controlled area.

Photograph 15: Warning Sign at West Side of SS046.

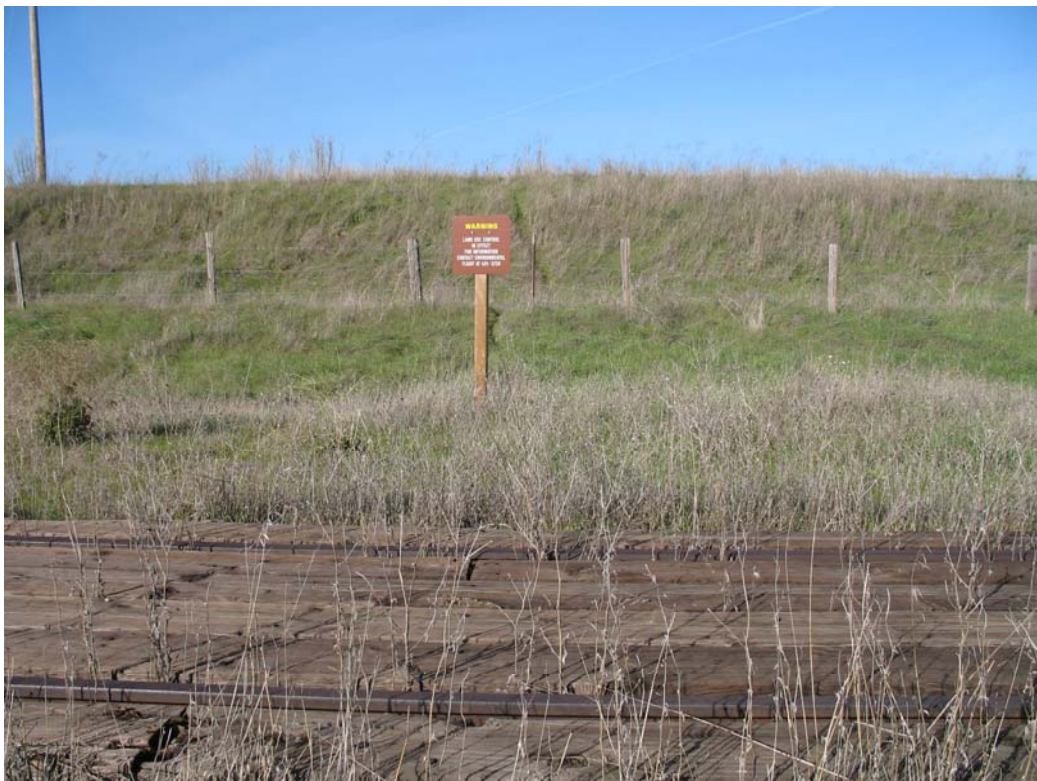
Photograph 16: Warning Sign at East Side of SS046.

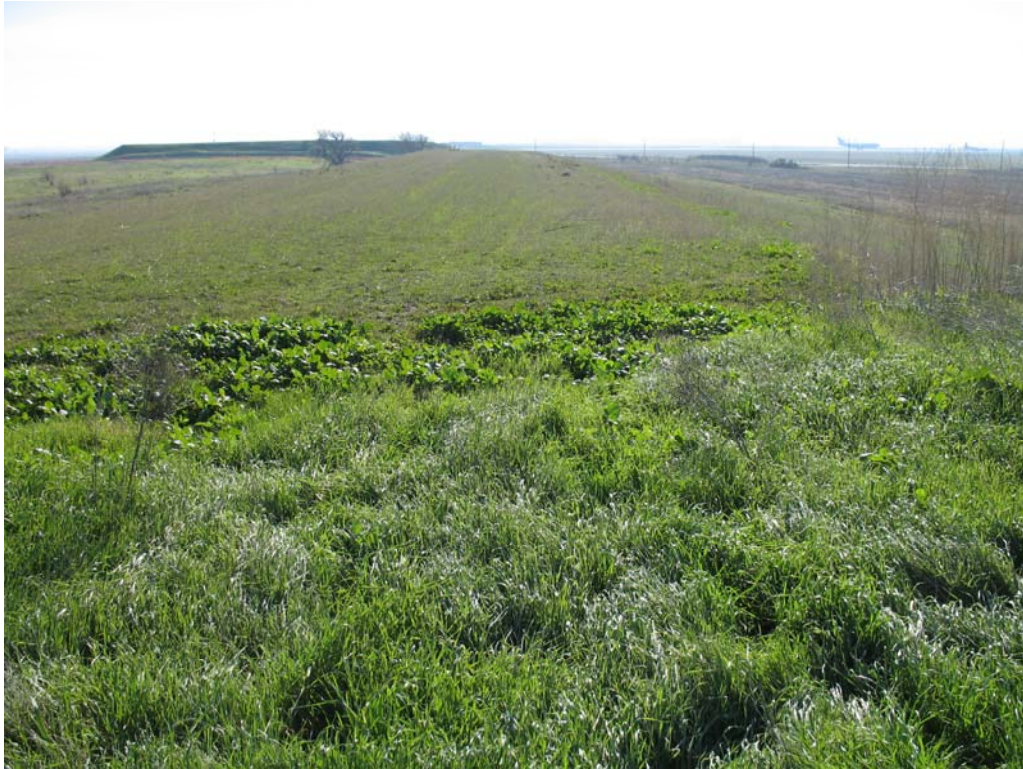
The 2009 inspection of the LUCs at LF007 found that the current administrative and physical controls are adequate to enforce the restrictions. There is no evidence that the contaminated soil at LF007 has been disturbed. Photograph 17 in Appendix B of this report shows the top of CAMU Phase 3, looking from the northwest end. Photograph 18 shows the top of the CAMU Phase 3, looking from the southeast end. Photograph 19 shows the warning sign at the CAMU entrance. The inspectors noted that the gate post on the right side of the entrance is rotting and will need to be replaced this summer.

Photograph 17: Top of CAMU Phase 3 (Northwest End).

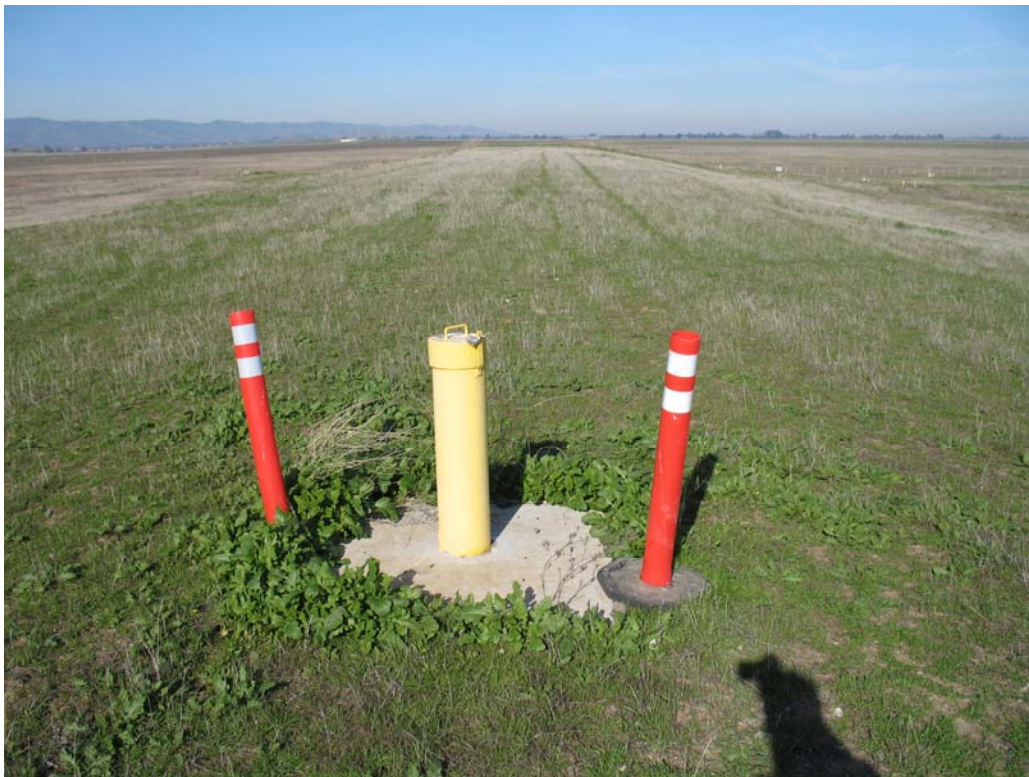
Photograph 18: Top of CAMU Phase 3 (Southeast End).

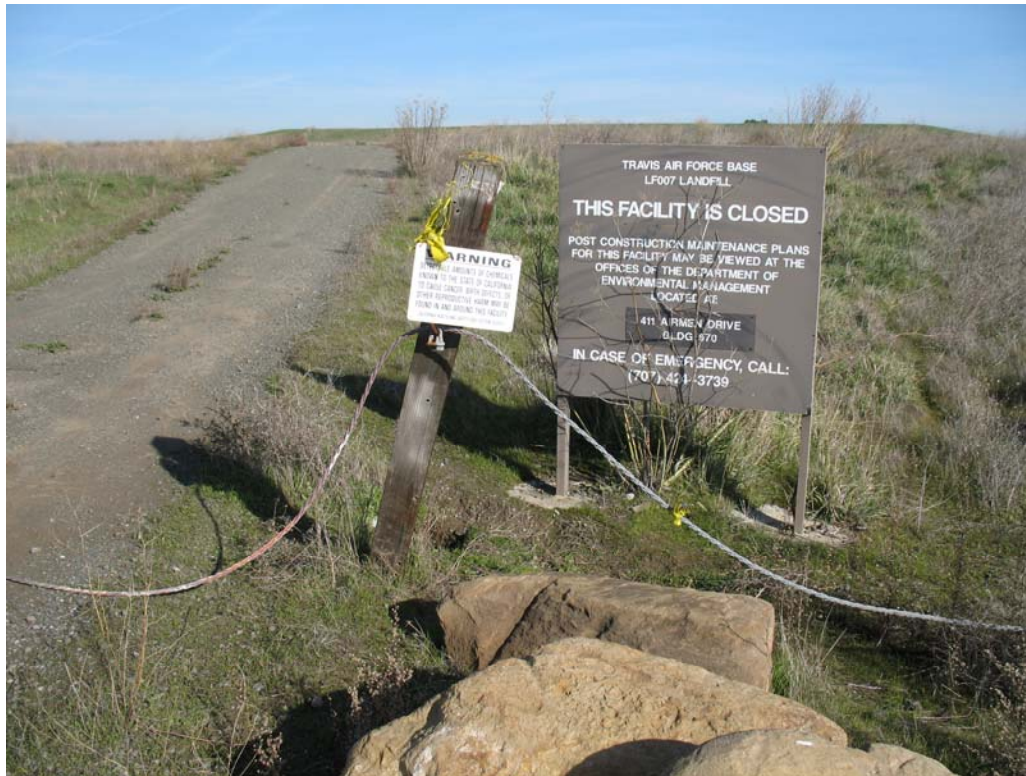
Photograph 19: Warning Sign at CAMU Phase 3 Entrance.

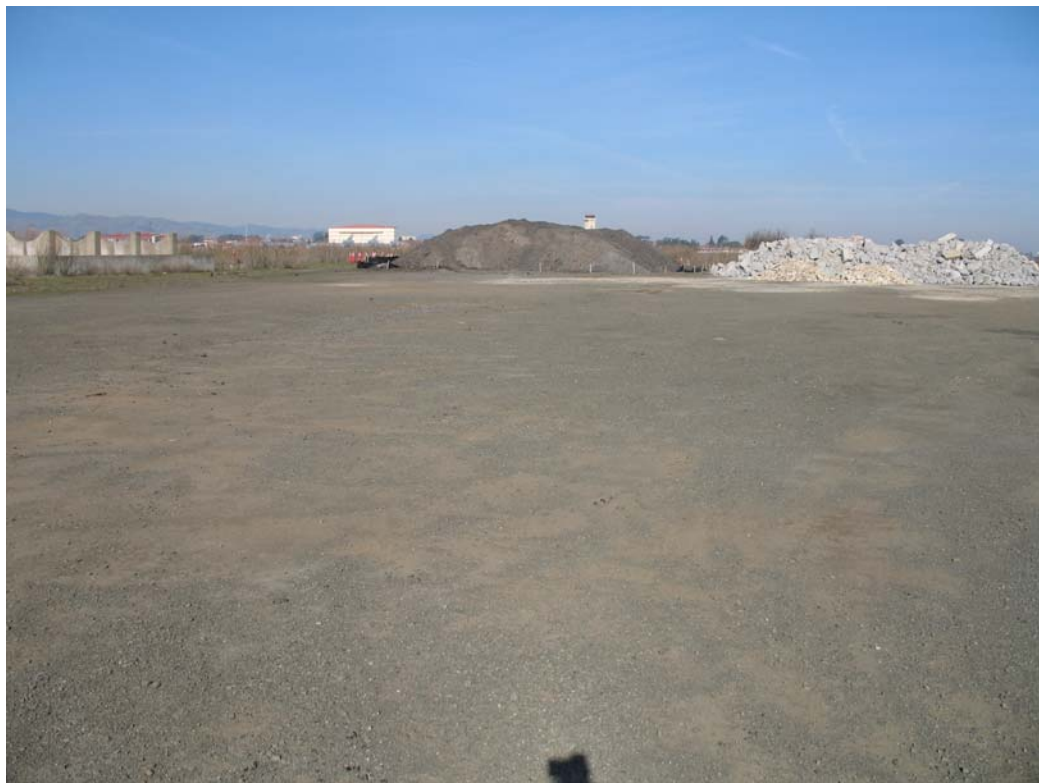
The 2009 inspection of the LUCs at FT005 found that administrative controls are adequate to enforce the restriction, so additional physical barriers (i.e., fences not associated with the

Photograph 20: Controlled Area at FT005.

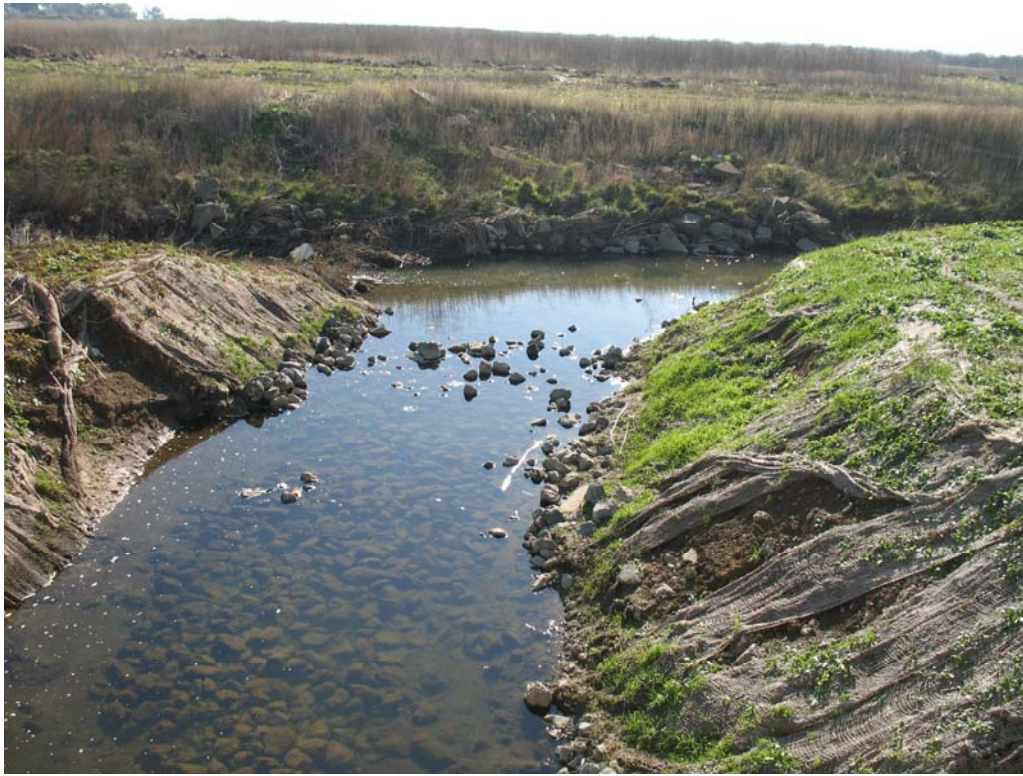
Photograph 21: Controlled Area at Sediment Portion of SD033 After Cleanup.

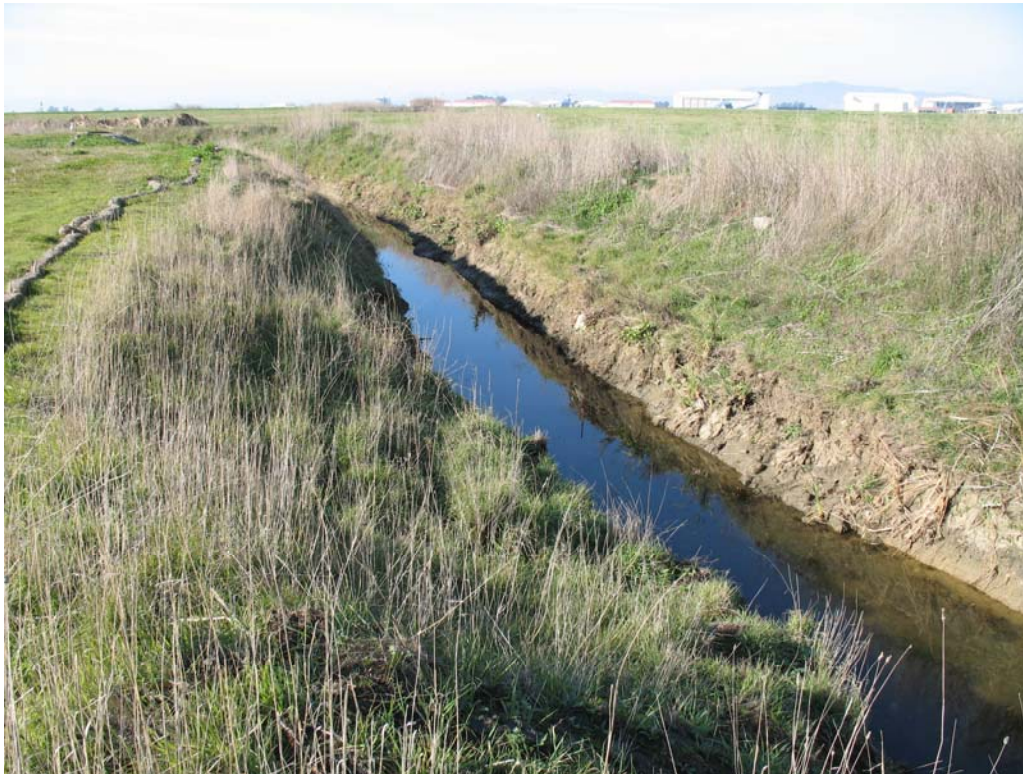
The 2009 inspection of SD001 found that administrative controls are adequate to enforce the sediment disturbance restriction, so physical barriers are not needed. There is no evidence that the contaminated sediment has been disturbed from unauthorized activity. The inspection also checked on the effectiveness of the erosion control measures both along the creek sides and in the creek itself. Photograph 22 of Appendix B of this report shows the controlled area at SD001.

Photograph 22: Controlled Area at SD001 After Cleanup.
