TRAVIS AIR FORCE BASE
ENVIRONMENTAL RESTORATION PROGRAM

**ANNUAL REPORT
ON THE STATUS OF
LAND USE CONTROLS
ON RESTORATION SITES
IN 2011**

60TH CIVIL ENGINEER SQUADRON
Travis Air Force Base, California

FEBRUARY 2012

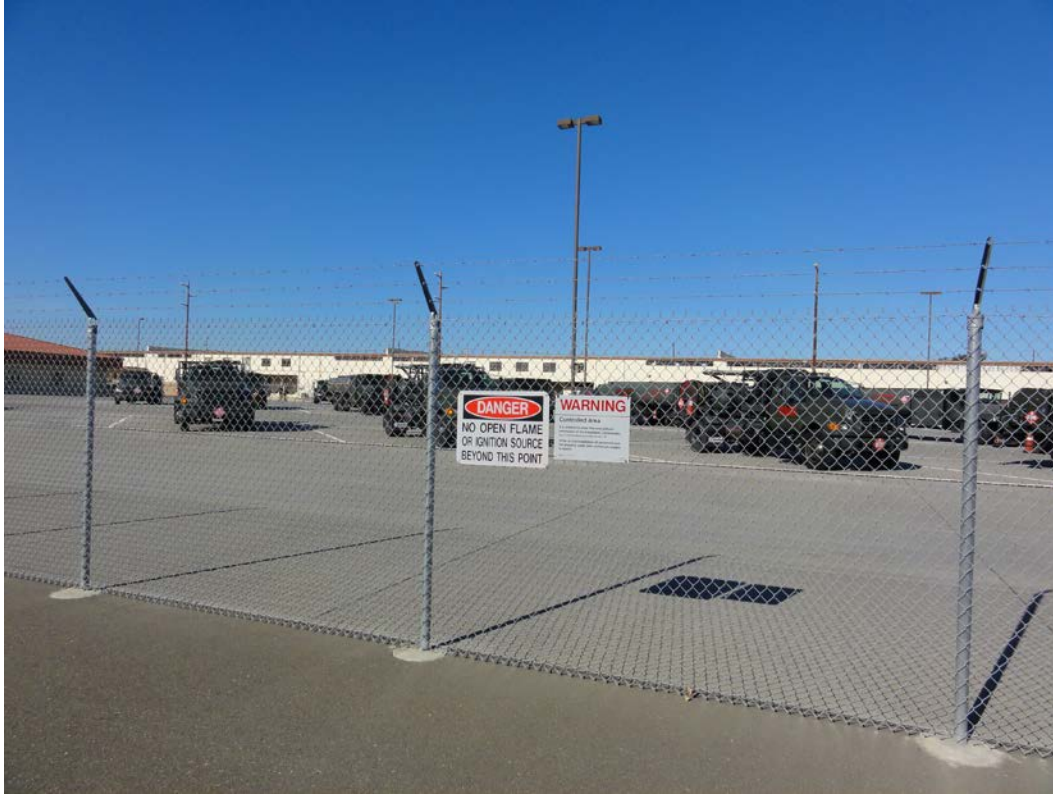
inspectors noted a potential for additional physical barriers (i.e., fences) and signage to adversely impact vehicle operations. There is no evidence that the cadmium-impacted soil beneath the concrete parking area has been disturbed. Photograph 1 in Appendix B of this report shows the controlled area at SS015.

Photograph 1: Controlled Area at SS015

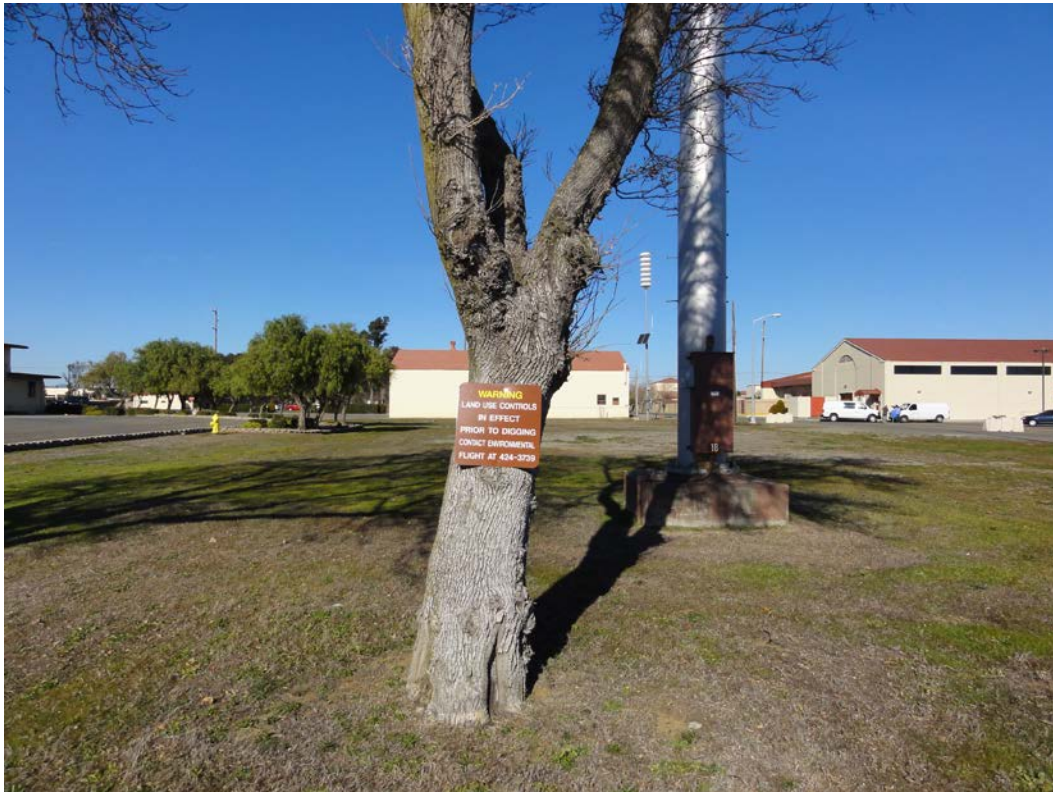
The 2011 inspection of the LUCs at SS016 found that administrative controls are adequate to enforce the restriction, so physical barriers (i.e., fences) are not needed. There is no evidence that the PAH-impacted soil has been disturbed either with or without proper authorization. A warning sign has been posted on a tree in the middle of the site to notify base workers of the

Photograph 2: Controlled Area at SS016

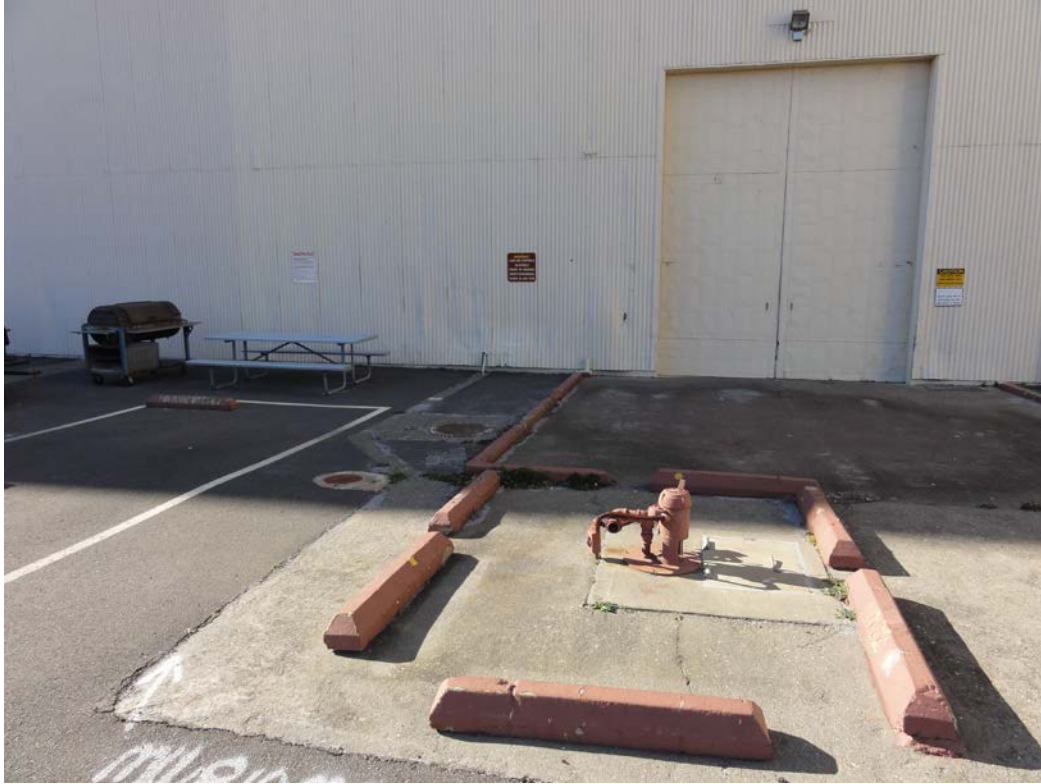
The 2011 inspection of the LUCs at the soil portion of SD033 found that administrative controls are adequate to enforce the restriction, so physical barriers (i.e., fences) are not needed. There is no evidence that the cadmium- and benzo(a)pyrene-impacted soil has been disturbed. Warning signs have been posted on both sides of Facility 810 to notify base workers of the presence of the controlled area. Photographs 3 and 4 in Appendix B of this report show the controlled soil areas at SD033.

Photograph 3: Warning Sign at Controlled Area on East Side of SD033

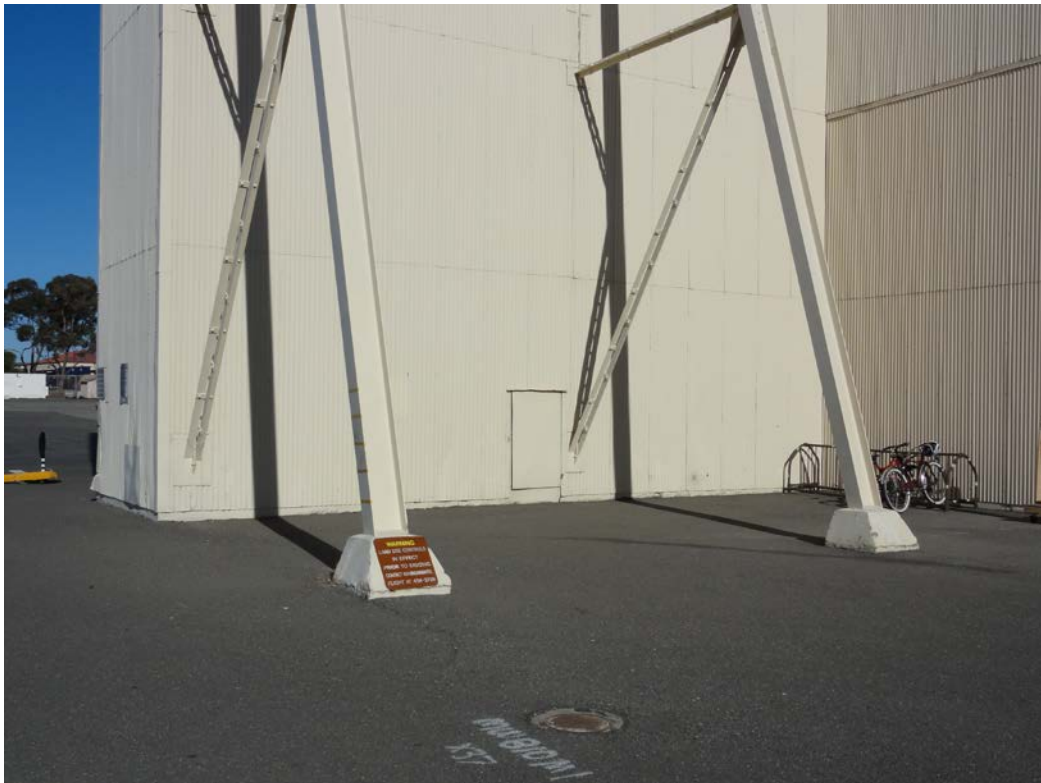
Photograph 4: Warning Sign at Controlled Area on West Side of SD033

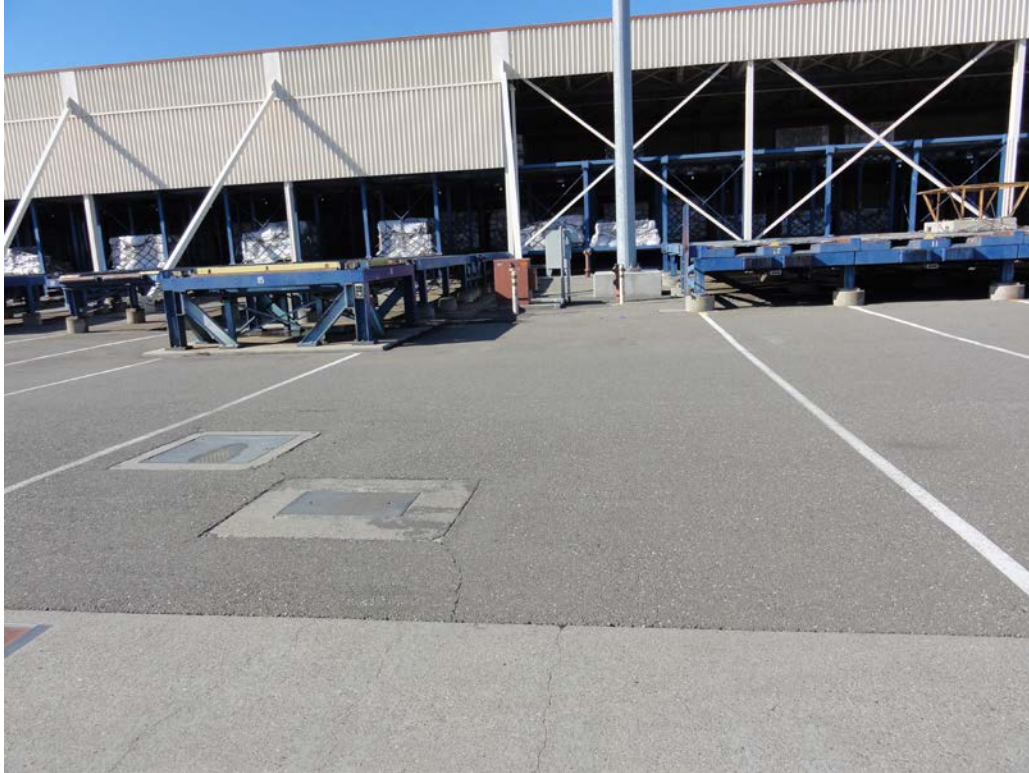
Specifically, vehicles that are designed to transport large cargo pallets to and from both military and commercial aircraft require an open area free of physical hazards. The two small controlled areas lie in the middle of these open work areas, and there are no existing posts or structures that could be used to post signs that point out their location. Because of the high tempo of mission-critical operations associated with the air freight terminal, any obstructions would pose significant risk to both personnel and equipment. Photographs 5 and 6 in Appendix B of this report show the controlled areas within the open work areas at SD037.

Photograph 5: Controlled Area on Southeast Side of SD037

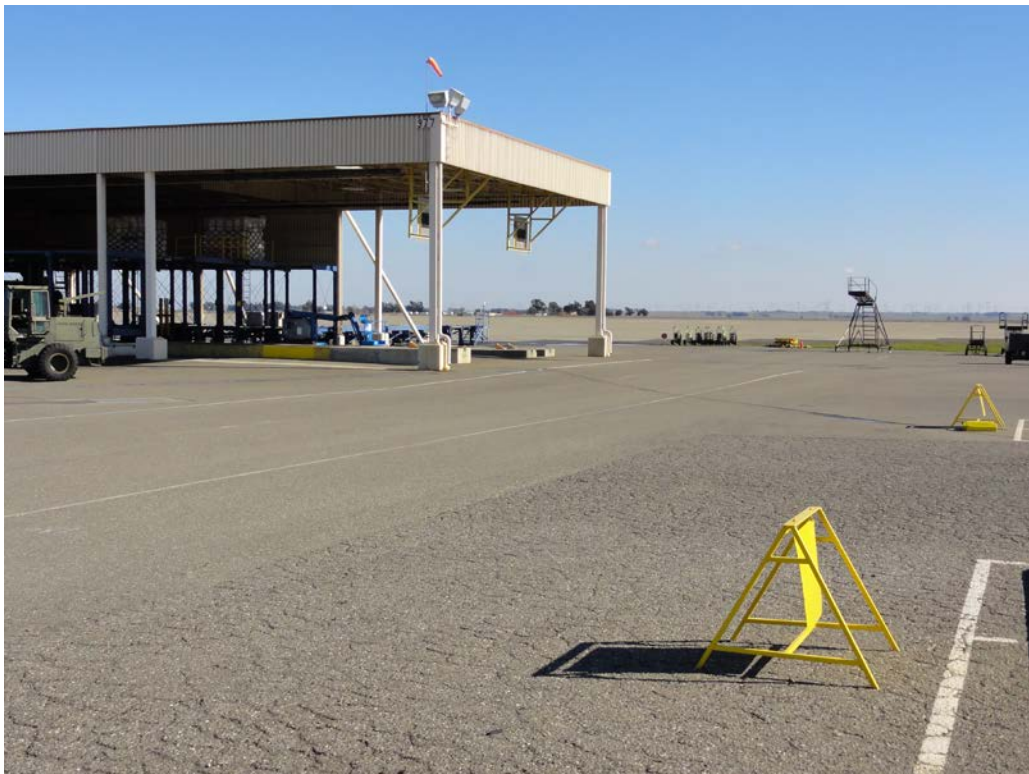
Photograph 6: Controlled Area on Southwest Side of SD037

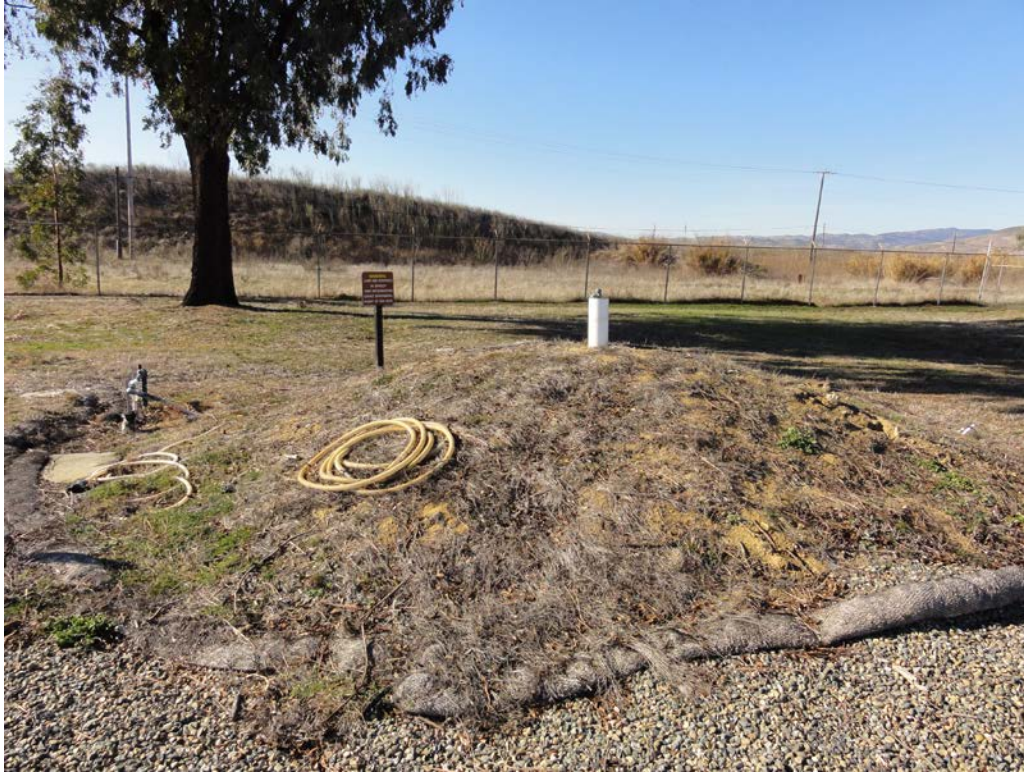
The 2011 inspection of the LUCs at DP039 found that administrative controls and a LUC warning sign are still adequate to enforce the restriction, so physical barriers (i.e., fences) are not needed. The lead-impacted soil has been excavated and sent by truck to an appropriate landfill as a result of the bioreactor demonstration project. Travis AFB will continue to enforce the DP039 controls until the upcoming technical memorandum has received regulatory review and the base receives approval to modify the controls for this part of the site. Photograph 7 in Appendix B of this report shows the surface of the bioreactor over the controlled area at DP039. The warning sign that notifies visitors to the site of the presence of LUCs can be seen in the background. Building 755 was vacated and demolished in 2009.

Photograph 7: Controlled Area at DP039 (Post Bioreactor Construction)

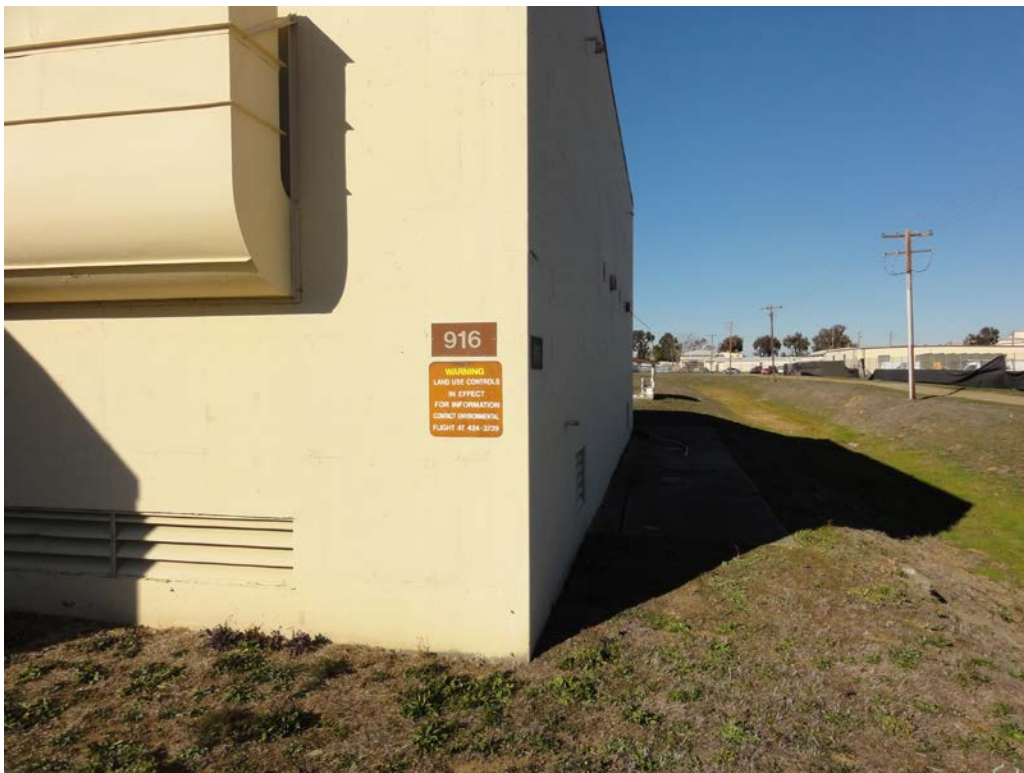
The 2011 inspection of the LUCs at SD043 found that administrative controls are adequately enforcing the restriction, so physical barriers (i.e., fences) are not needed. There is no evidence that any soil disturbances in the vicinity of the concrete pad and generator took place in 2011. Photograph 8 in Appendix B shows the east side of the generator and pad south of Building 916, and photograph 9 shows the warning signs in relation to the west side of the controlled area at SD043.

Photograph 8: Sign near East Side of Installed Generator at SD043

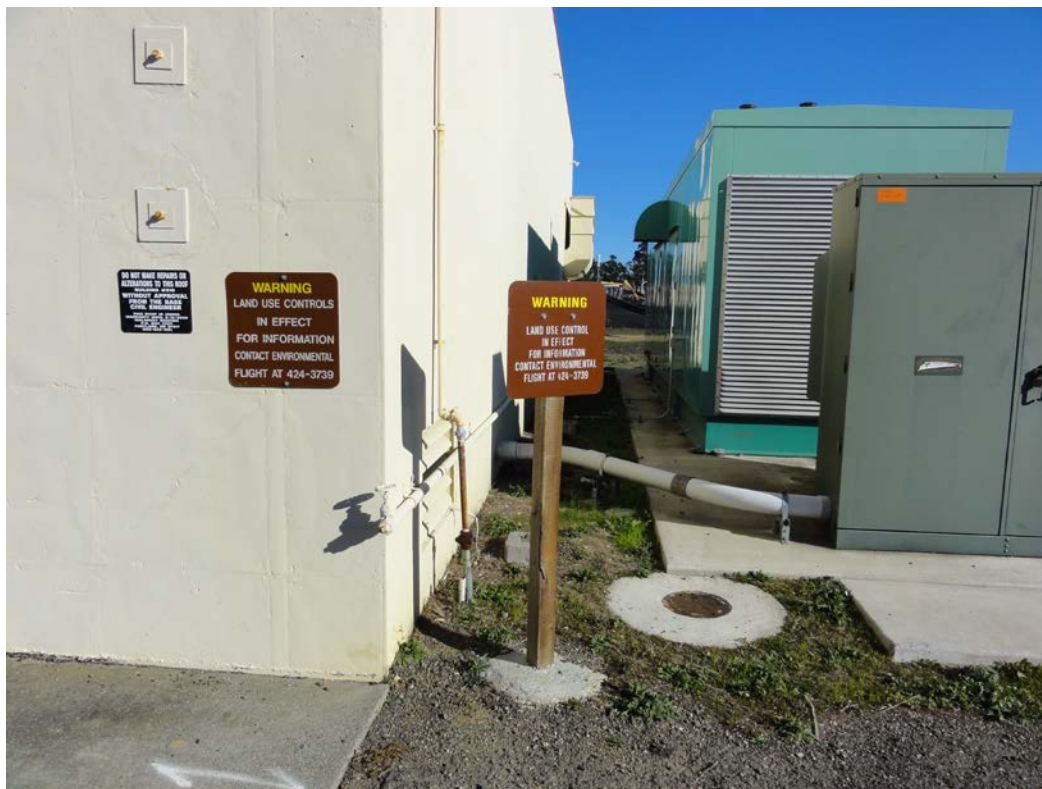
Photograph 9: Generator Pad and Warning Signs at SD043. Stanchion of Former Pad with Leaking Transformers is visible in the foreground.

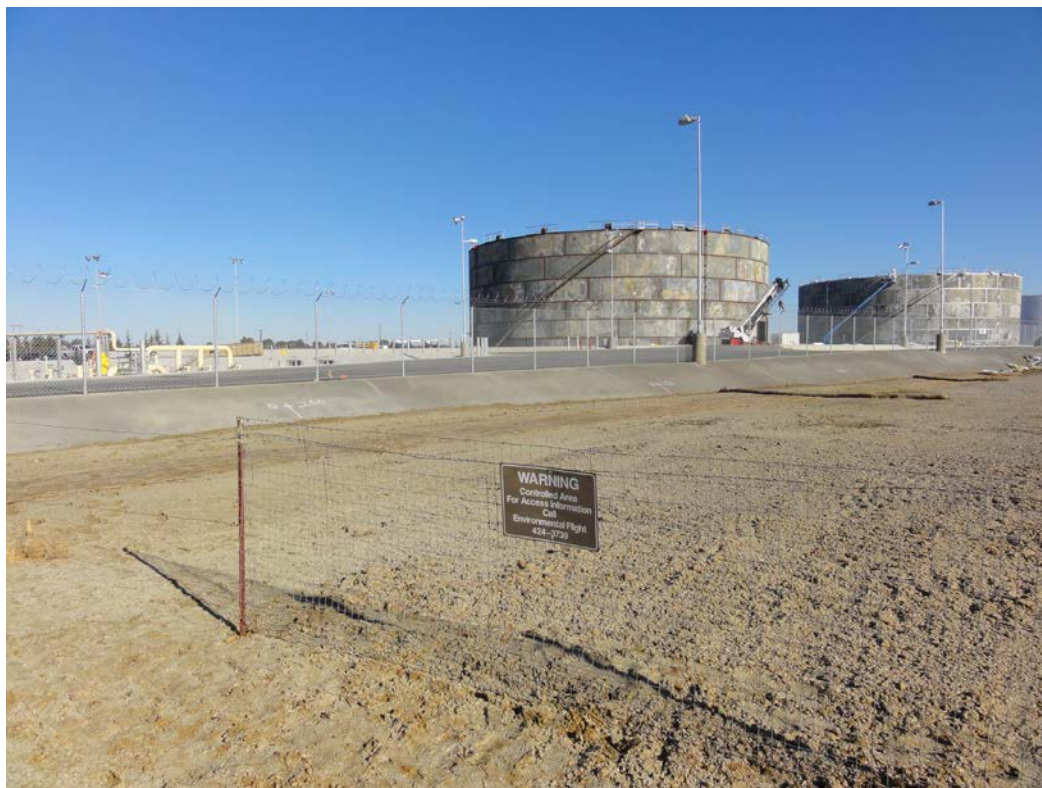
The 2011 inspection of the LUCs at LF044 found the fence and signs along all but the southern sides of the controlled area as well as the north gate had been removed and replaced with security fencing and gate to support the AST construction project. All of the contaminated soil and construction debris within the footprint of the AST construction area had been excavated and taken off-site. A significant portion of the security fence around the southern side of the new AST facility now serves as part of the fence around the remaining LF044 controlled area.

Photograph 10: Warning Sign at LF044 outside new AST Containment Enclosure

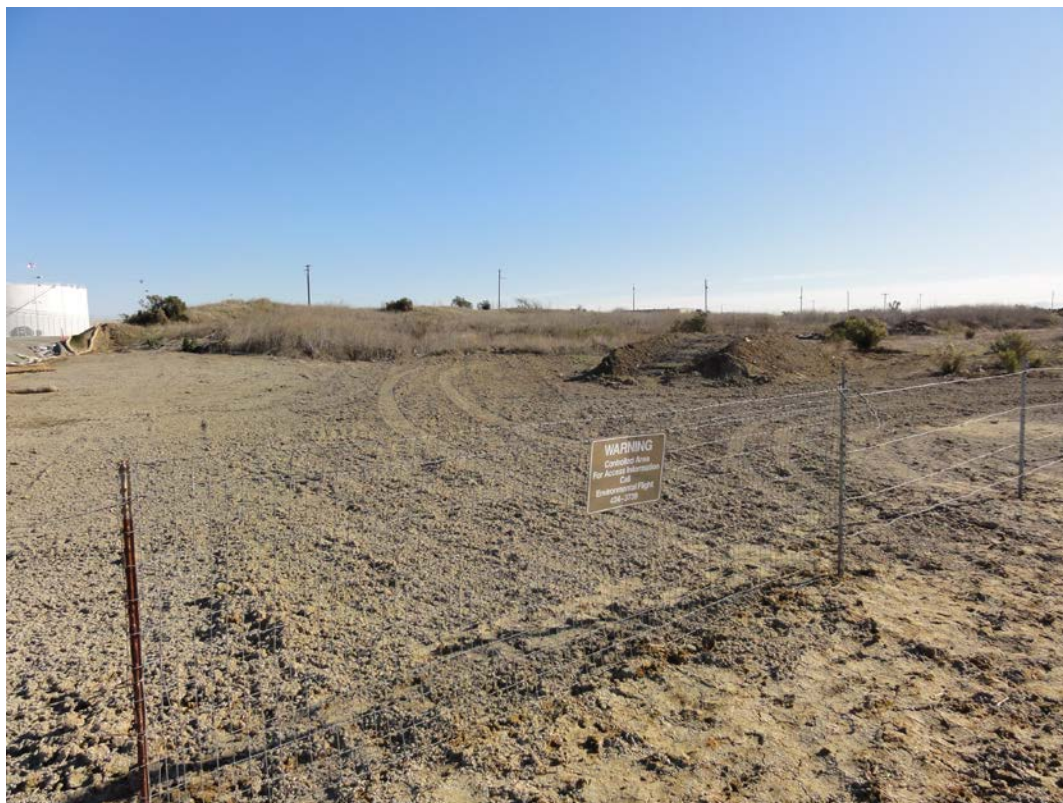
Photograph 11: West Side of LF044 Fence/AST Construction Area

There are several fence sections along the southern sides with broken strands. These deficiencies were noted in the past, but repairs were postponed until after the completion of the AST facility construction project. Once construction is complete (probably around the first half of 2012), the base will evaluate the amount of fence repair and any sign replacement that will be required to support the LUC restrictions.

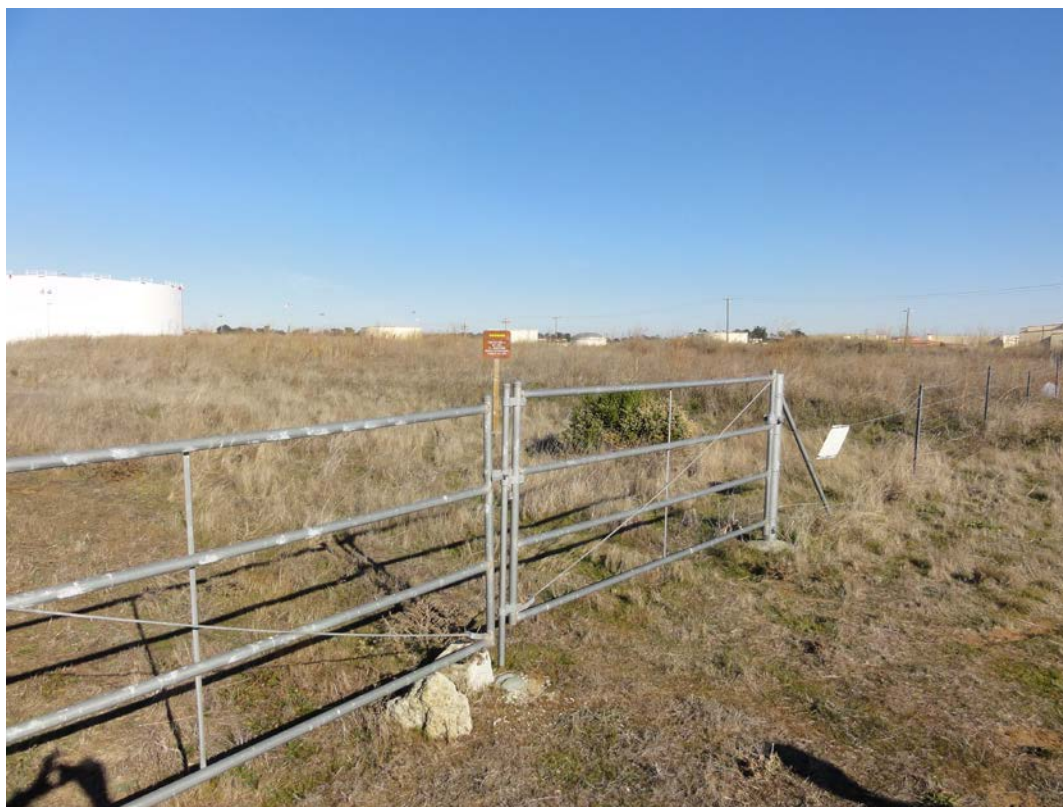
Photograph 12: Gate and Warning Sign on South Side of LF044

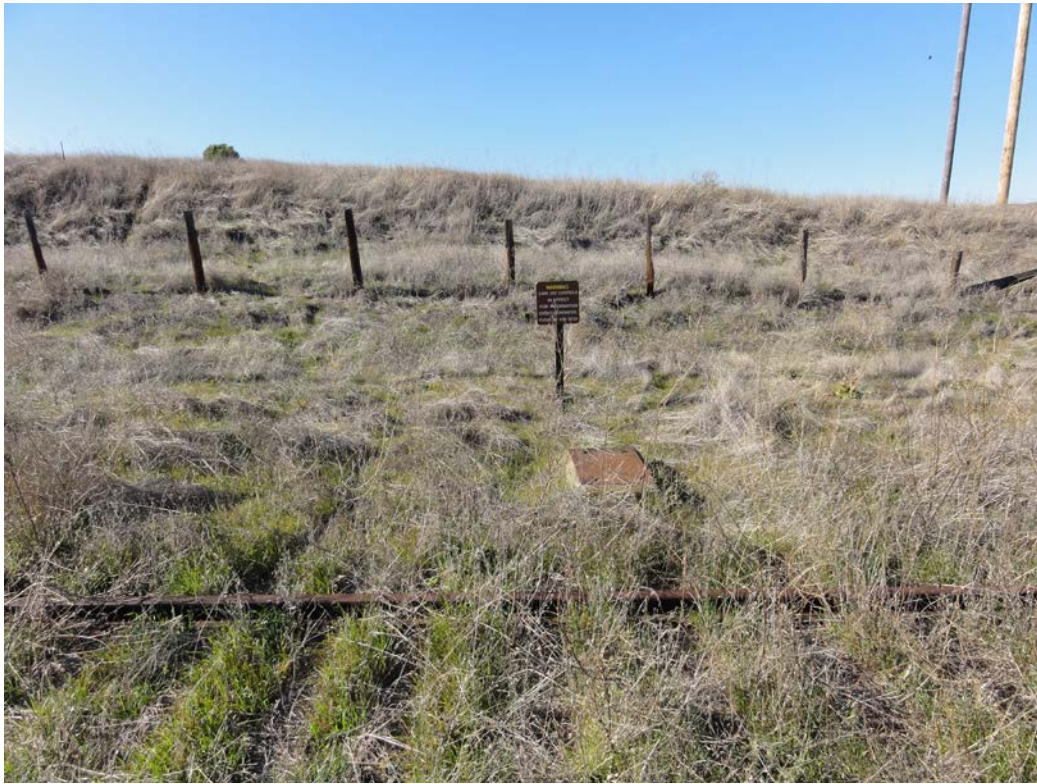
The 2011 inspection of the LUCs at SS046 found that administrative controls and two warning signs are adequate to enforce the restriction, so additional physical barriers (i.e., fences not associated with the Grazing Management Unit) are not needed. There is no evidence that the contaminated soil has been disturbed. Photograph 13 of Appendix B of this report shows the warning sign at the west end of the SS046 controlled area, and photograph 14 shows the warning sign at the east end of the controlled area.

Photograph 13: Warning Sign at West Side of SS046

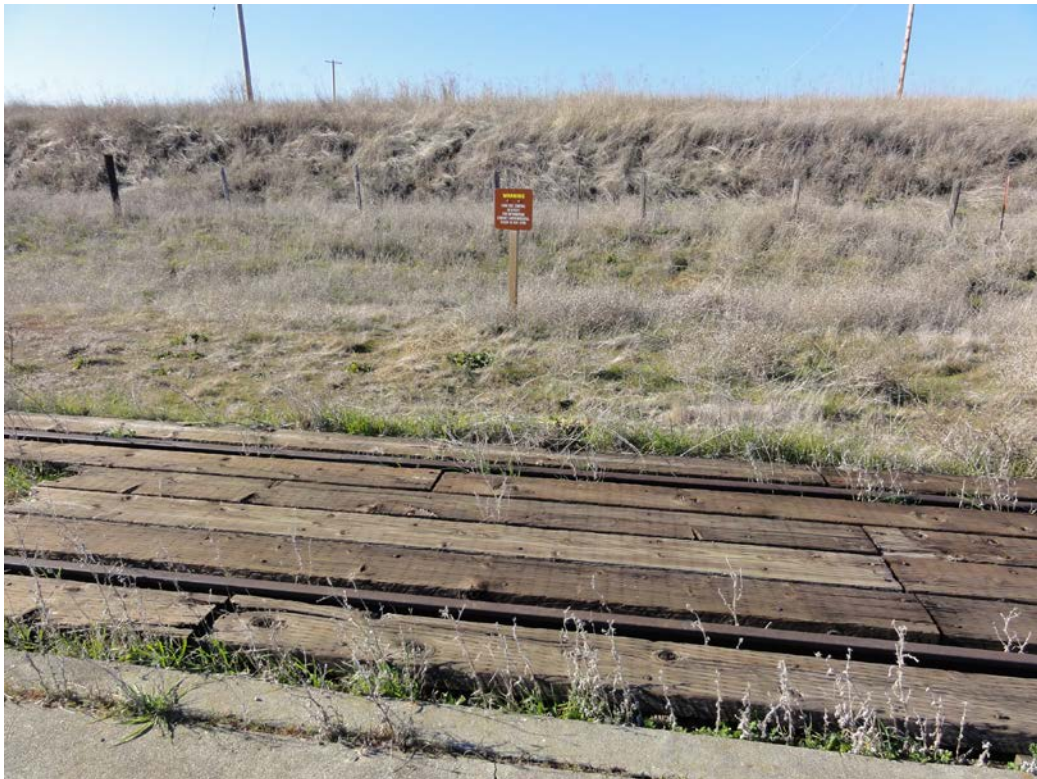
Photograph 14: Warning Sign at East Side of SS046

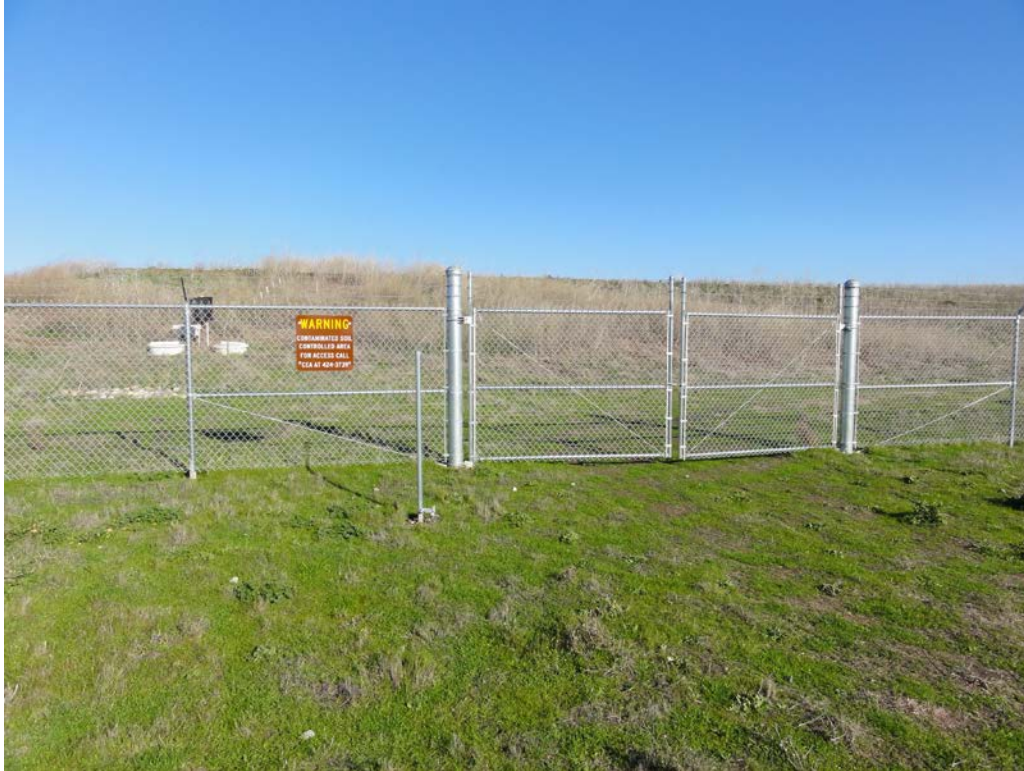
The 2011 inspection of the LUCs at LF007 found that the current administrative and physical controls are adequate to enforce the restrictions. There is no evidence that the contaminated soil at LF007 has been disturbed or that the active operations at Buildings 1360, 1365 and 1370 are compromising the LUCs in place on the portions of LF007 discussed above.

Photograph 15: Northwest CAMU Gate with Warning Sign

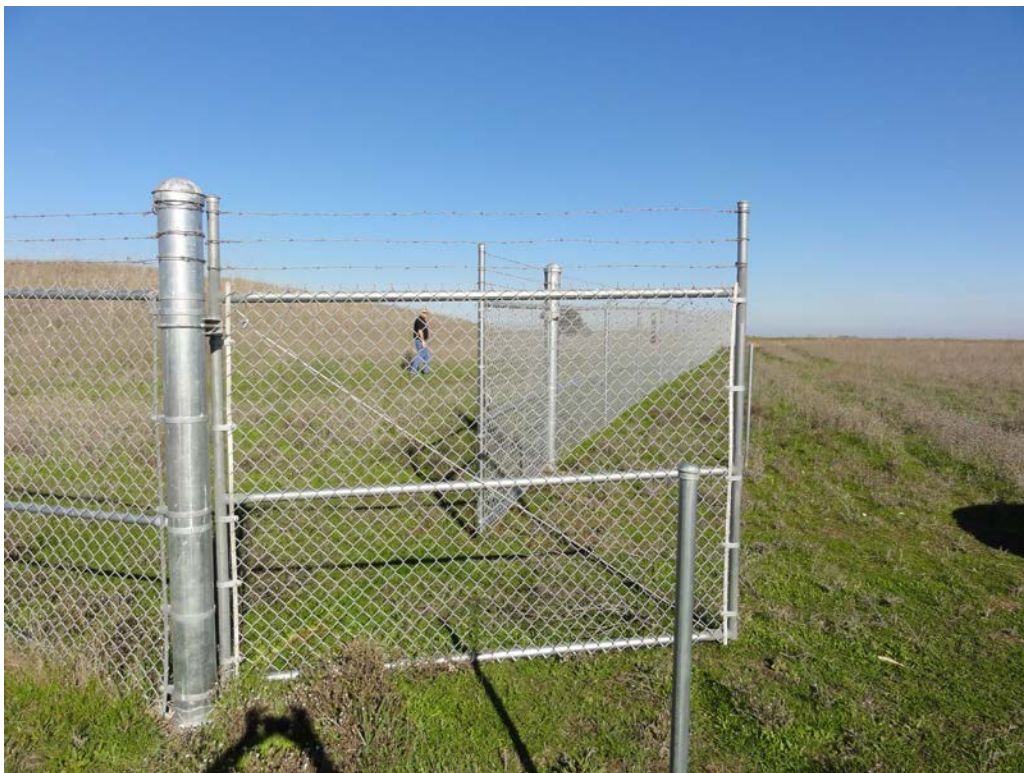
Photograph 16: Southern CAMU Gate

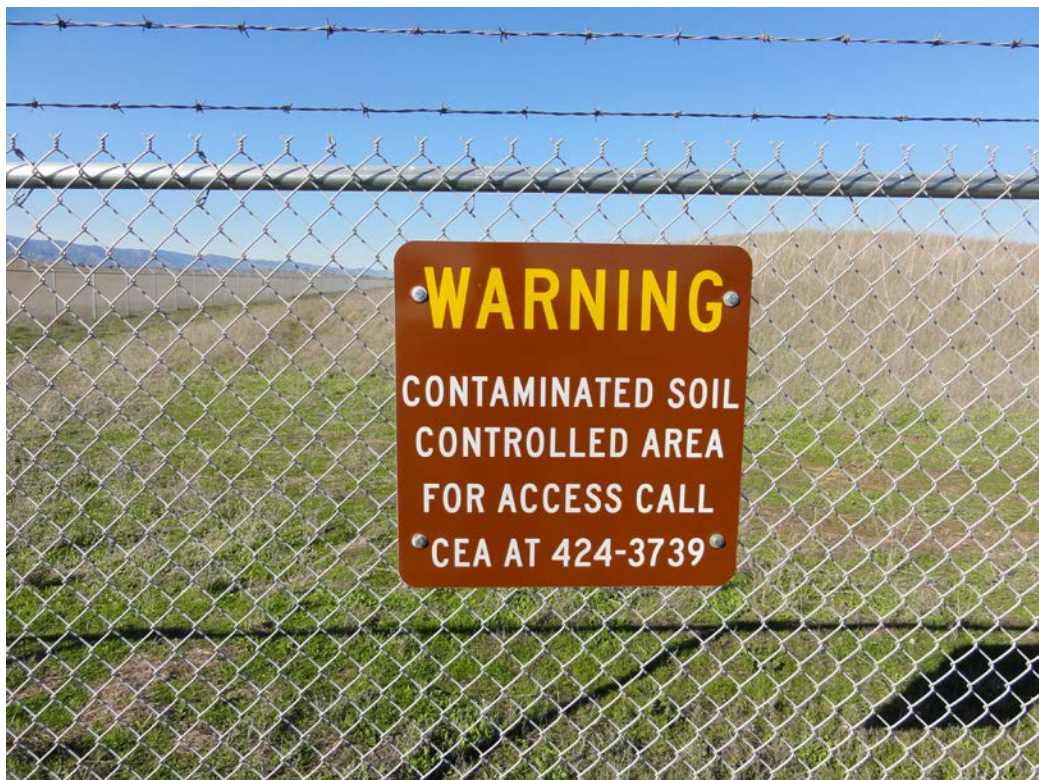
Photograph 17: Close-up of LUC Sign on CAMU Fence.

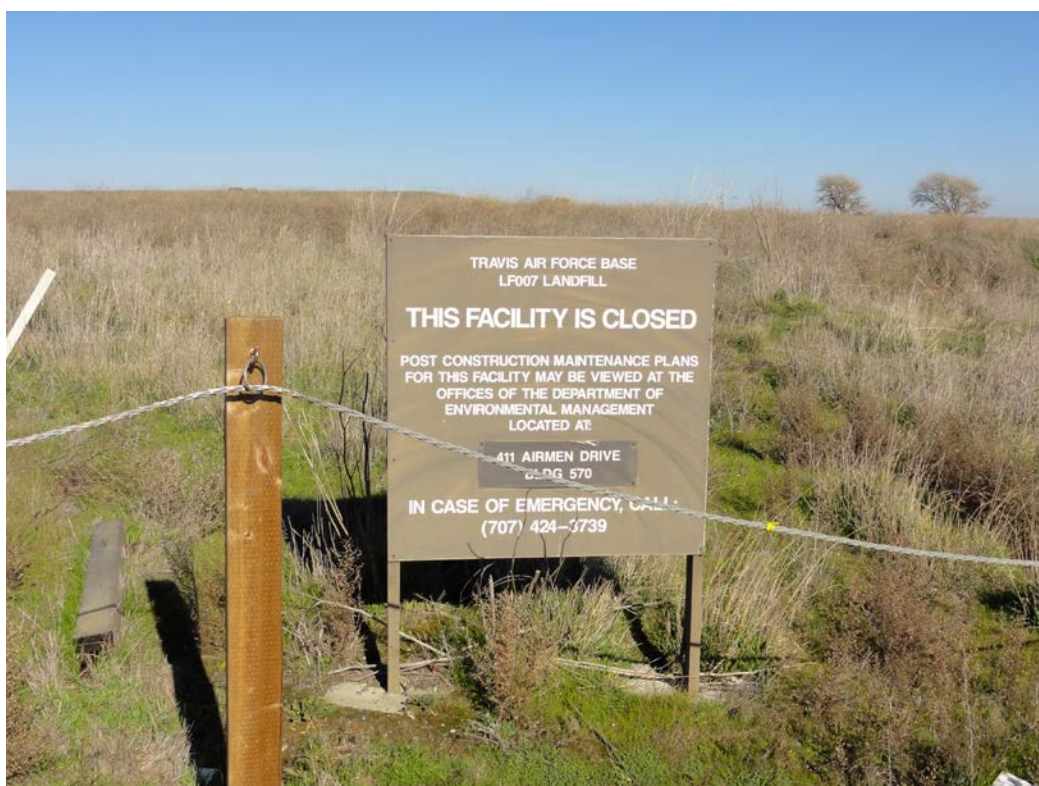
Photograph 18: Warning Sign at LF007 Entrance

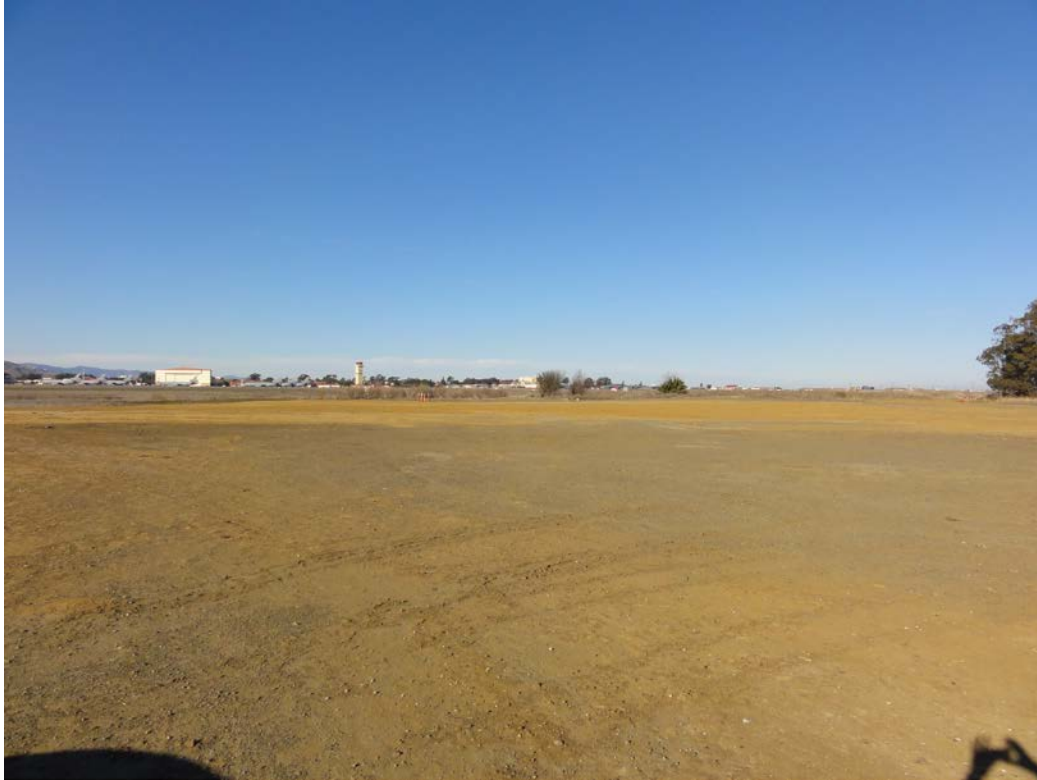
The 2011 inspection of the LUCs at FT005 found that administrative controls are adequate to enforce the restriction, so additional physical barriers (i.e., fences not associated with the Explosive Ordnance Disposal area) are not needed. The field activities associated with the Site FT005 soil remedial action had been completed, including the restoration of the excavation voids with clean soil. There is no evidence that an unauthorized disturbance of the restored site has taken place. Photograph 19 of Appendix B of this report shows the controlled area after the soil remedial action at this site was finished.

Photograph 19: Controlled Area at FT005 (Post Soil Cleanup)

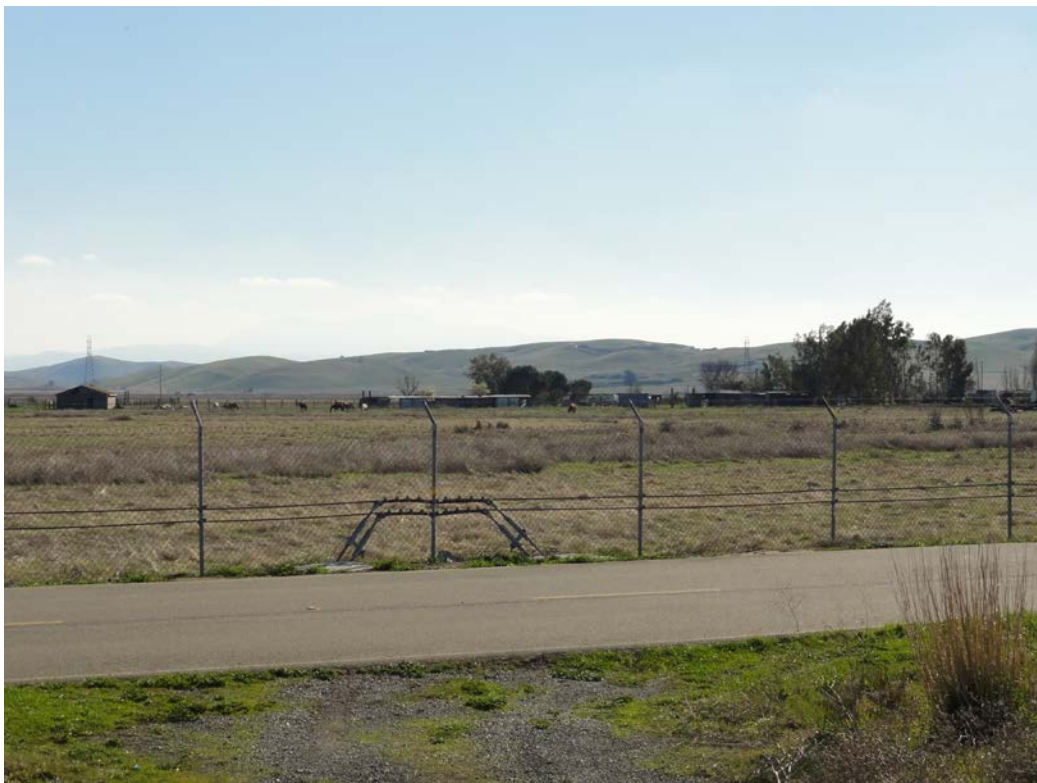
The 2011 inspection did not include a visit to all groundwater sites. The three off-base easements were inspected to verify that no residential development or well drilling activities other base remedial activities had taken place. For the on-base sites, a records review revealed no drinking water wells have been constructed. The remaining controls are procedural in nature and are based on the tasks that base personnel and contractors must complete to obtain permission to excavate soil as part of a construction or repair project. There are no physical controls associated with these groundwater restrictions that can be inspected.

Photograph 20: View of SS030 Easement from South Groundwater Treatment Plant
