TRAVIS AIR FORCE BASE  
ENVIRONMENTAL RESTORATION PROGRAM

**ANNUAL REPORT  
ON THE STATUS OF  
LAND USE CONTROLS  
ON RESTORATION SITES  
IN 2012**

60<sup>TH</sup> CIVIL ENGINEER SQUADRON  
Travis Air Force Base, California

JANUARY 2013

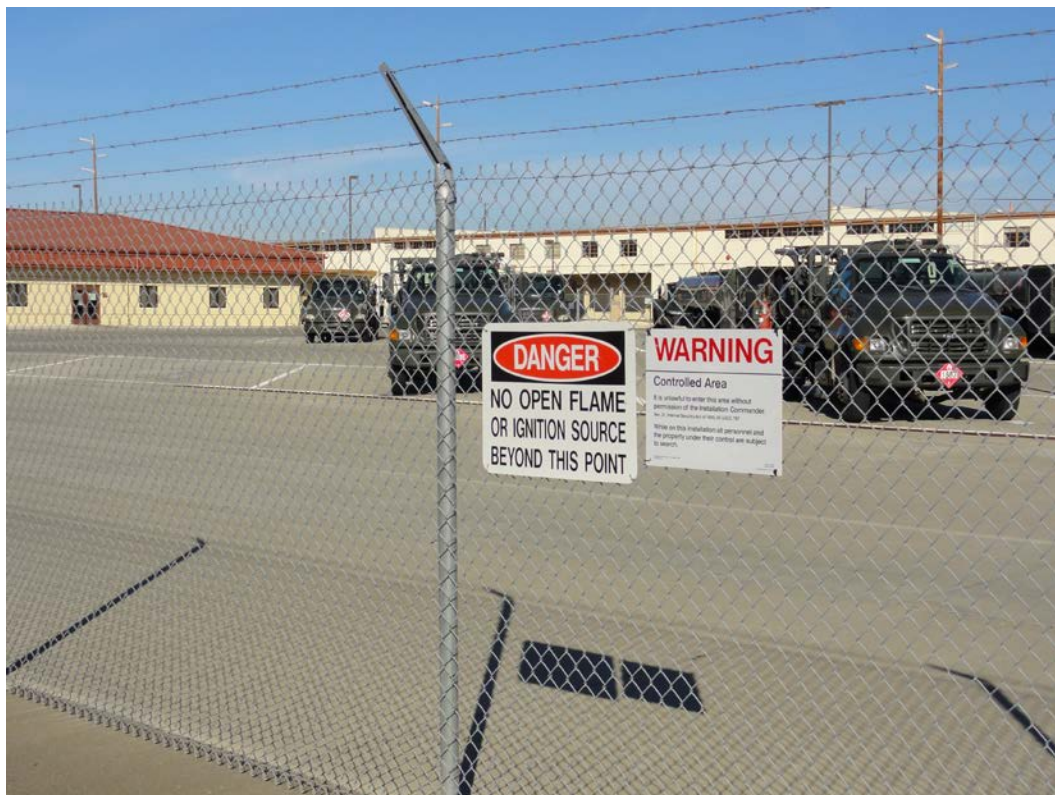
inspectors noted a potential for additional physical barriers (i.e., fences) and signage to adversely impact vehicle operations. There is no evidence that the cadmium-impacted soil beneath the concrete parking area has been disturbed. Photograph 1 in Appendix B of this report shows the controlled area at SS015.

Photograph 1: Controlled Area at SS015

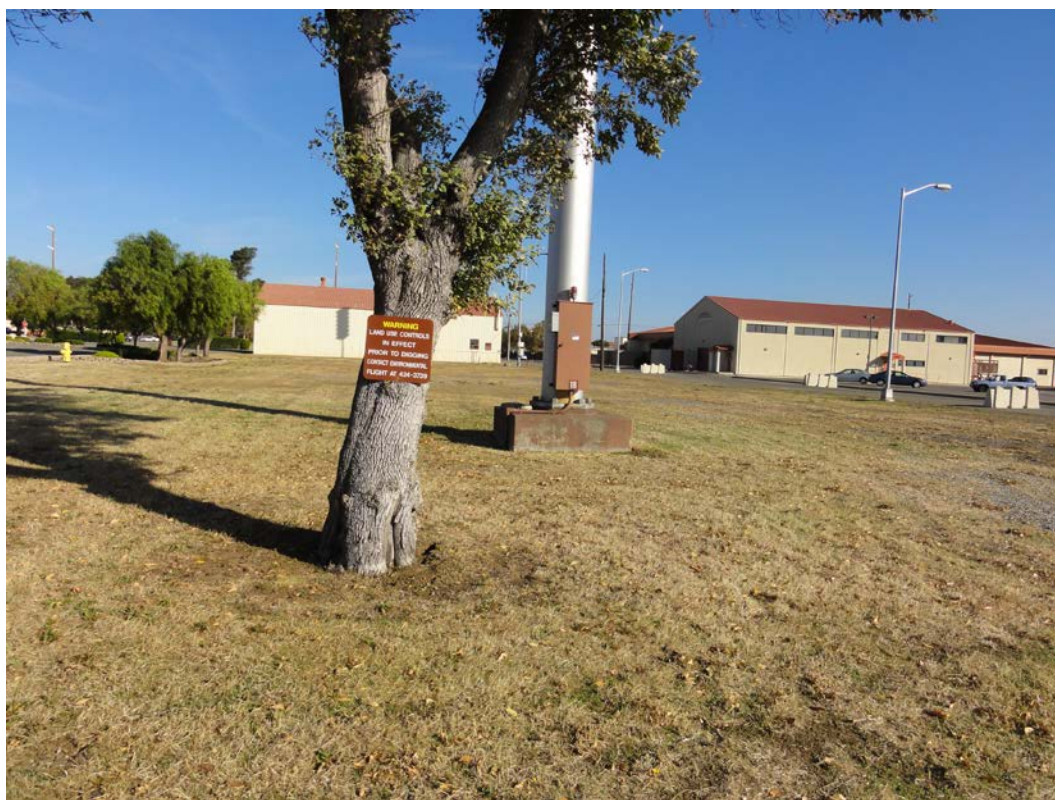
The 2012 inspection of the LUCs at SS016 found that administrative controls are adequate to enforce the restriction, so physical barriers (i.e., fences) are not needed. There is no evidence that the PAH-impacted soil has been disturbed either with or without proper authorization. A warning sign has been posted on a tree in the middle of the site to notify base workers of the

Photograph 2: Controlled Area at SS016

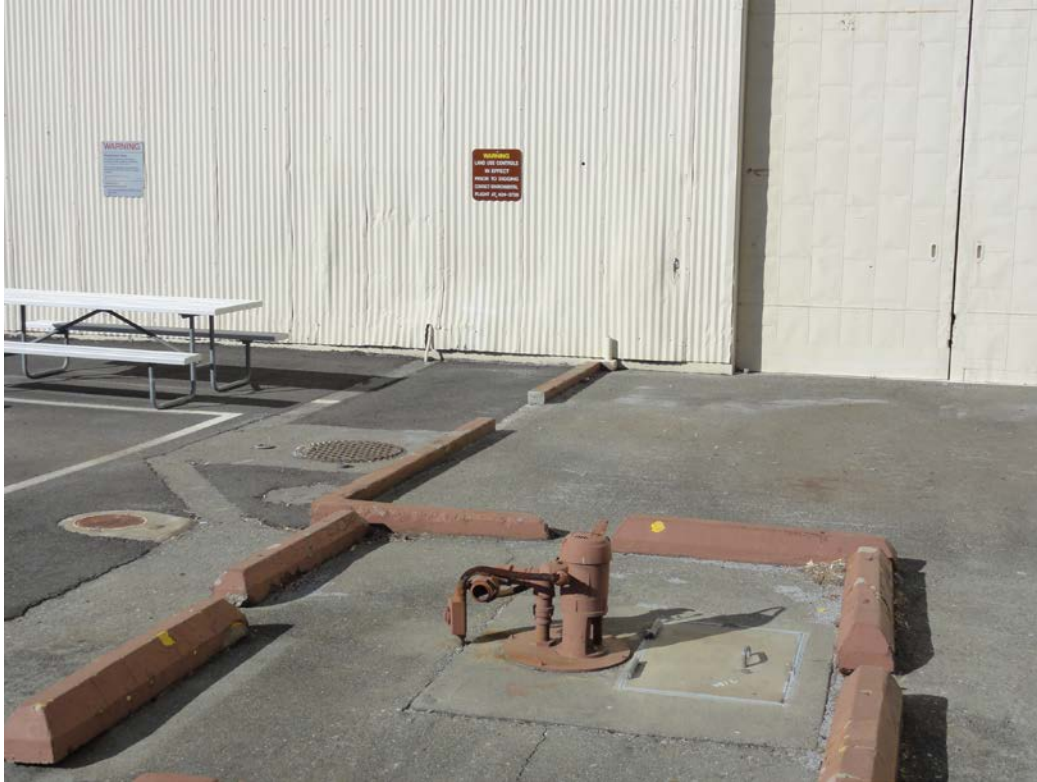
The 2012 inspection of the LUCs at the soil portion of SD033 found that administrative controls are adequate to enforce the restriction, so physical barriers (i.e., fences) are not needed. There is no evidence that the cadmium- and benzo(a)pyrene-impacted soil has been disturbed. Warning signs have been posted on both sides of Facility 810 to notify base workers of the presence of the controlled area. Photographs 3 and 4 in Appendix B of this report show the controlled soil areas at SD033.

Photograph 3: Warning Sign at Controlled Area on East Side of SD033

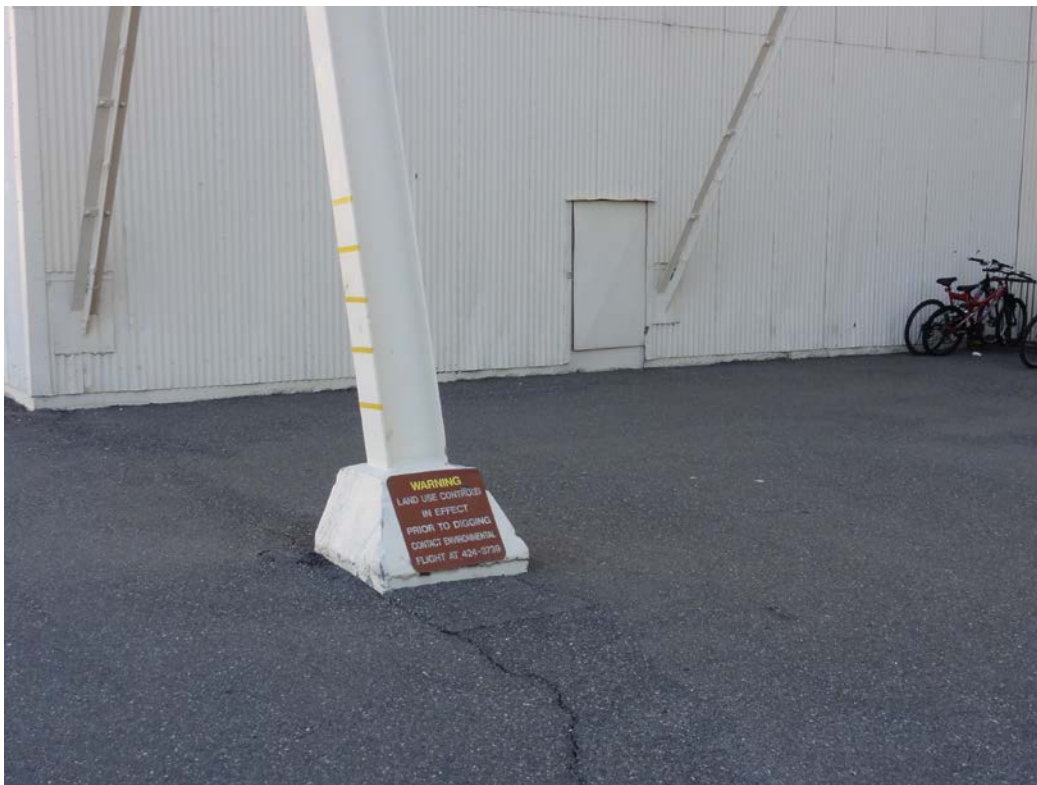
Photograph 4: Warning Sign at Controlled Area on West Side of SD033

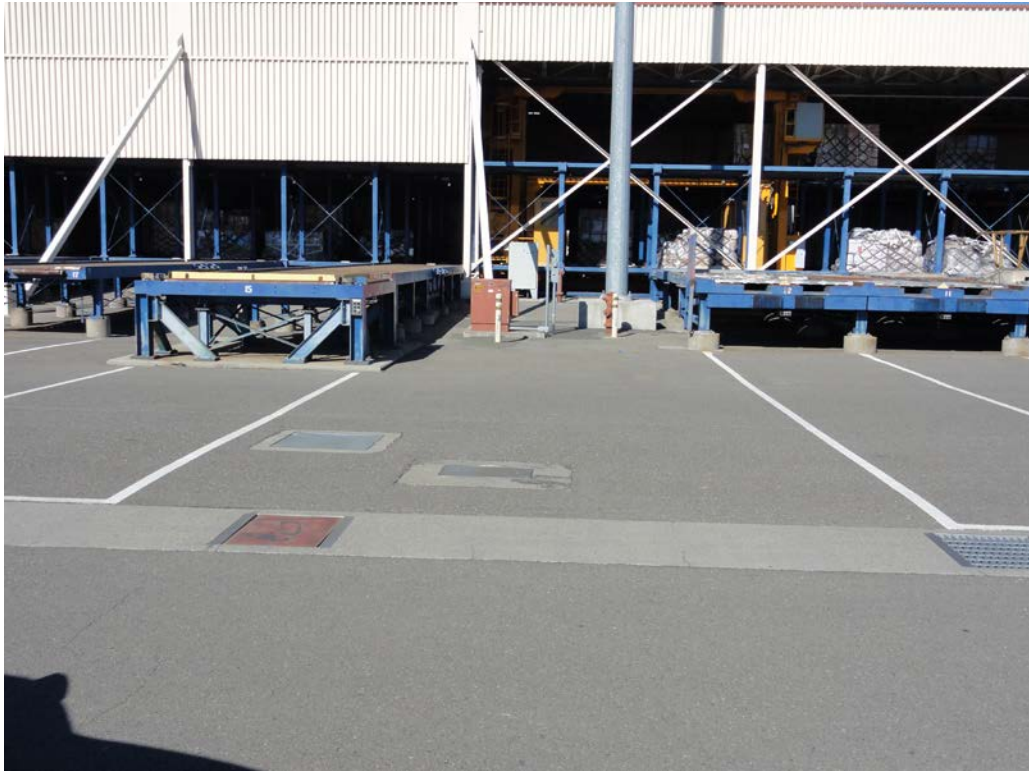
Specifically, vehicles that are designed to transport large cargo pallets to and from both military and commercial aircraft require an open area free of physical hazards. The two small controlled areas lie in the middle of these open work areas, and there are no existing posts or structures that could be used to post signs that point out their location. Because of the high tempo of mission-critical operations associated with the air freight terminal, any obstructions would pose significant risk to both personnel and equipment. Photographs 5 and 6 in Appendix B of this report show the controlled areas within the open work areas at SD037.

Photograph 5: Controlled Area on Southeast Side of SD037

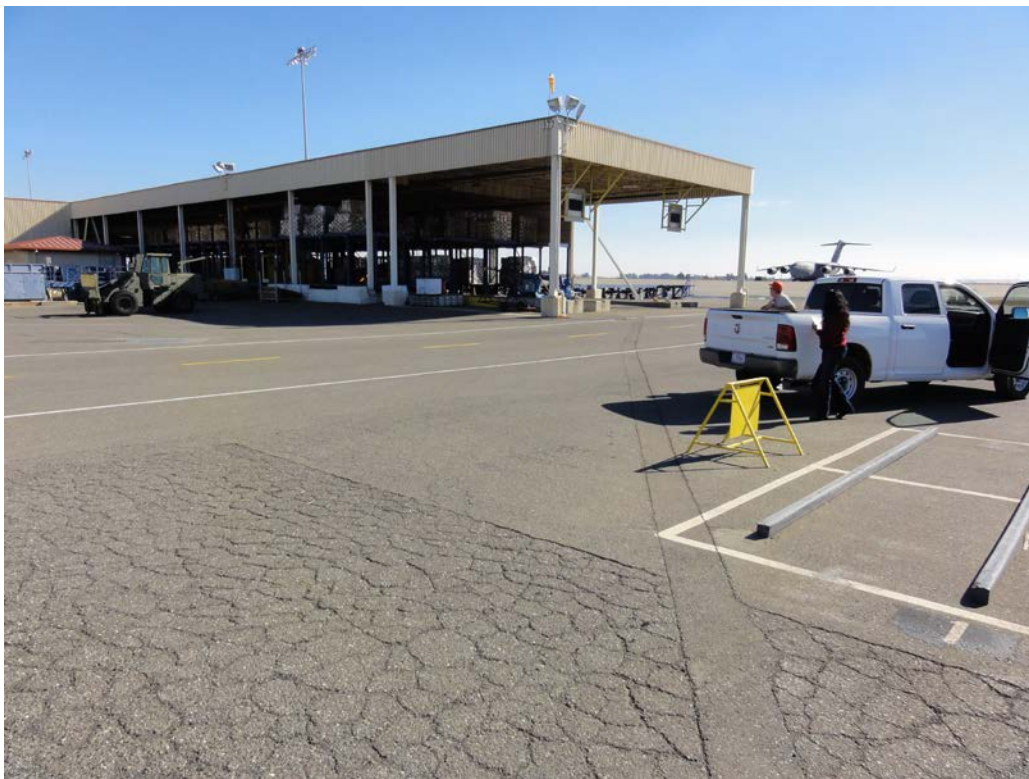
Photograph 6: Controlled Area on Southwest Side of SD037

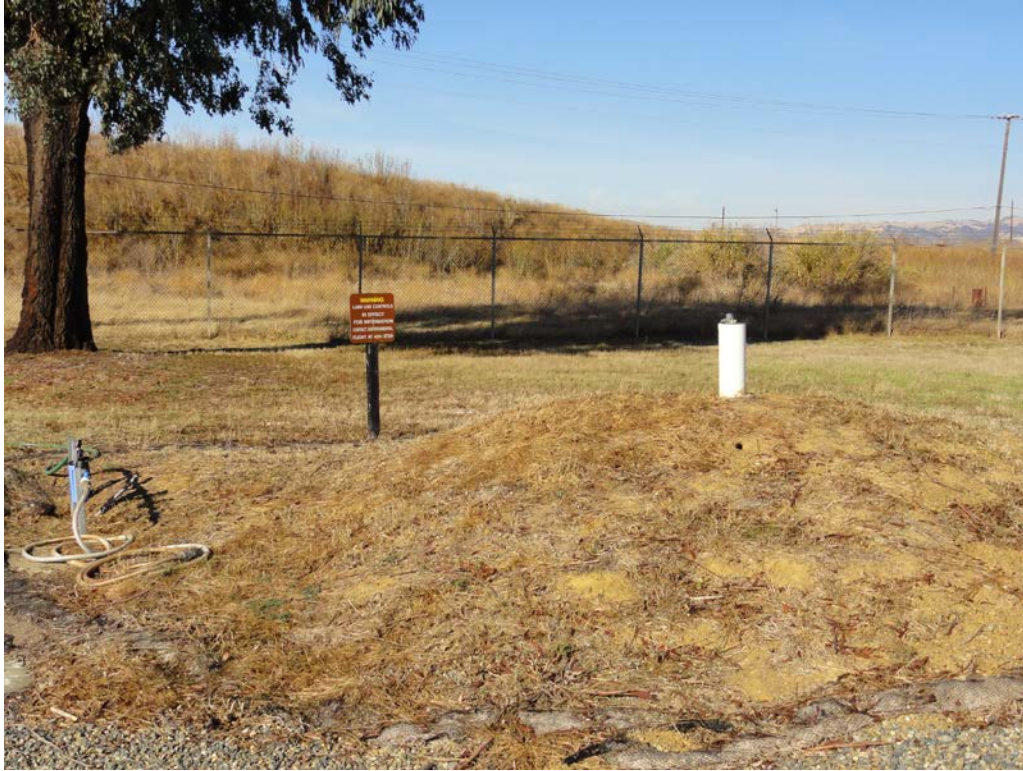
The 2012 inspection of the LUCs at DP039 found that administrative controls and a LUC warning sign are still adequate to enforce the restriction, so physical barriers (i.e., fences) are not needed. The lead-impacted soil has been excavated and sent by truck to an appropriate landfill as a result of the bioreactor demonstration project. Travis AFB will continue to enforce the DP039 controls until the upcoming technical memorandum has received regulatory review and the base receives approval to modify the controls for this part of the site. Photograph 7 in Appendix B of this report shows the surface of the bioreactor over the controlled area at DP039. The warning sign that notifies visitors to the site of the presence of LUCs can be seen in the background. Building 755 was vacated and demolished in 2009.

Photograph 7: Controlled Area at DP039 (Post Bioreactor Construction)

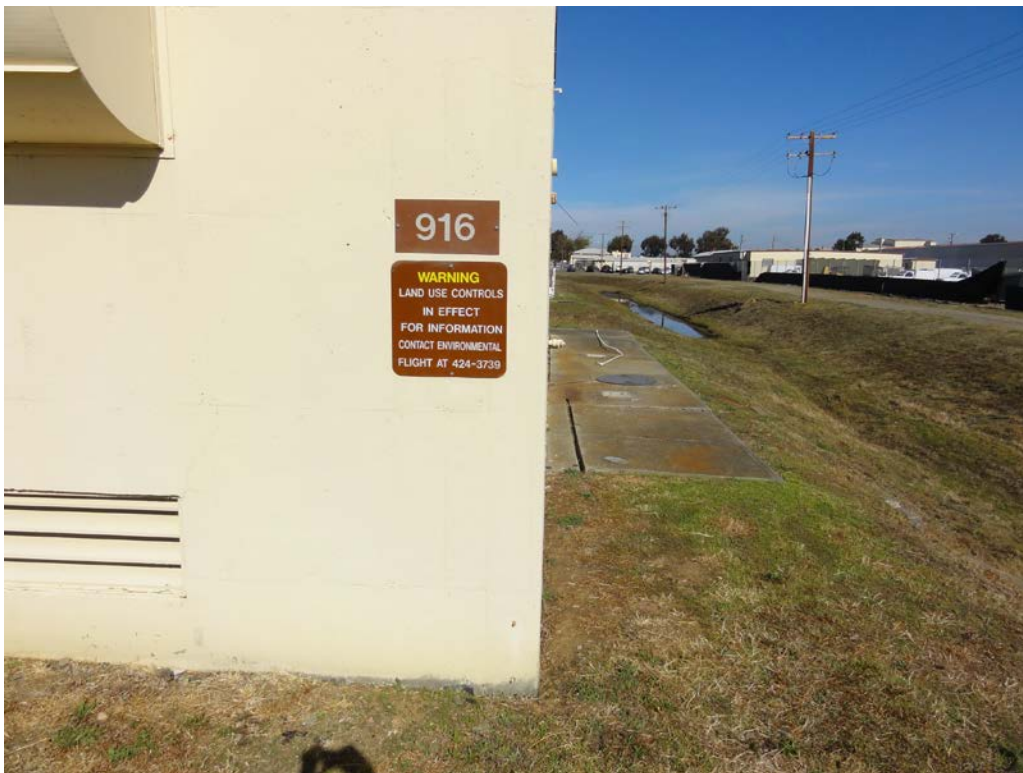
The 2012 inspection of the LUCs at SD043 found that administrative controls are adequately enforcing the restriction, so physical barriers (i.e., fences) are not needed. There is no evidence that any soil disturbances in the vicinity of the concrete pad and generator took place in 2012. Photograph 8 in Appendix B shows the east side of the generator and pad south of Building 916, and photograph 9 shows the warning signs in relation to the west side of the controlled area at SD043.

Photograph 8: Sign near East Side of Installed Generator at SD043

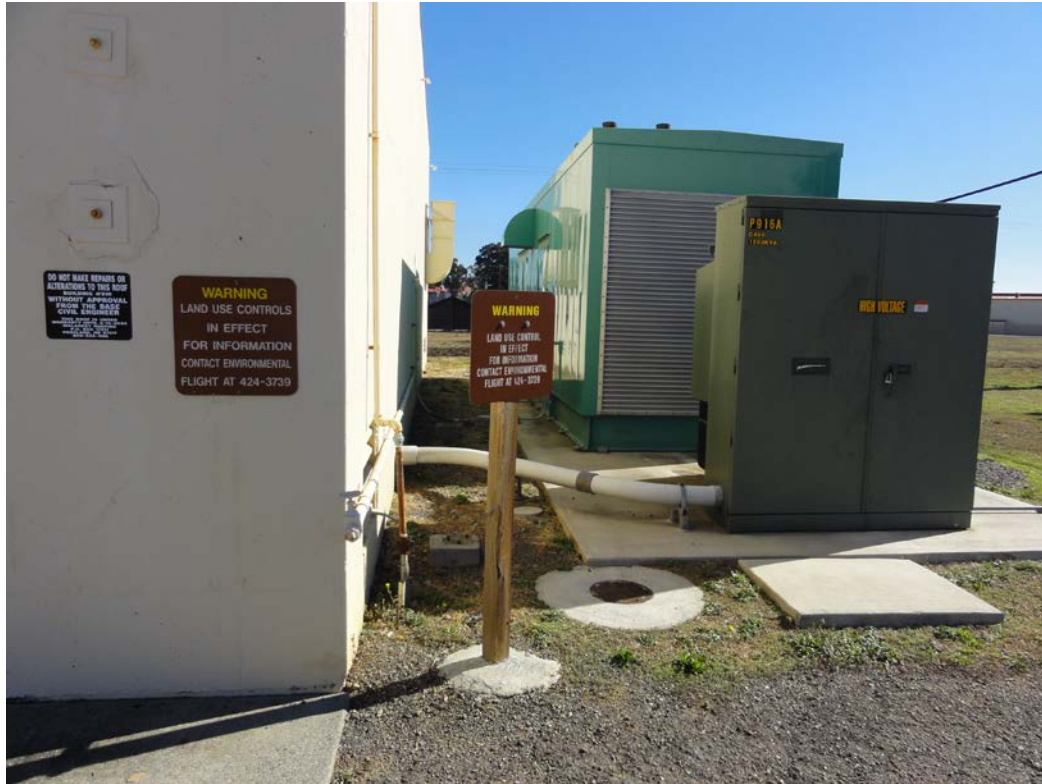
Photograph 9: Generator Pad and Warning Signs at SD043. Stanchion of Former Pad with Leaking Transformers is visible in the foreground.

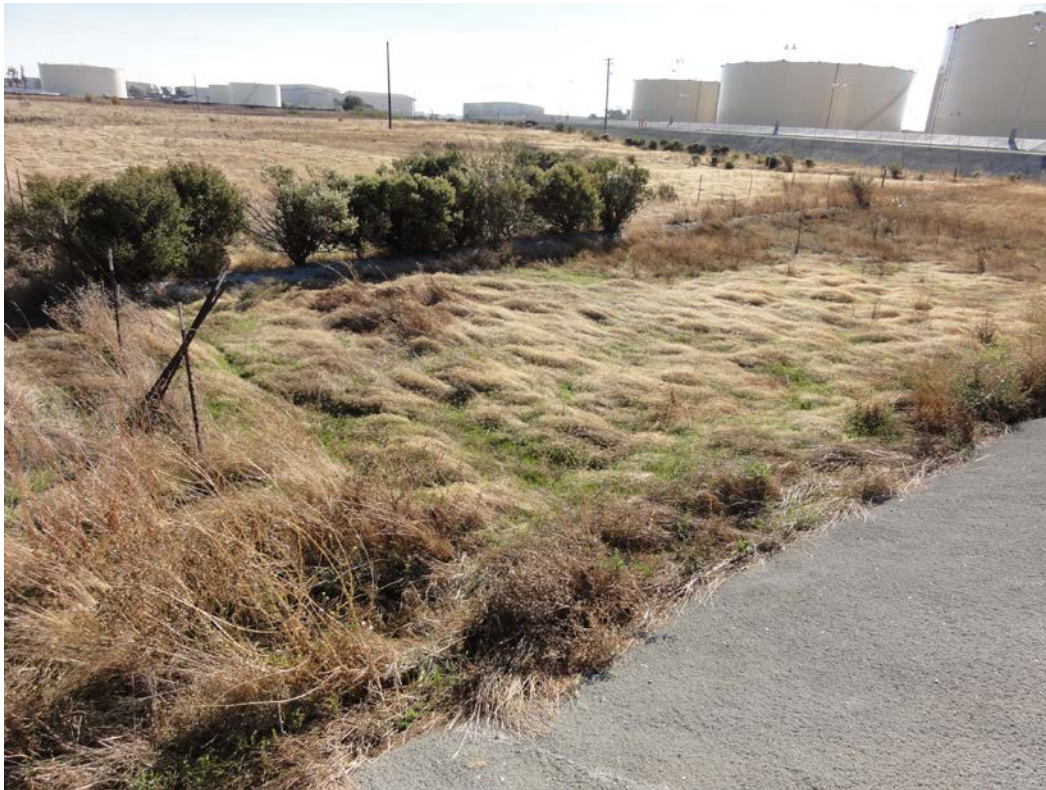
The 2012 inspection of the LUCs at LF044 found the berm to be in good to excellent physical condition. However, there are secondary containment walls next to the LF044 berm that are designed to capture and hold 110% of the contents of the new tanks. These walls are much larger than the LF044 berm. As a result, the berm no longer serves its original purpose, which was to prevent the flow of contaminated sediment into nearby vernal pools. This is because the contaminated materials next to the berm have been removed, and the amount of land between the berm and the secondary containment walls is very small (as shown in Photograph 10), so a large amount of water will not accumulate between the berm and the containment walls. It is likely that the base will seek regulatory concurrence to remove the requirement for a berm from the LF044 controlled area in the upcoming joint Travis/Kinder Morgan report.

Photograph 10: Area between Berm and new AST Containment Enclosure

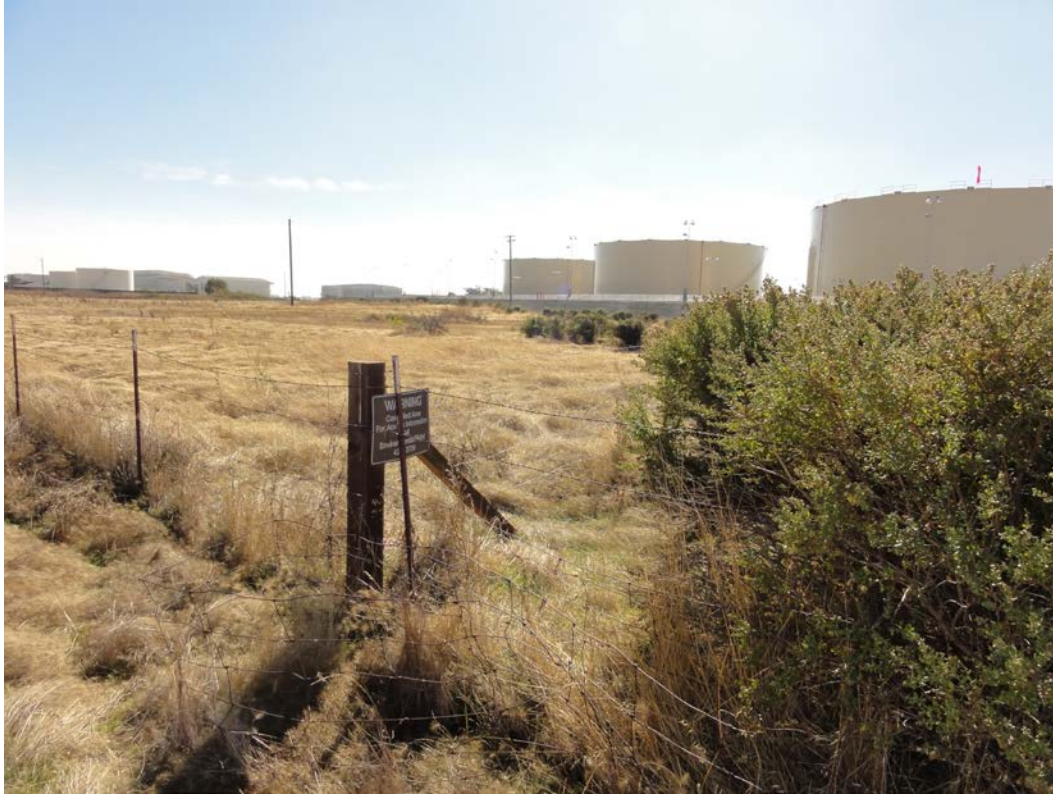
The 2012 inspection of the LUCs at LF044 found the fence and signs along all but the southern sides of the controlled area as well as the north gate had been removed and replaced with security fencing and a new gate to control entry into the tank facility. All contaminated soil and construction debris within the footprint of the new tank facility had been excavated and taken off-site. A significant portion of the security fence around the southern side of the new tank facility now serves as part of the fence around the remaining LF044 controlled area.

Photograph 11: North Side of LF044 Fence

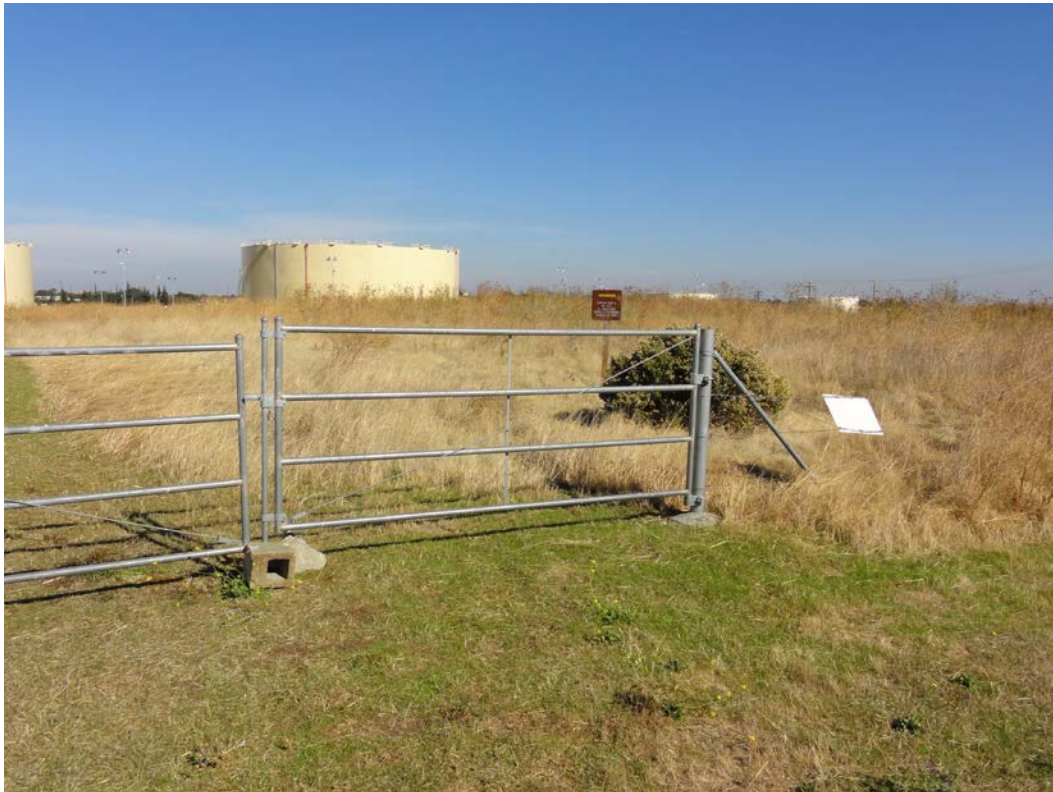
There are several fence sections along the southern sides with broken strands. These deficiencies were noted in the past, but repairs were postponed until after the completion of the AST facility construction project. Now that the tank facility construction is complete, the base will evaluate the amount of fence repair and any sign replacement that will be required in 2013 to support the LUC restrictions.

Photograph 12: Gate and Warning Sign on South Side of LF044

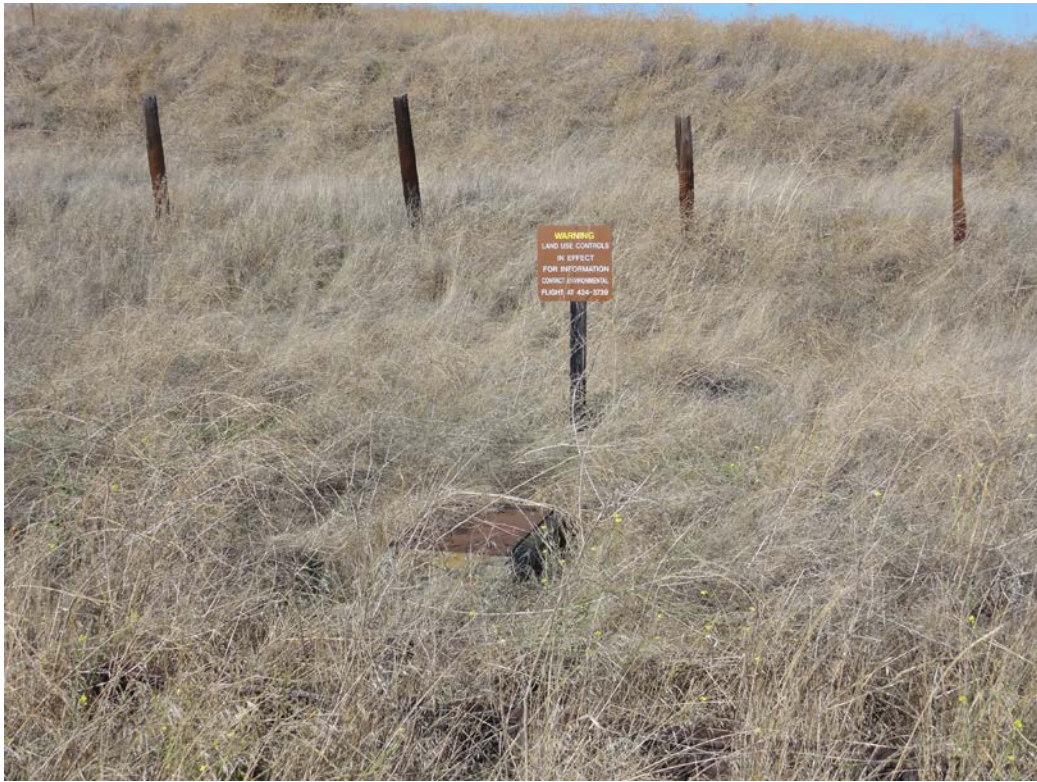
The 2012 inspection of the LUCs at SS046 found that administrative controls and two warning signs are adequate to enforce the restriction, so additional physical barriers (i.e., fences not associated with the Grazing Management Unit) are not needed. There is no evidence that the contaminated soil has been disturbed. Photograph 13 of Appendix B of this report shows the warning sign at the west end of the SS046 controlled area, and photograph 14 shows the warning sign at the east end of the controlled area.

Photograph 13: Warning Sign at West Side of SS046

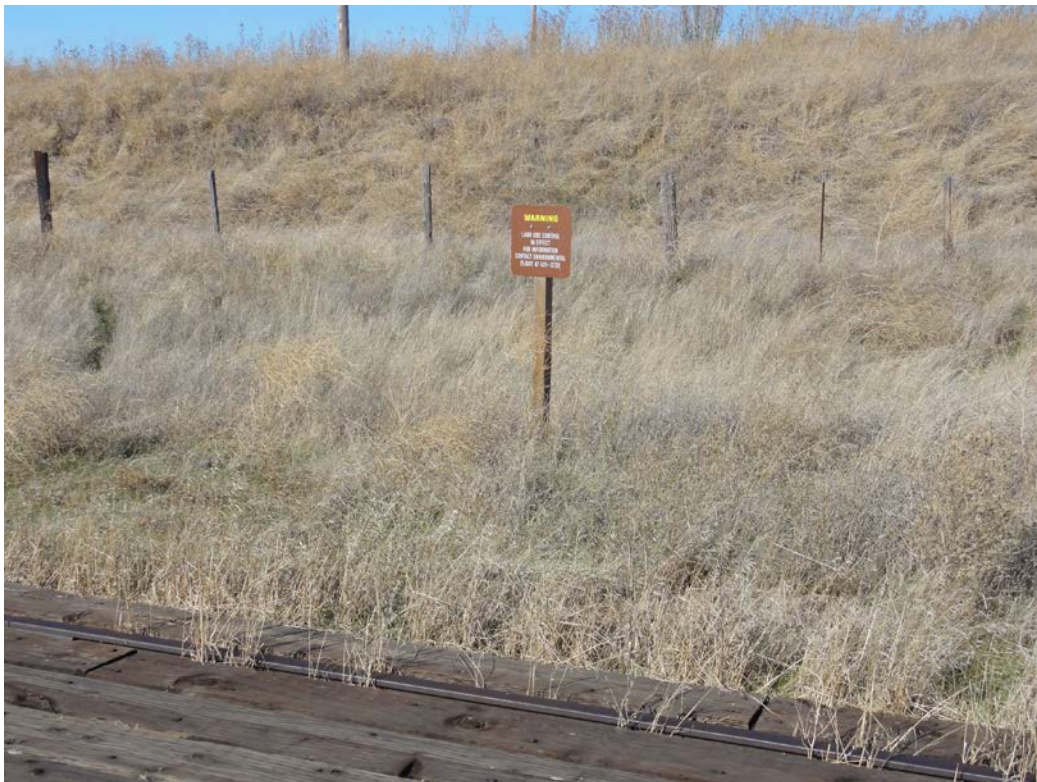
Photograph 14: Warning Sign at East Side of SS046

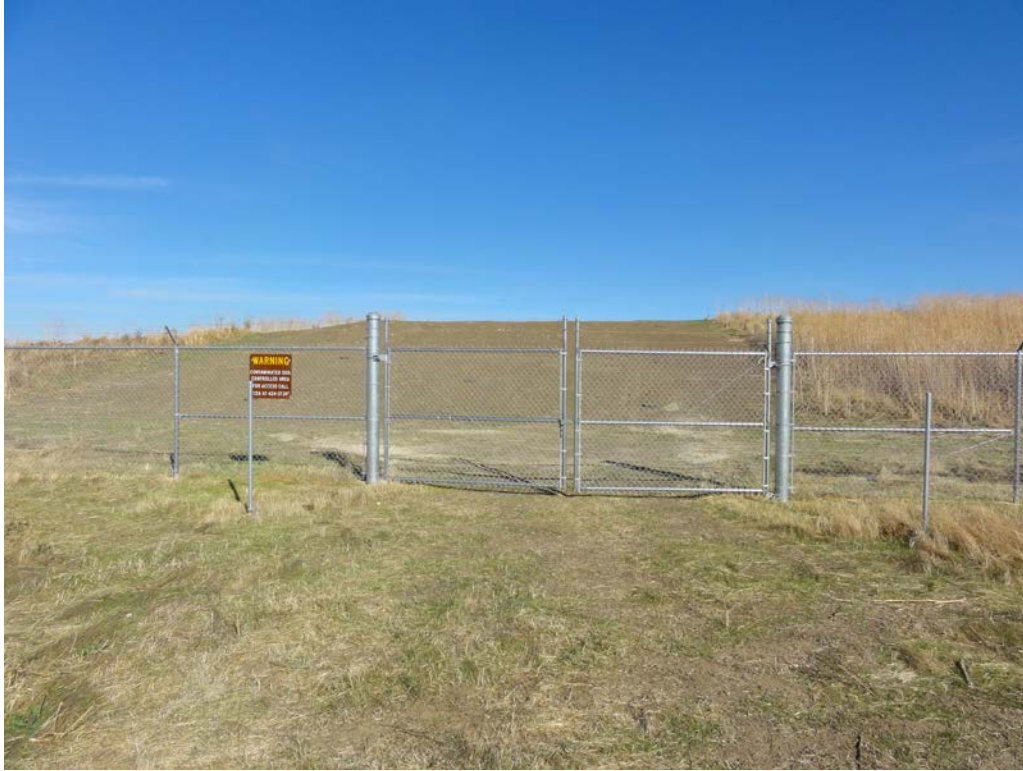
Photograph 15: Northwest CAMU Gate after Lysimeter Removal

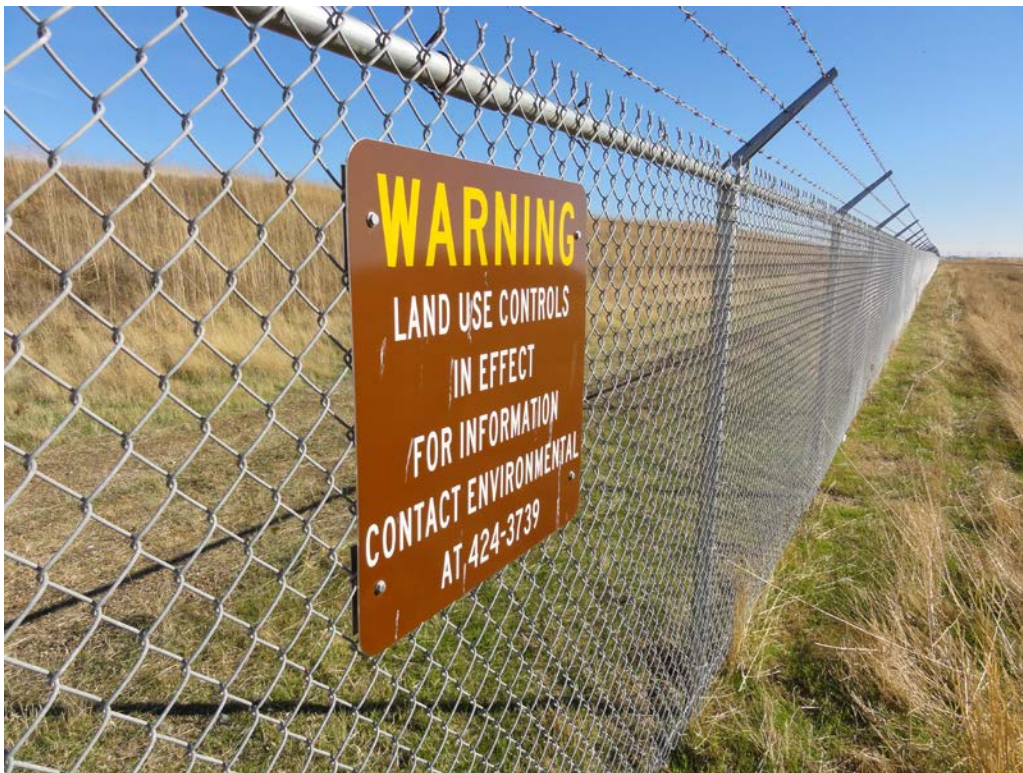
Photograph 16: Sign on southwestern CAMU Fence

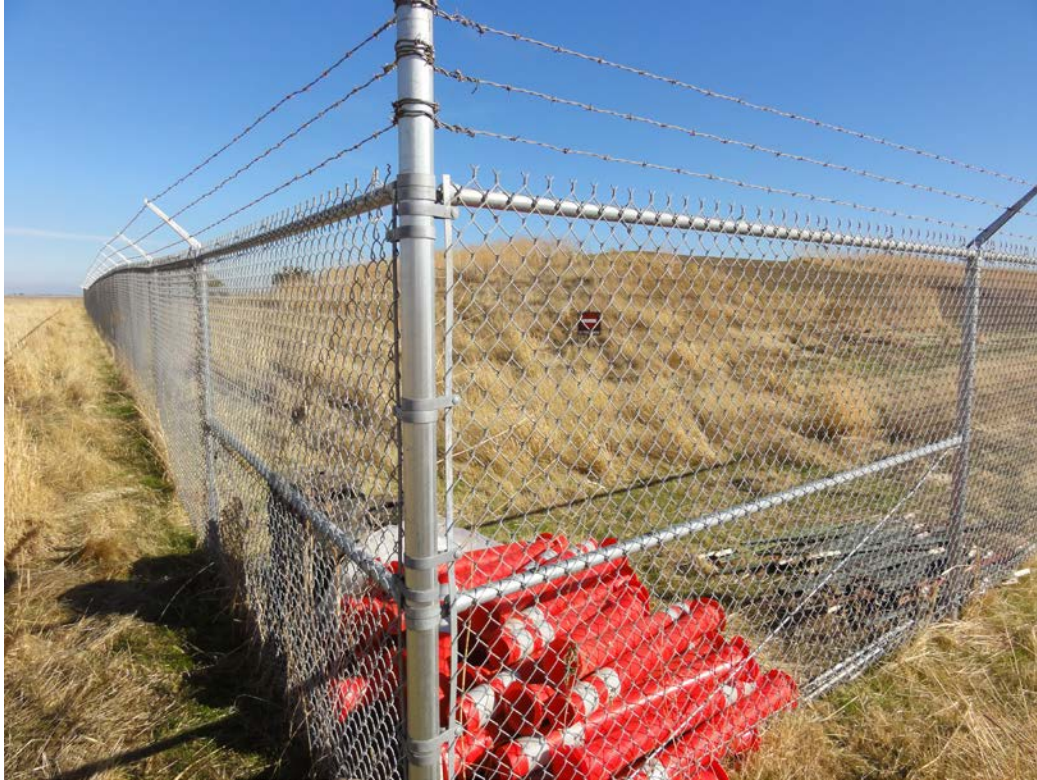
Photograph 17: Northwestern Corner of CAMU Fence.

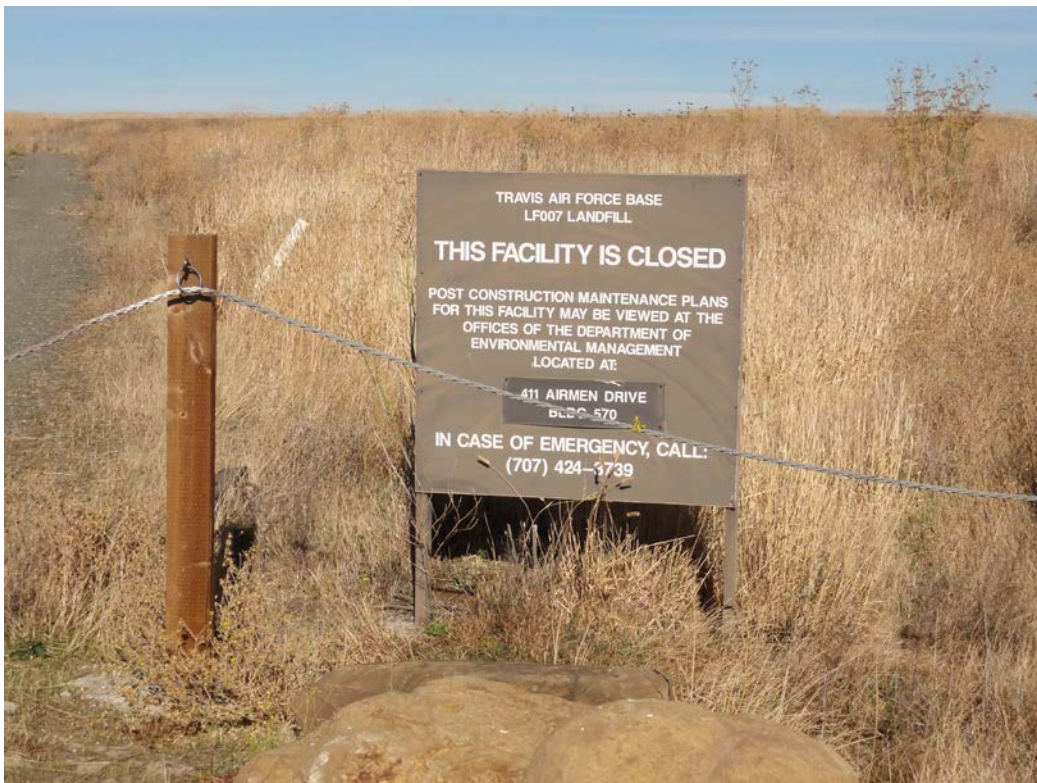
The 2012 inspection of the LUCs at LF007 found that the current administrative and physical controls are adequate to enforce the restrictions. There is no evidence that the contaminated soil at LF007 has been disturbed or that the active operations at Buildings 1360, 1365 and 1370 are compromising the LUCs in place on the portions of LF007 discussed above.

Photograph 18: Warning Sign at LF007 Entrance

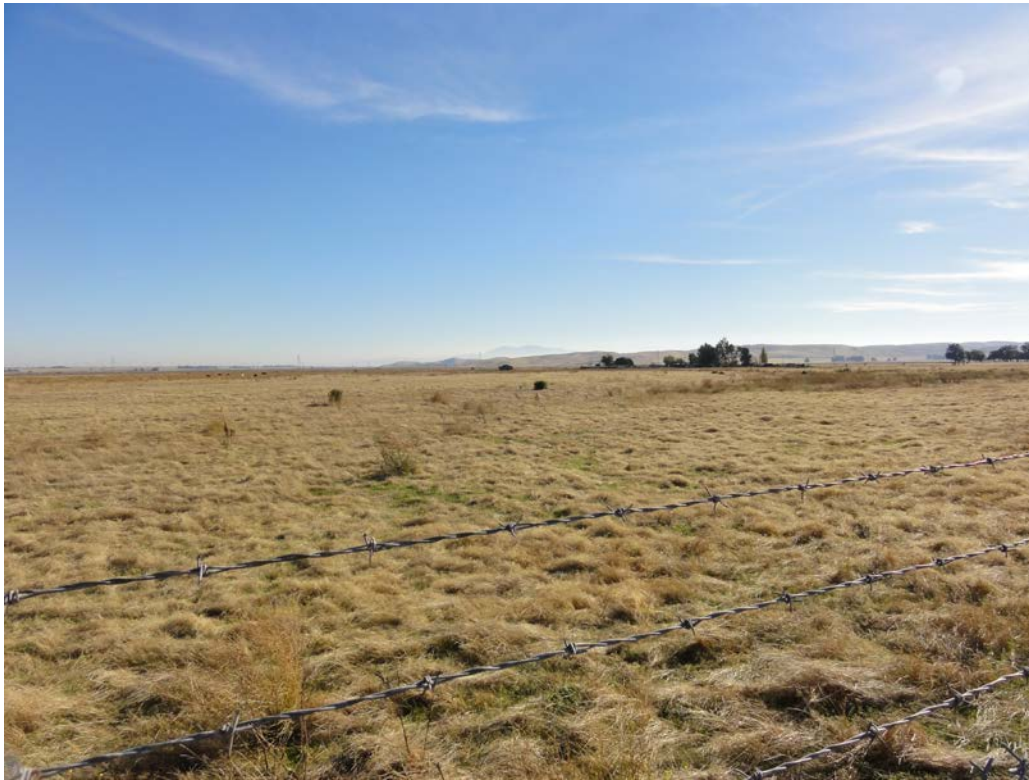
Photograph 19: View of SS030 Easement from South Groundwater Treatment Plant
