**FINAL
PRELIMINARY ASSESSMENT REPORT
FOR PERFLUORINATED COMPOUNDS
AT
TRAVIS AIR FORCE BASE
FAIRFIELD, CALIFORNIA**

**Contract No. FA8903-08-D-8772
Task Order 0065
CDRL A001A**

May 2015

**CH2M HILL
9311 San Pedro Avenue, Suite 800
San Antonio, Texas, 78216**

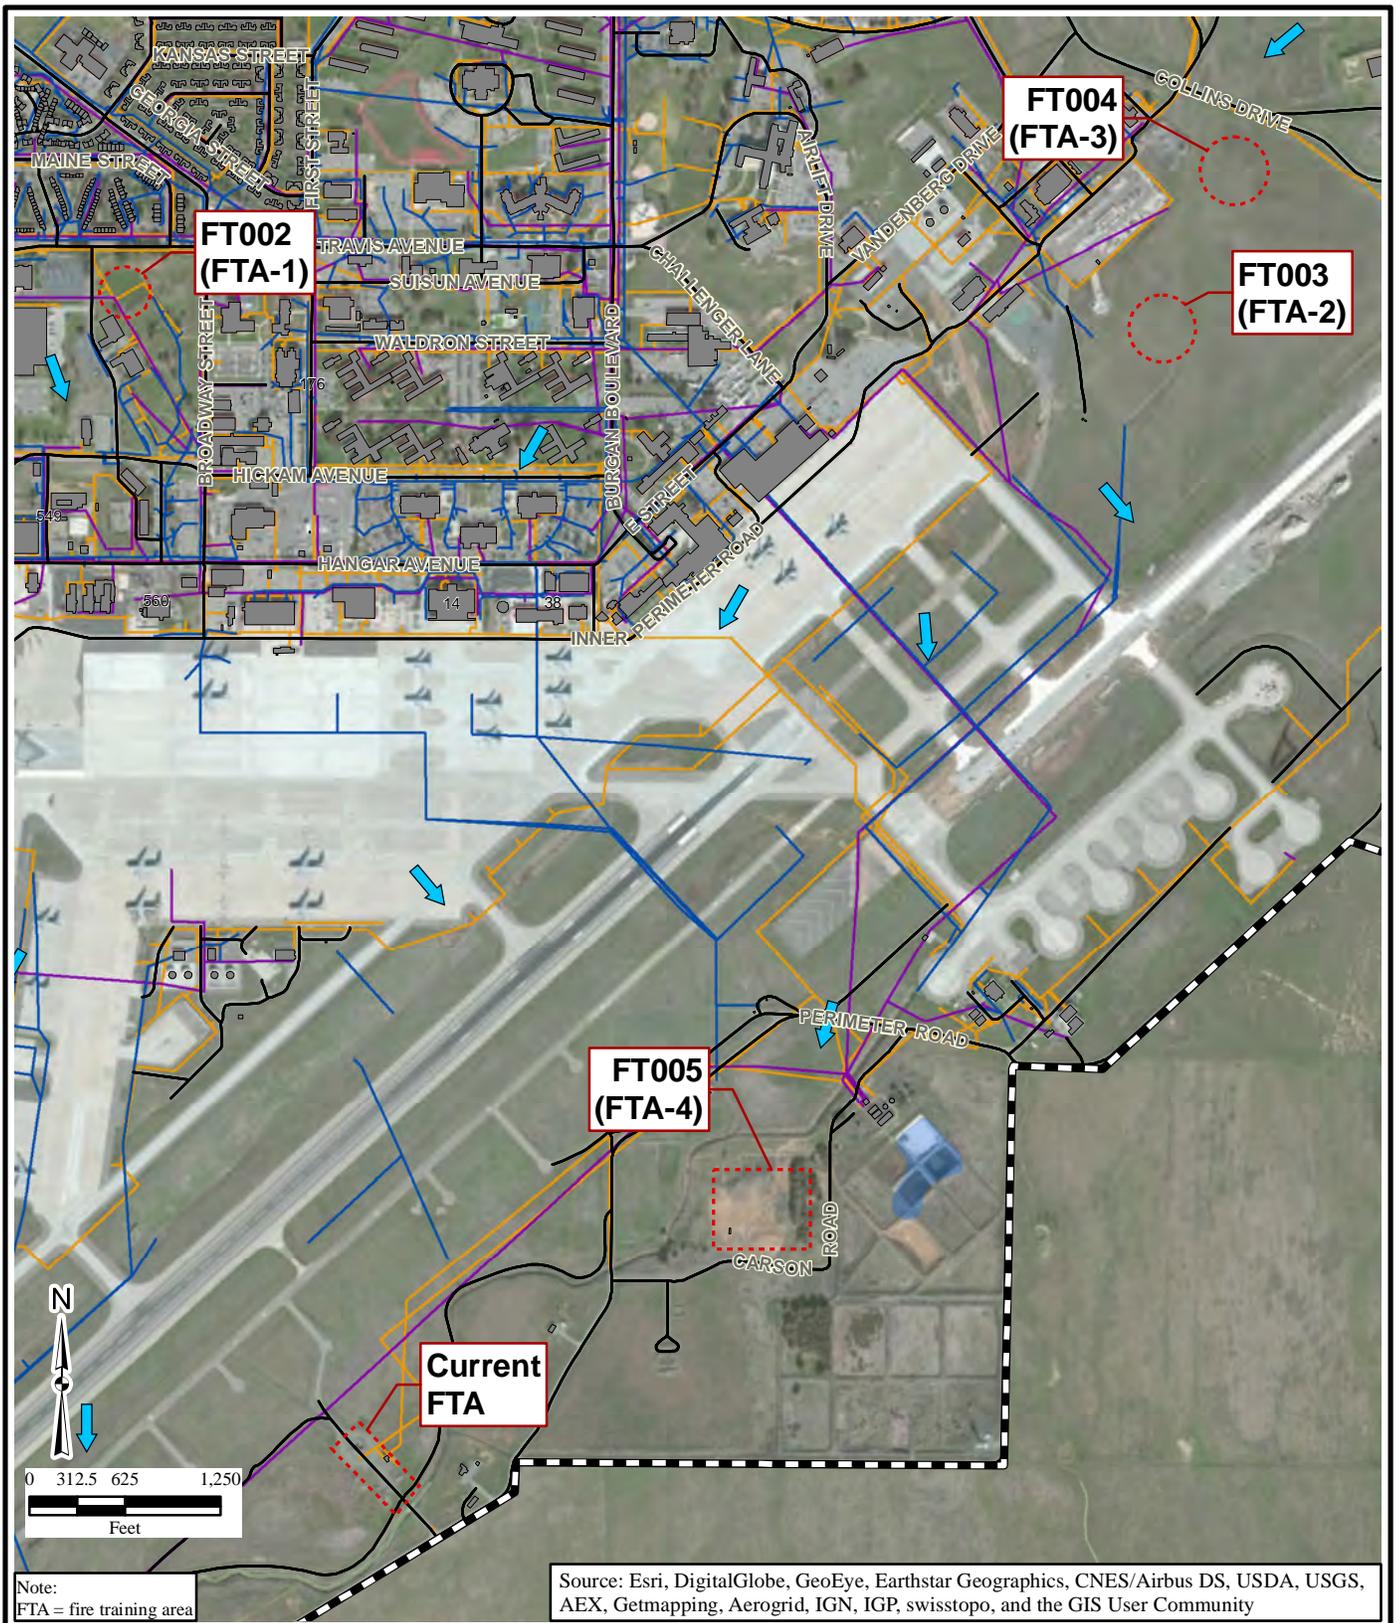
Note:
FTA = fire training area

From 1943 to 1950, waste fuels, oils, solvents, and other combustible wastes were allegedly burned in a 10-acre area during fire training exercises at FT002. The primary extinguishing agent used was water (Weston, 1995). AFFF was not introduced into Air Force inventory prior to 1970; therefore, FT002 never had AFFF applied as a fire extinguishing agent. The location of FT002 is shown on Figures 1.1 and 2.1.

From 1950 to 1952, waste fuels, oils, and solvents were reported to have been burned in a 15-acre area during fire training exercises at FT003. The flammable materials were usually sprayed or spilled on or in structures. The primary extinguishing agents used were water and protein foam (Weston, 1995). AFFF was not introduced into Air Force inventory prior to 1970; therefore, FT003 never had AFFF applied as a fire extinguishing agent. The location of FT003 is shown on Figures 1.1 and 2.1.

From 1953 to 1962, approximately 20 to 30 55-gallon drums of waste fuels, oils, and solvents were delivered to the site per week. The drums were emptied onto frames or mockups on the ground and burned during fire training exercises. The primary extinguishing agents used were water and protein foam (Weston, 1995). AFFF was not introduced into Air Force inventory prior to 1970; therefore, FT004 never had AFFF applied as a fire extinguishing agent. The location of FT004 is shown on Figures 1.1 and 2.1.

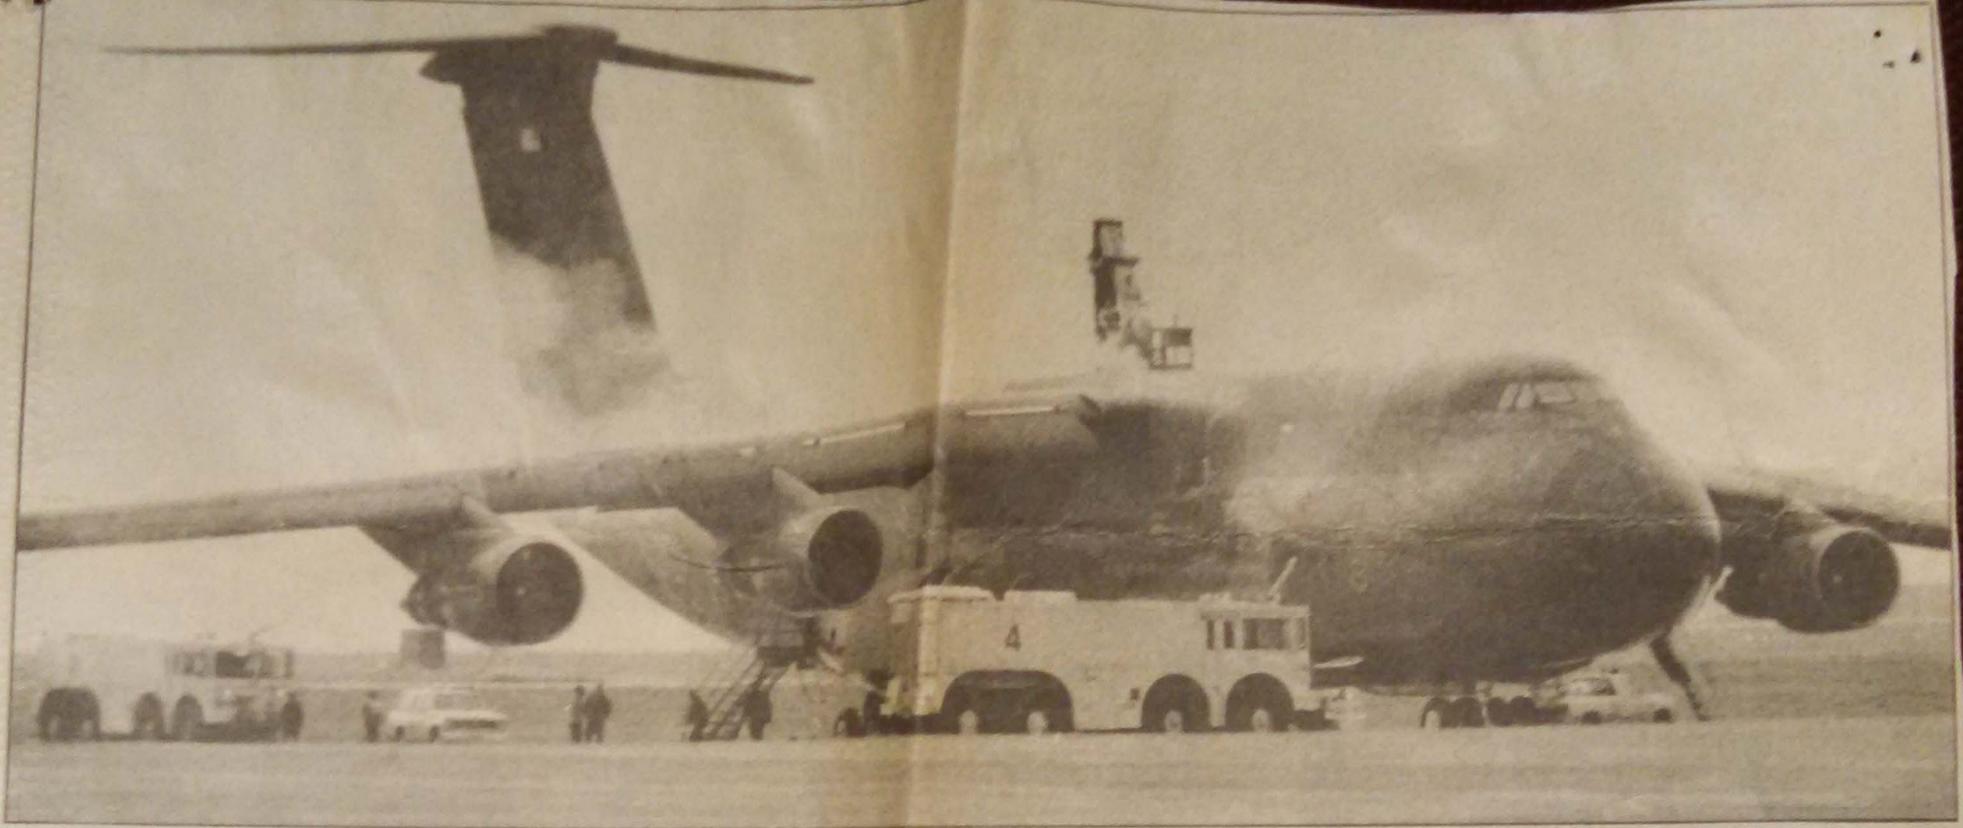
Plane catches fire

Travis Air Force Base emergency crews check over a C-5 transport plane that caught fire late Friday morning. The plane, which was on a local training flight, made a forced landing after a malfunction light warned the crew there was trouble. One of the eight crew members was treated for smoke inhalation.

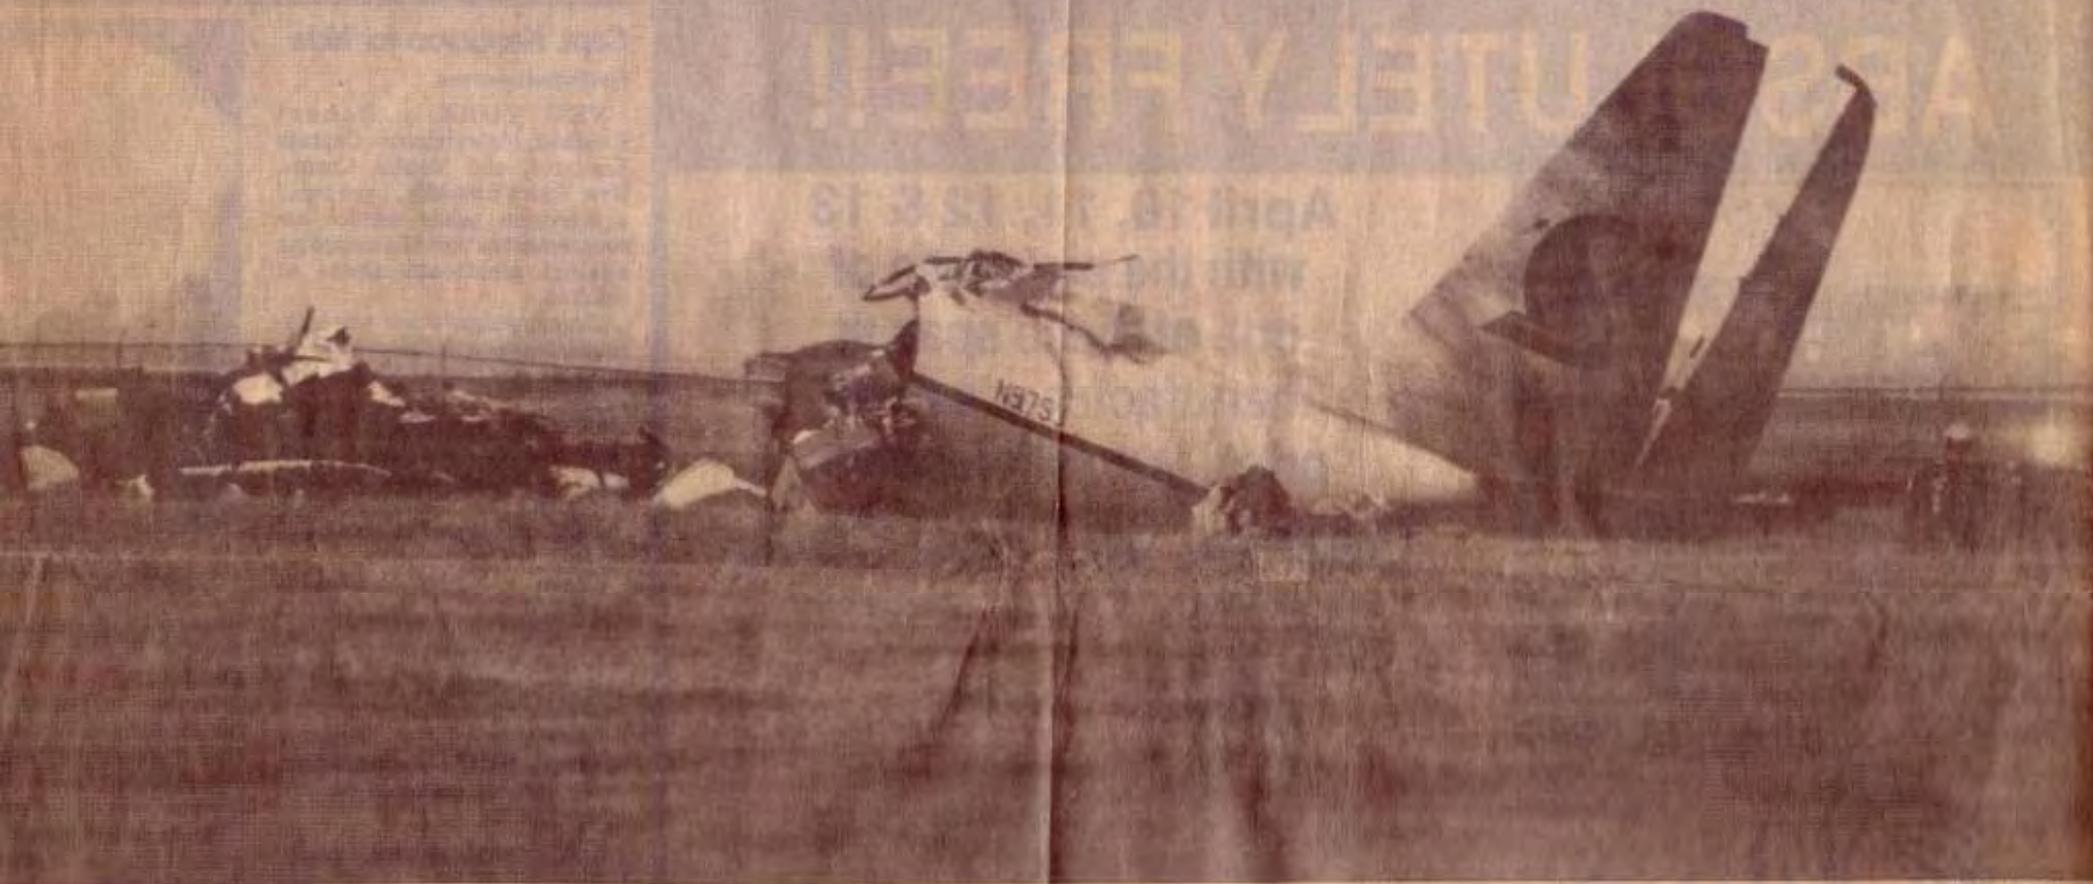
Five killed in tragedy near Travis runway

Section of a Southern Air Transport civilian cargo plane, above, rests in a field just west of Travis Air Force Base after it crashed and exploded about 5:30 p.m. Wednesday, killing

all five crew members. Below, base firefighters spray foam on smoking debris from the Lockheed L-100. A propeller is visible in the foreground.
