TRAVIS AIR FORCE BASE
ENVIRONMENTAL RESTORATION PROGRAM

**ANNUAL REPORT
ON THE STATUS OF
LAND USE CONTROLS
ON RESTORATION SITES
IN 2010**

FINAL

FEBRUARY 2011

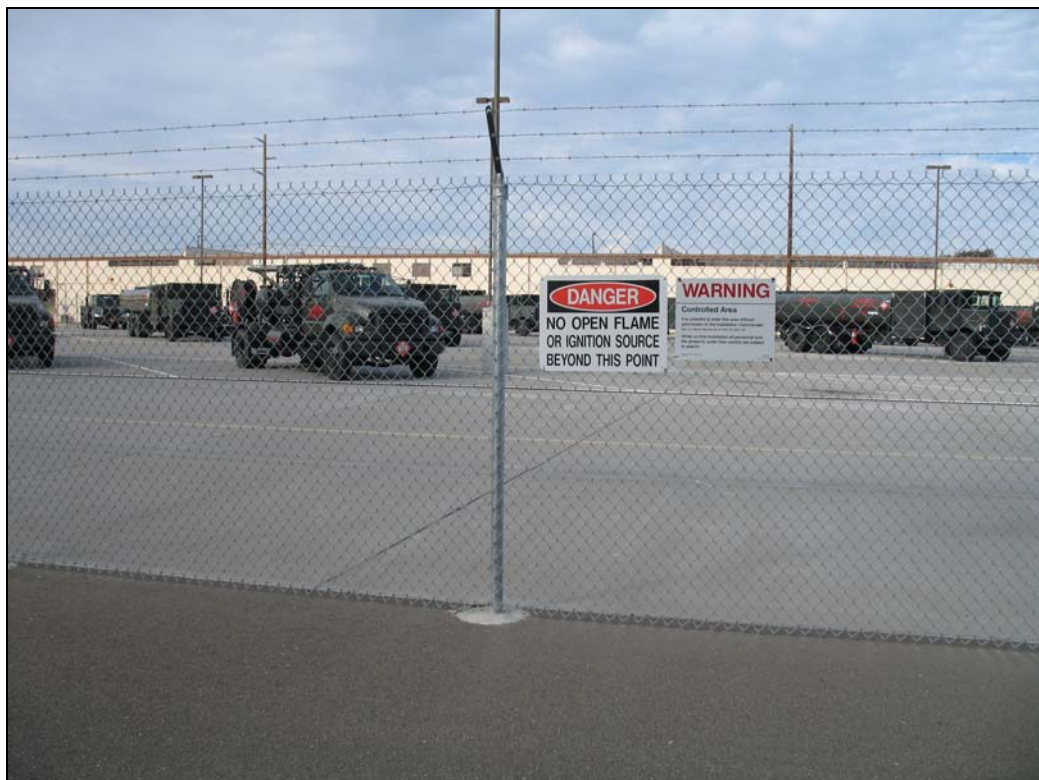
inspectors noted a potential for additional physical barriers (i.e., fences) and signage to adversely impact vehicle operations. There is no evidence that the cadmium-impacted soil beneath the concrete parking area has been disturbed. Photograph 1 in Appendix B of this report shows the controlled area at SS015.

Photograph 1: Controlled Area at SS015

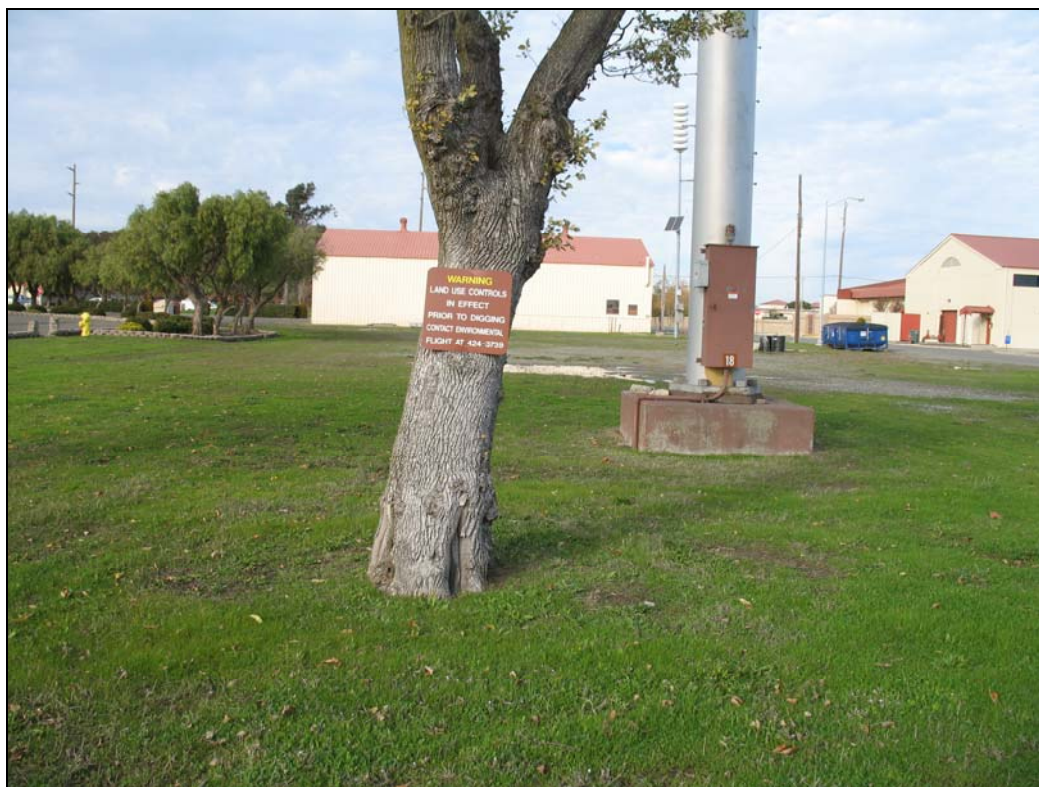
The 2010 inspection of the LUCs at SS016 found that administrative controls are adequate to enforce the restriction, so physical barriers (i.e., fences) are not needed. There is no evidence that the PAH-impacted soil has been disturbed either with or without proper authorization. A warning sign has been posted on a tree in the middle of the site to notify base workers of the

Photograph 2: Controlled Area at SS016

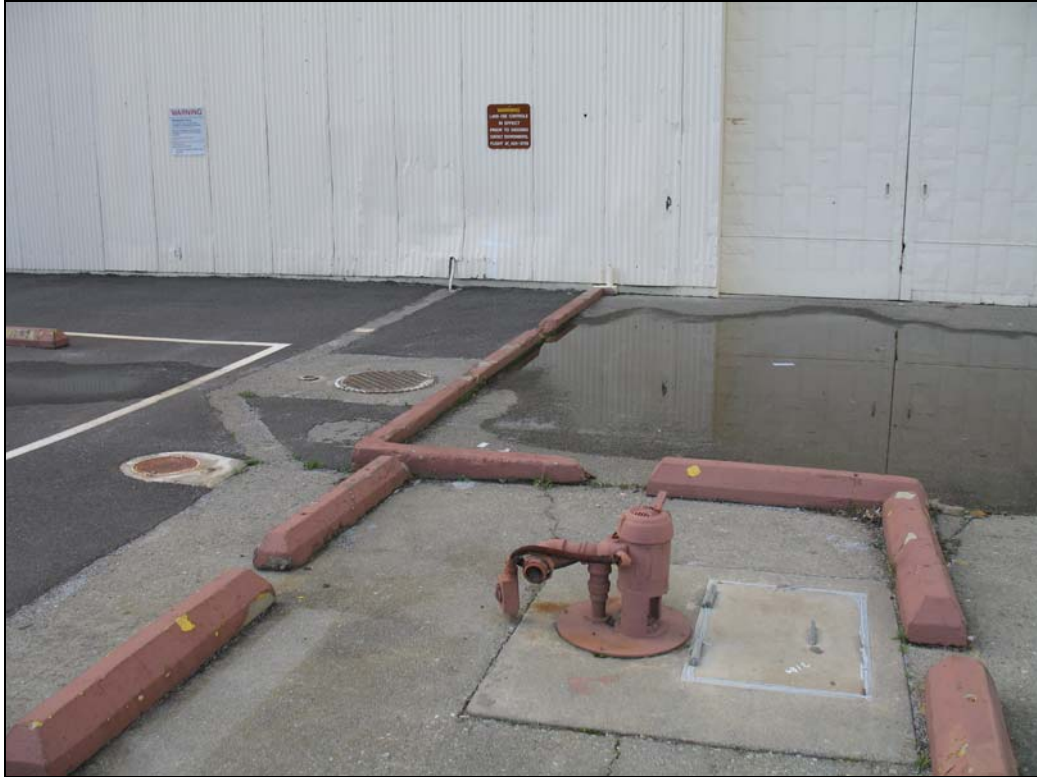
The 2010 inspection of the LUCs at the soil portion of SD033 found that administrative controls are adequate to enforce the restriction, so physical barriers (i.e., fences) are not needed. There is no evidence that the cadmium- and benzo(a)pyrene-impacted soil has been disturbed. Warning signs have been posted on both sides of Facility 810 to notify base workers of the presence of the controlled area. Photographs 3 and 4 in Appendix B of this report show the controlled soil areas at SD033.

Photograph 3: Warning Sign at Controlled Area on East Side of SD033

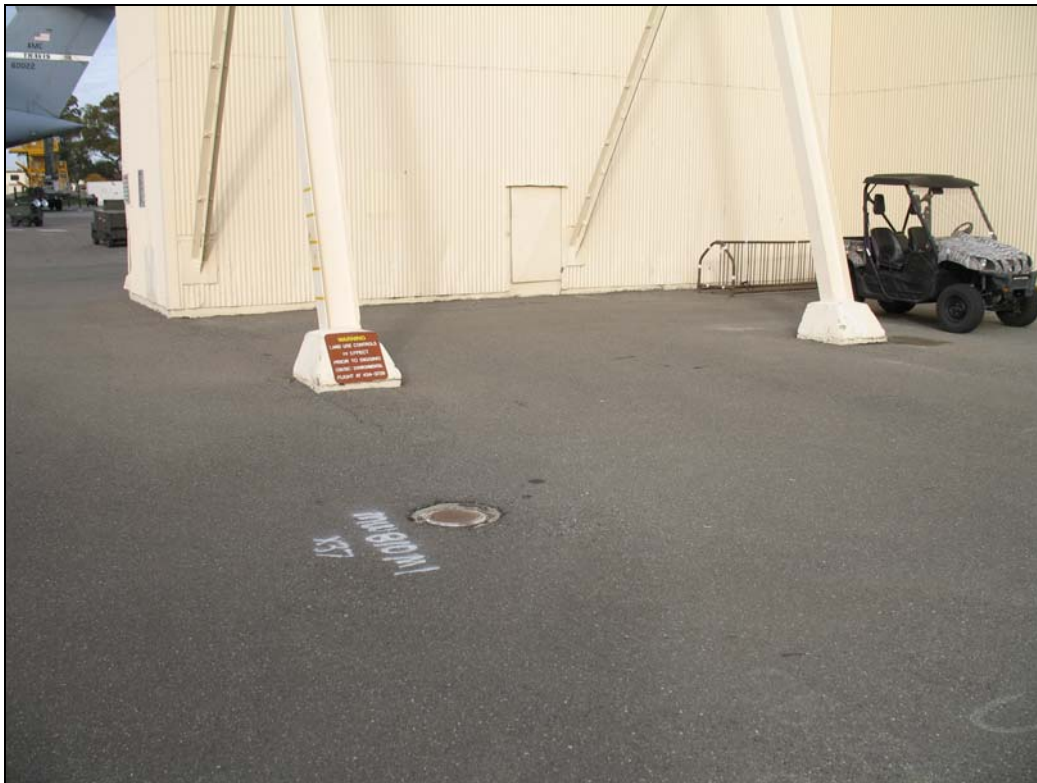
Photograph 4: Warning Sign at Controlled Area on West Side of SD033

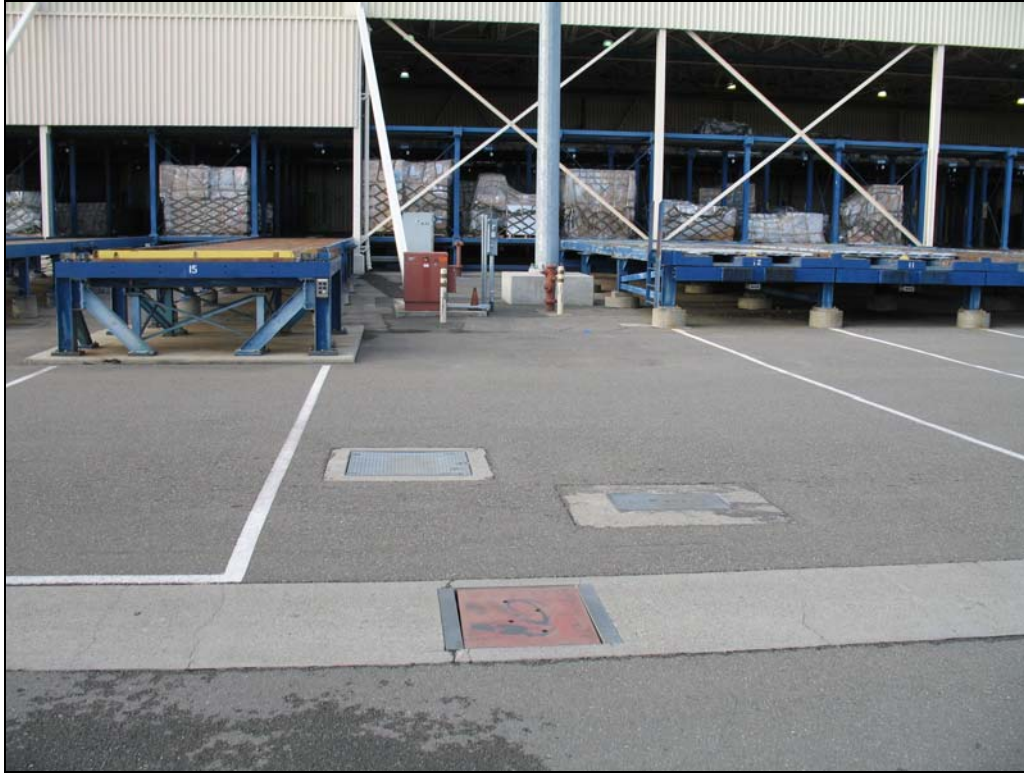
Specifically, vehicles that are designed to transport large cargo pallets to and from both military and commercial aircraft require an open area free of physical hazards. The two small controlled areas lie in the middle of these open work areas, and there are no existing posts or structures that could be used to post signs that point out their location. Because of the high tempo of mission-critical operations associated with the air freight terminal, any obstructions would pose significant risk to both personnel and equipment. Photographs 5 and 6 in Appendix B of this report show the controlled areas within the open work areas at SD037.

Photograph 5: Controlled Area on Southeast Side of SD037

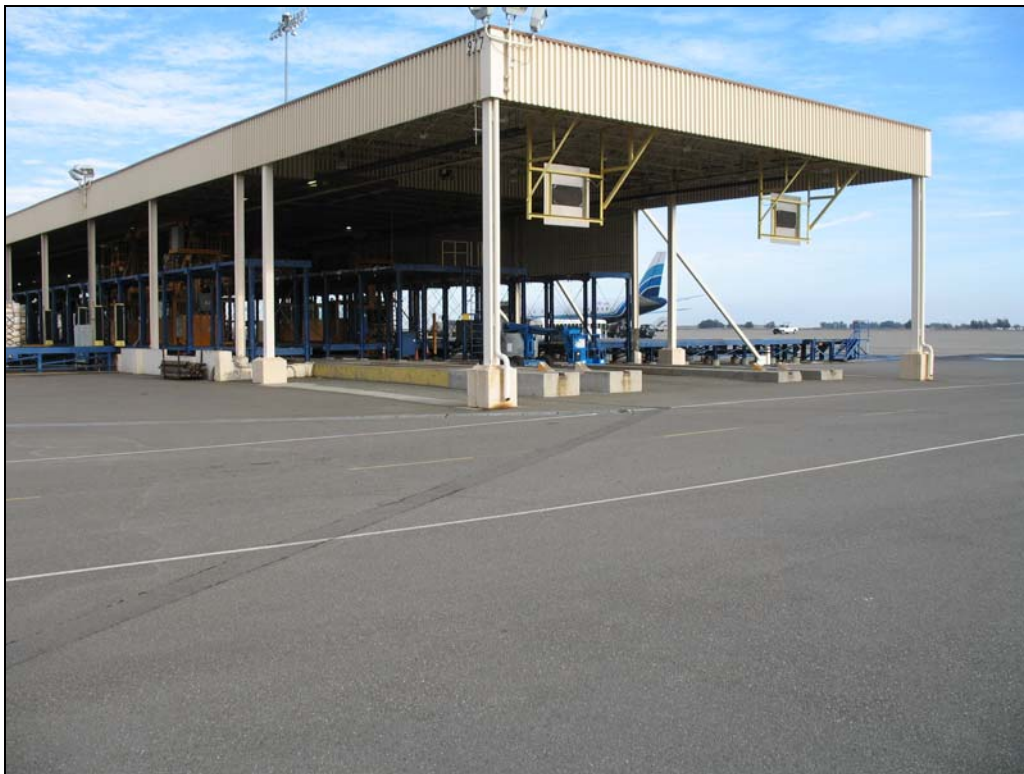
Photograph 6: Controlled Area on Southwest Side of SD037

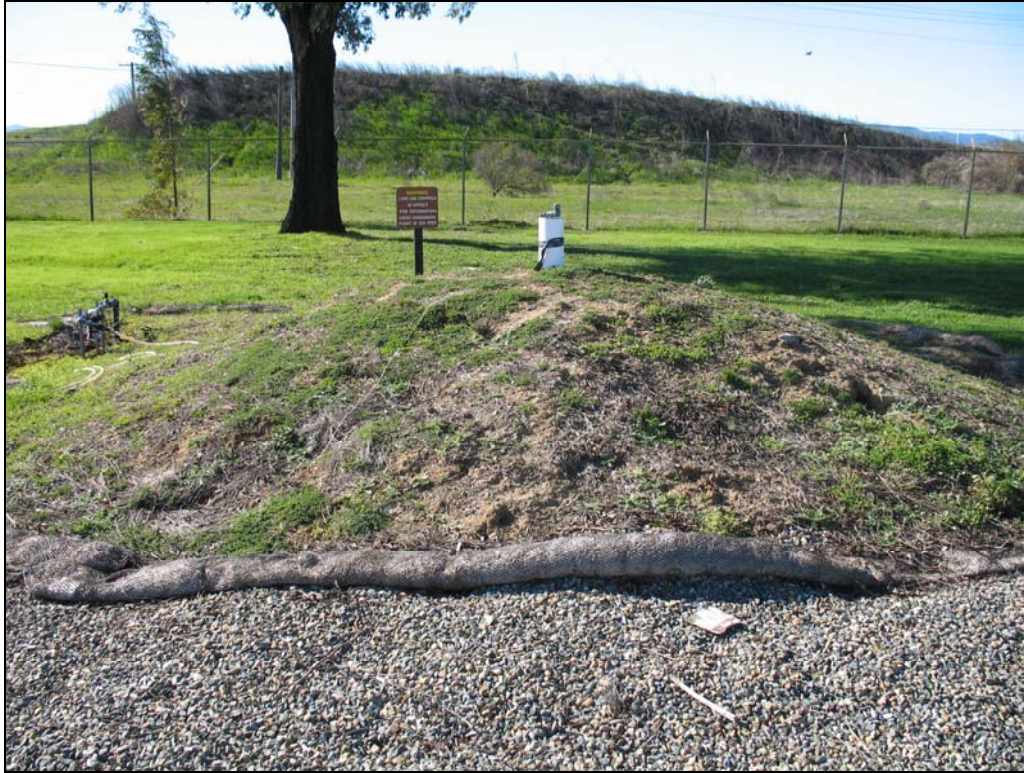
The 2010 inspection of the LUCs at DP039 found that administrative controls and a LUC warning sign are still adequate to enforce the restriction, so physical barriers (i.e., fences) are not needed. Most of the lead-impacted soil has been excavated and sent by truck to an appropriate landfill as a result of the bioreactor demonstration project. Travis AFB will continue to enforce the DP039 controls until the upcoming bioreactor report has received regulatory review and the base receives approval to modify the footprint of the controlled area. Photograph 7 in Appendix B of this report shows the surface of the bioreactor over the controlled area at DP039. The warning sign that notifies visitors to the site of the presence of LUCs can be seen in the background. Building 755 was vacated and demolished in 2009.

Photograph 7: Controlled Area at DP039 (Post Bioreactor Construction)

The inspectors noted that the lead-contaminated surface soil that required the placement of land use controls at site DP039 had been completely excavated as part of an unrelated groundwater cleanup demonstration project (bioreactor). The footprint of the bioreactor completely covered the controlled area, so the bioreactor construction also removed the need for soil land use controls at this site. The base will document the excavation and disposal of the lead-contaminated soil in a report on the performance evaluation of the DP039 bioreactor, scheduled for 2011. The base will maintain the DP039 land use controls until the regulatory agencies have

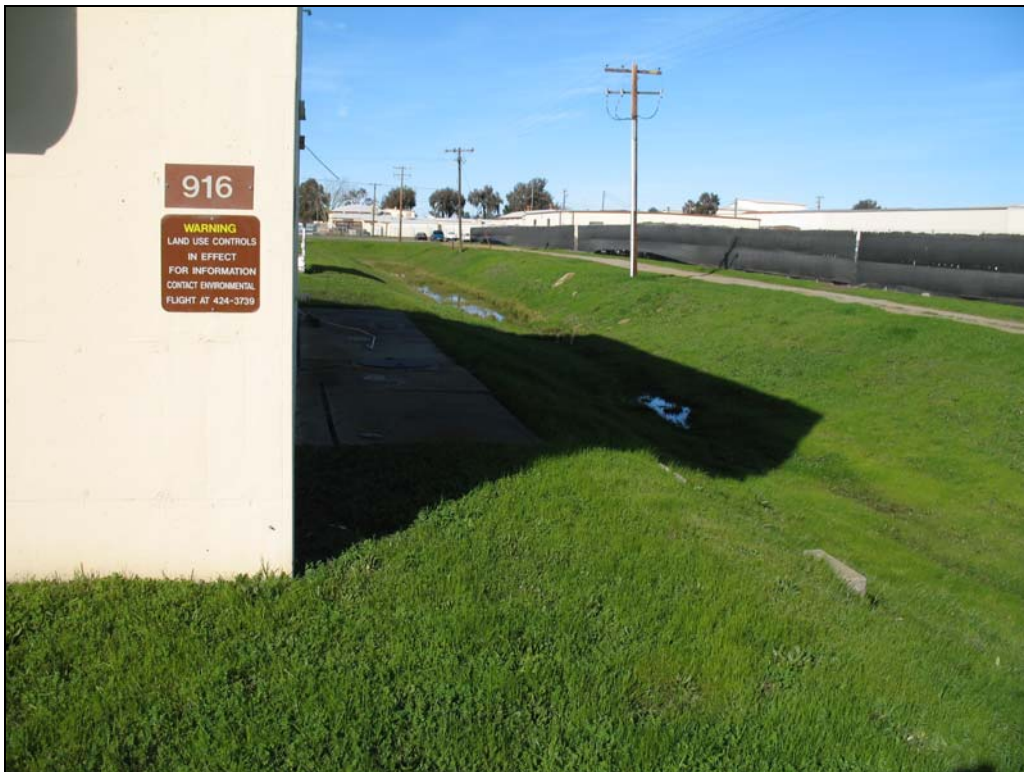
The 2010 inspection of the LUCs at SD043 found that administrative controls are adequately enforcing the restriction, so physical barriers (i.e., fences) are not needed. There is no evidence that any soil disturbances in the vicinity of the concrete pad and generator took place in 2010. Photograph 8 in Appendix B shows the east side of the generator and pad south of Building 916, and photograph 9 shows the warning signs in relation to the west side of the controlled area at SD043.

Photograph 8: Sign near East Side of Installed Generator at SD043

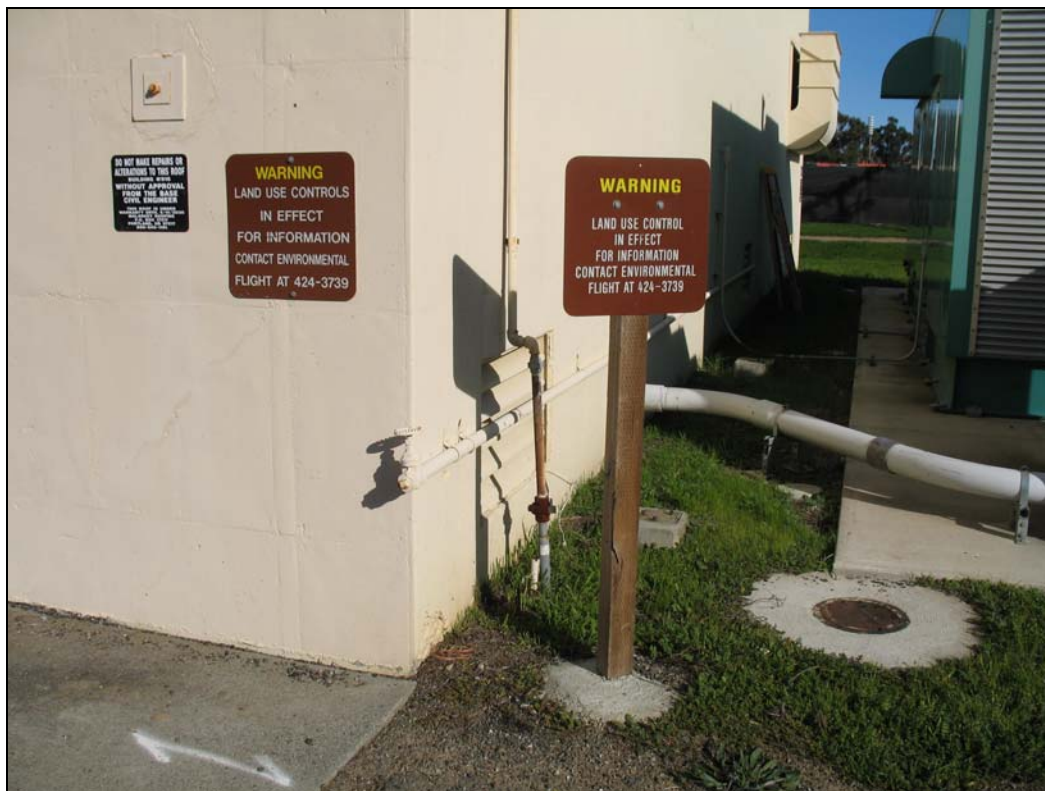
Photograph 9: Generator Pad and Warning Signs at SD043. Stanchion of Former Pad with Leaking Transformers is visible in the foreground.

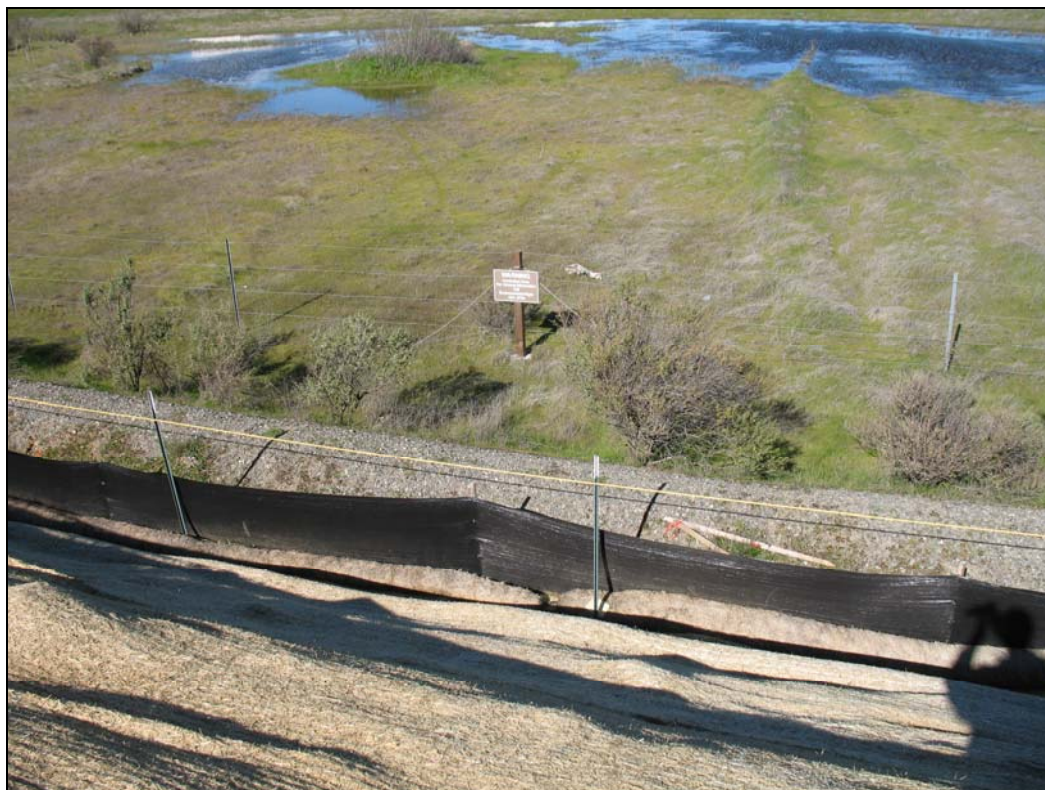
There is no evidence to suggest that the property is being used for other than industrial purposes. The south gate was locked, and the Asset Management Flight keeps a copy of the key. Photograph 10 of Appendix B shows a warning sign on the north side of the controlled area, next to the berm. Photograph 11 shows the north side of the north side of the LF044 Fence and AST construction area, and photograph 12 shows the south gate and a warning sign. Both are in good condition.

Photograph 10: Warning Sign at LF044 near new AST Containment Enclosure

The 2010 inspection of the LUCs at LF044 found the fence and signs along the northwestern and western sides of the controlled area as well as the north gate had been removed to support the AST construction project. All of the contaminated soil and construction debris within the footprint of the AST construction area had been excavated and taken off-site. There are several fence sections along the southern and eastern sides with broken strands. Several signs showed metal fatigue and were lying near the fence posts. Several of these deficiencies were noted in the 2009 annual LUC report, but repairs were postponed until after the completion of the AST facility construction project. It is highly likely that the security fence around the new AST facility will serve as part of the fence around the remaining LF044 controlled area. Once construction is complete, the base will evaluate the amount of fence repair and sign replacement that will be required to support the LUC restrictions.

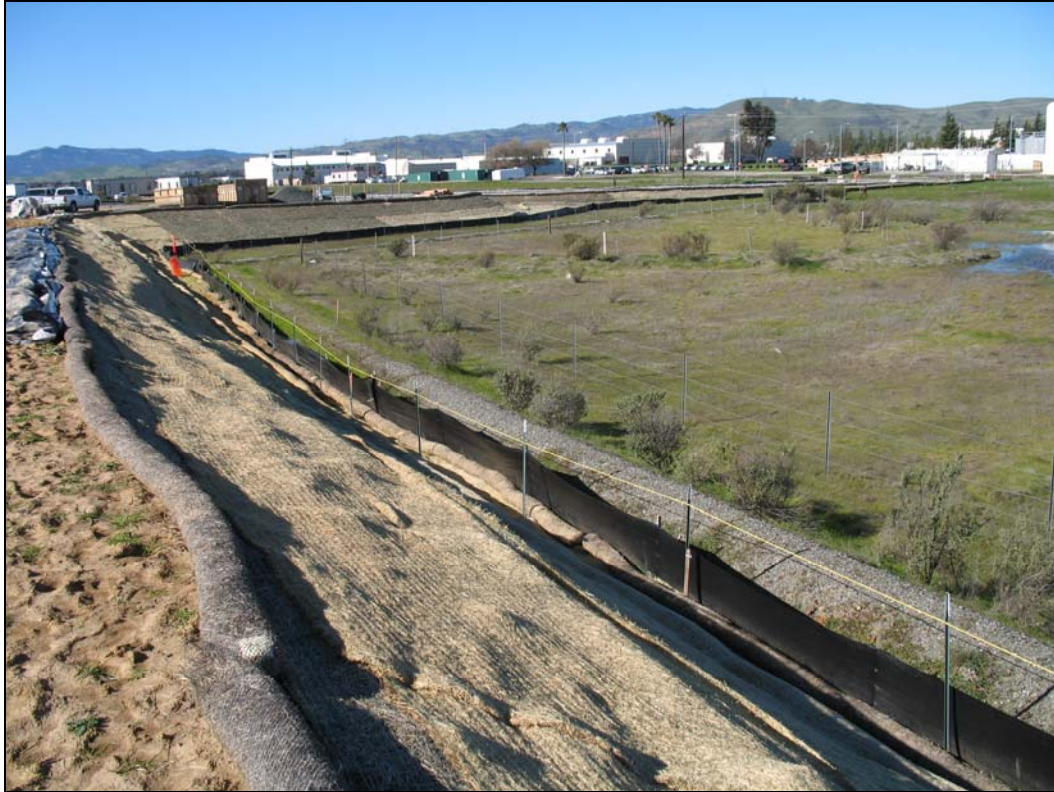
Photograph 11: North Side of LF044 Fence/AST Construction Area

The inspectors noted that the construction of an aboveground storage tank (AST) facility is taking place within most of the LF044 footprint. In the early stages of the project, the construction debris and contaminated soil in the central portion of LF044 were excavated and taken to either a local recycling facility or landfill, as appropriate. Once native soil was reached, heavy equipment continued to rearrange the topography and clean soil was brought into the construction area to form the foundations and secondary containment walls for the ASTs. Until this project is complete, the base cannot accurately delineate the boundaries of the remaining portion of the LF044 controlled area. As a result, the base will continue to treat all of LF044 as an environmentally controlled area and enforce LUCs until the tank facility is built and revised fencing and signage requirements for the portion of LF044 that is outside of the tank farm can be identified. All LUC revisions will be coordinated and approved by the environmental regulatory agencies before implementation.

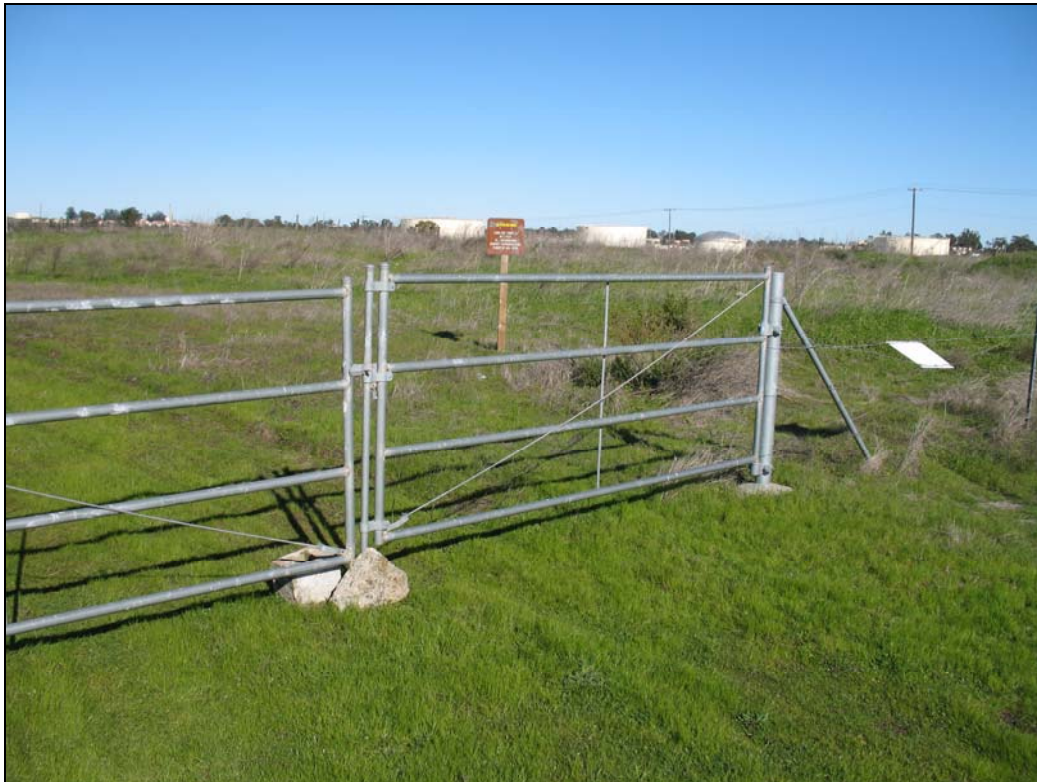
Photograph 12: Gate and Warning Sign on South Side of LF044

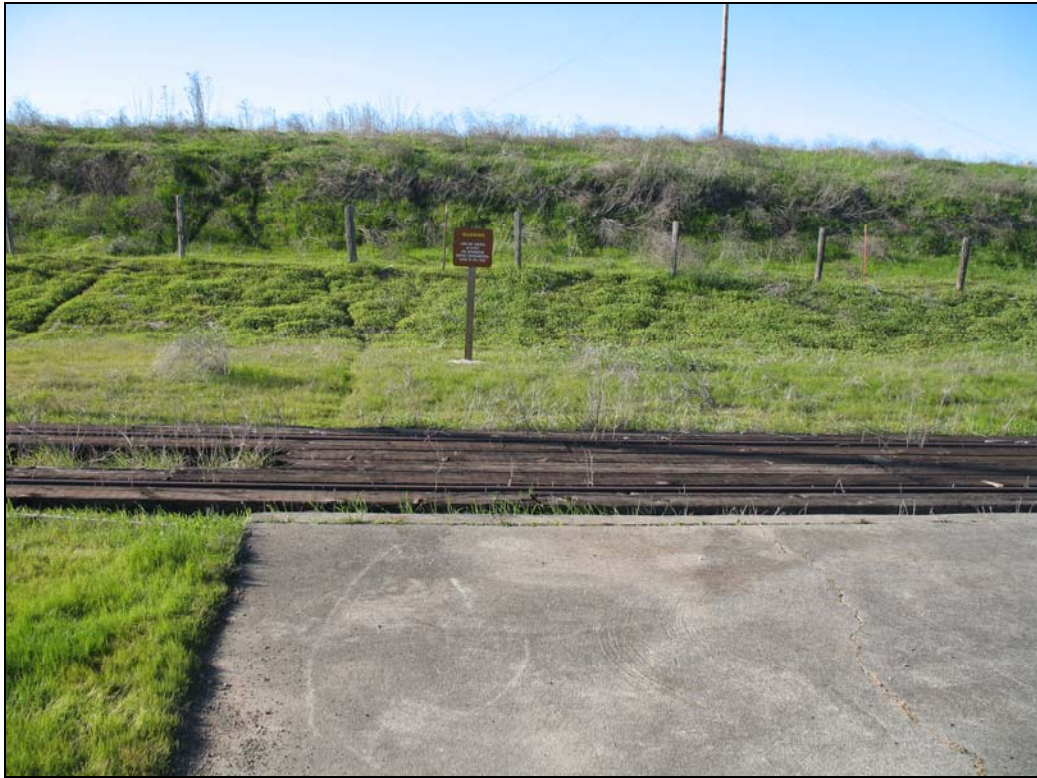
The 2010 inspection of the LUCs at SS046 found that administrative controls and two warning signs are adequate to enforce the restriction, so additional physical barriers (i.e., fences not associated with the Grazing Management Unit) are not needed. There is no evidence that the contaminated soil has been disturbed. Photograph 13 of Appendix B of this report shows the warning sign at the west end of the SS046 controlled area, and photograph 14 shows the warning sign at the east end of the controlled area.

Photograph 13: Warning Sign at West Side of SS046

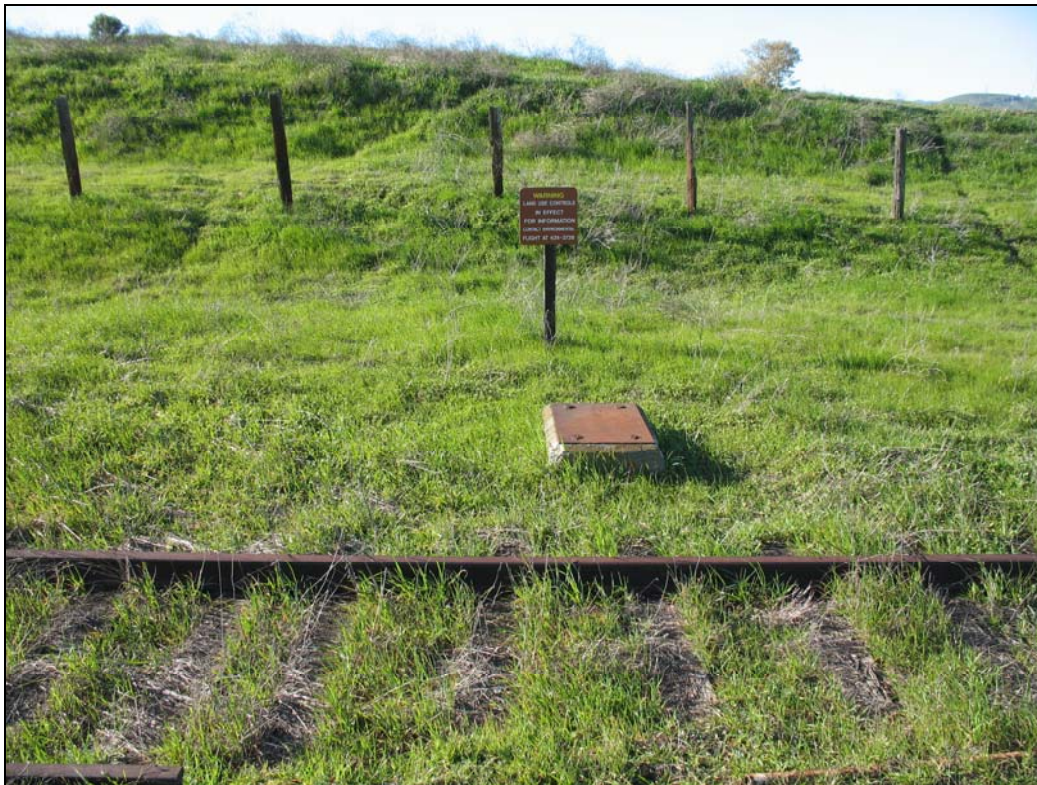
Photograph 14: Warning Sign at East Side of SS046

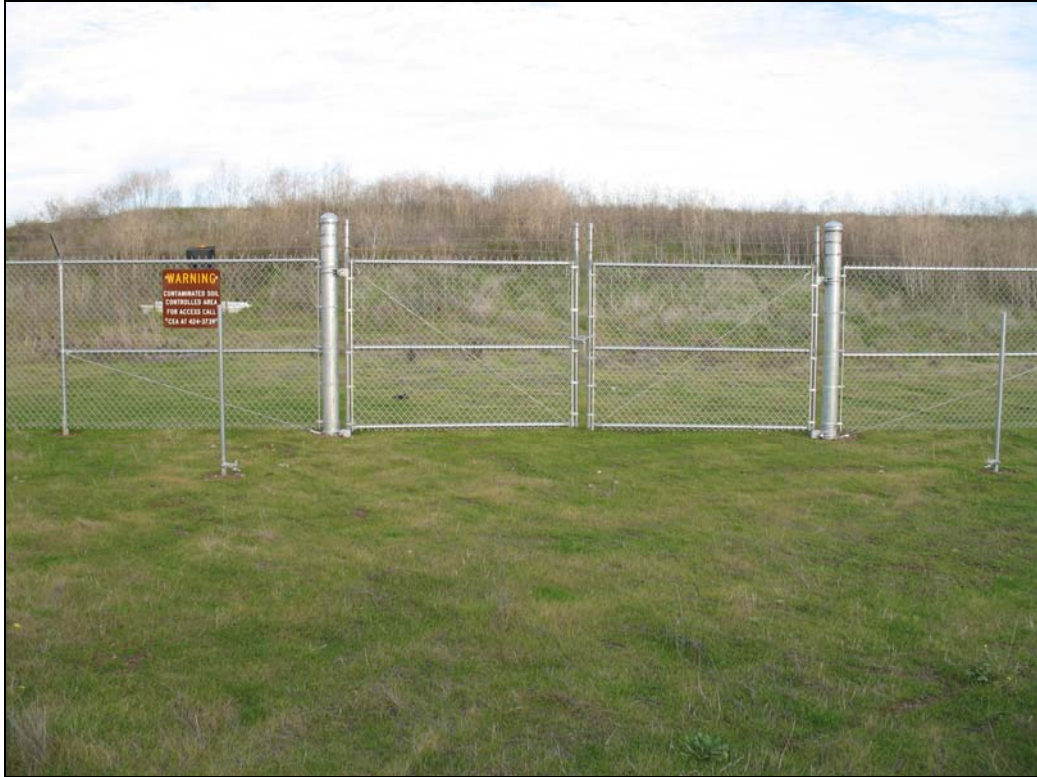
Photograph 15: New Northwest CAMU Gate with Warning Sign

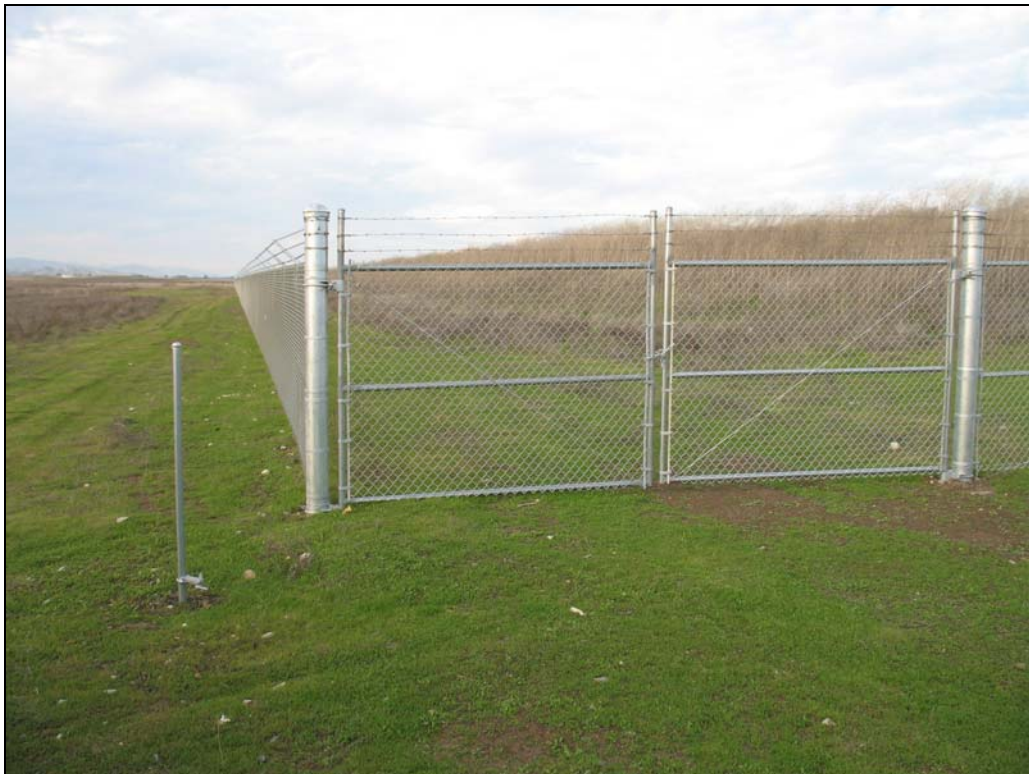
Photograph 16: New Southern CAMU Gate

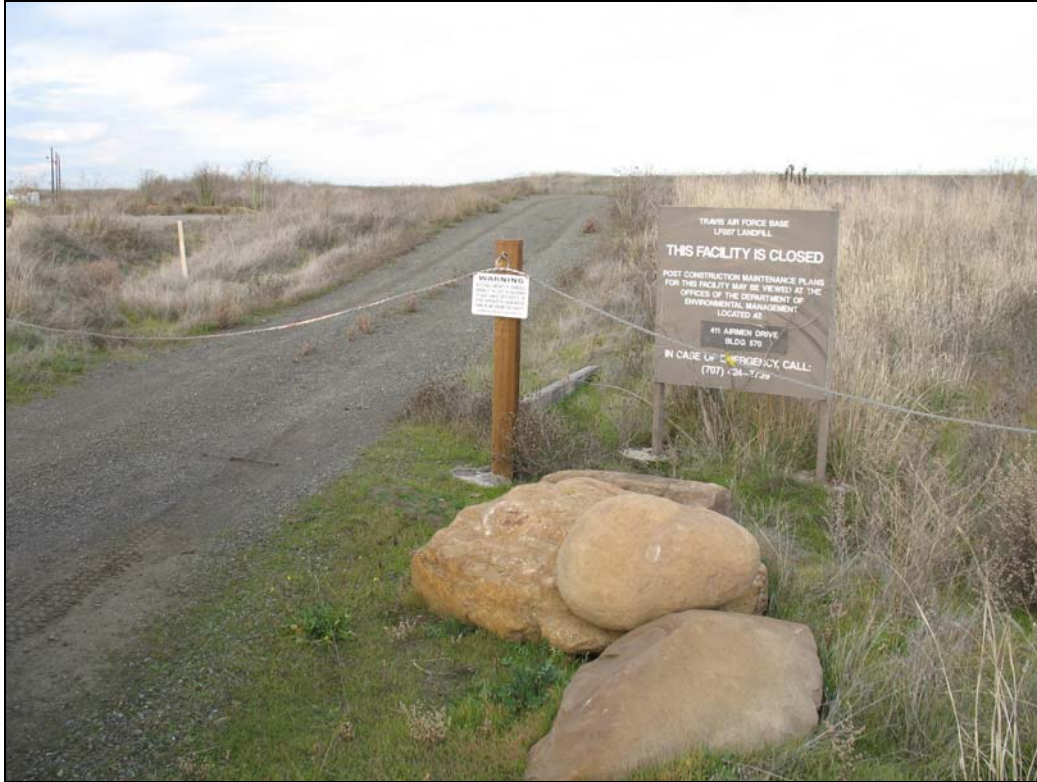
Photograph 17: Warning Sign at LF007 Entrance

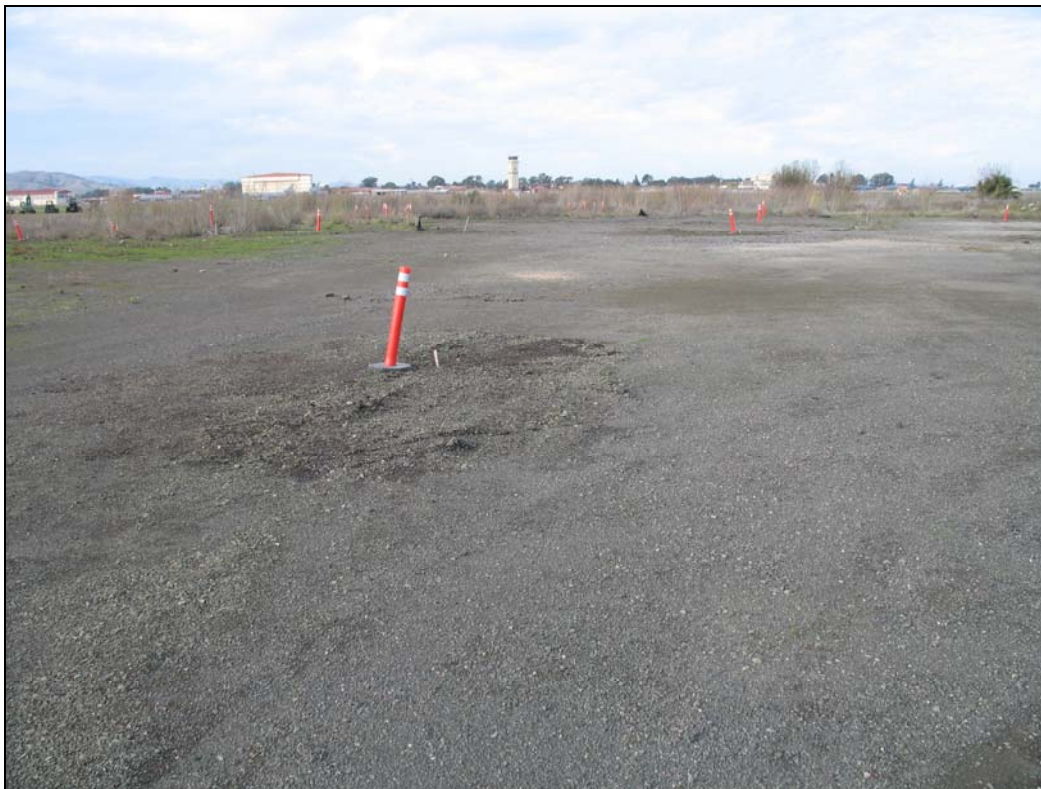
The 2010 inspection of the LUCs at FT005 found that administrative controls are adequate to enforce the restriction, so additional physical barriers (i.e., fences not associated with the Explosive Ordnance Disposal area) are not needed. There is no evidence that an unauthorized disturbance of the contaminated soil has taken place. Photograph 18 of Appendix B of this

Photograph 18: Controlled Area at FT005

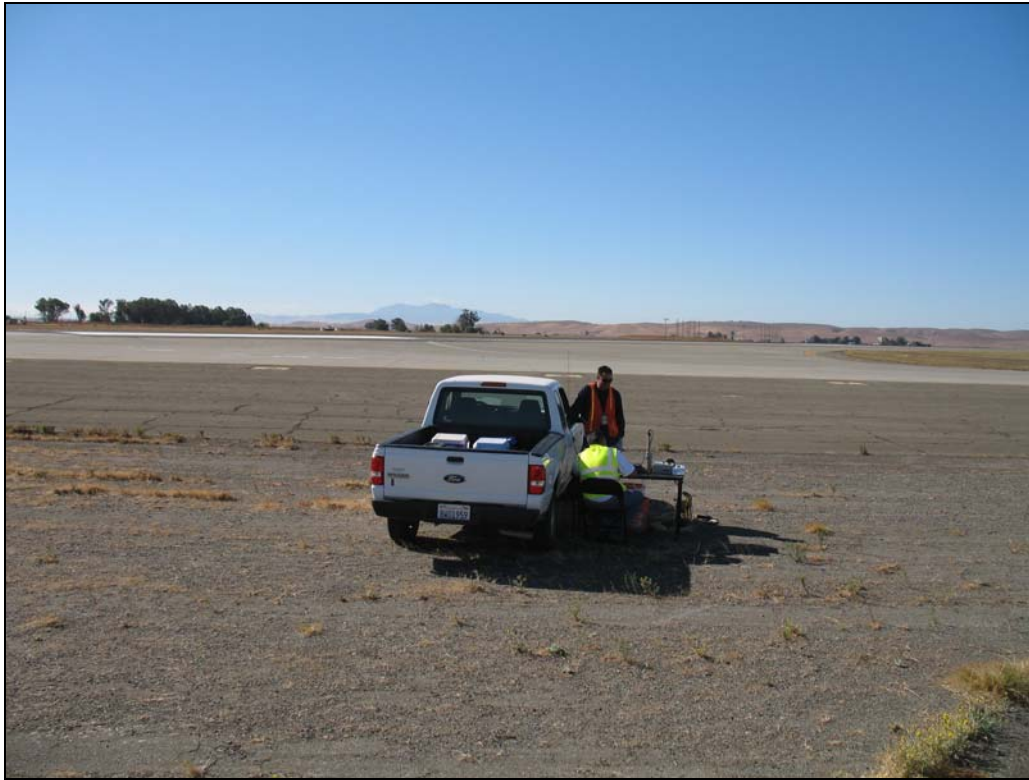
Monitoring wells at ST032 are sampled annually under the Travis AFB GSAP, usually in the May timeframe. Because of the difficulty in accessing the site, a base project manager conducted a LUC inspection during the sampling event. During the 2010 GSAP annual event, no LUC deficiencies were noted. Photographs 19 and 20 in Appendix B of this report provide two views of ST032 during groundwater sample collection last summer.

Photograph 19: Controlled Area at ST032 (Southwest View)

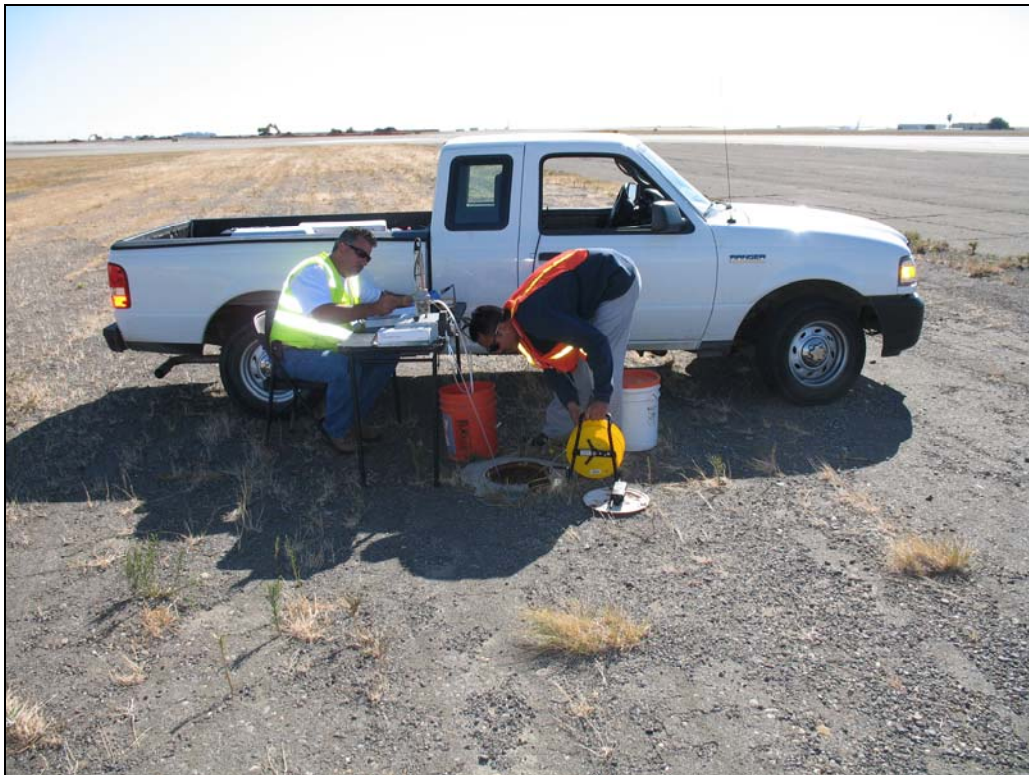
Photograph 20: Controlled Area at ST032 (Southeast View)
